**MAHS Field School 2018
Pickles Reef
Florida Keys National Marine Sanctuary**

MAHS returned to Pickles Reef in June of 2018 to hold its annual field school.

FKNMS reported extensive damage to both natural and cultural sites in the Upper Keys, including Pickles Reef. The Sanctuary asked MAHS to resurvey the Barrel Wreck to assess its condition following the storm.

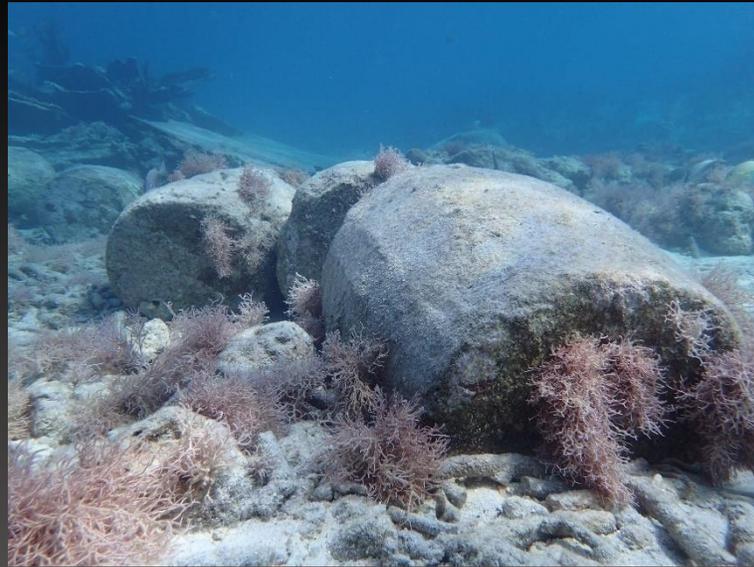
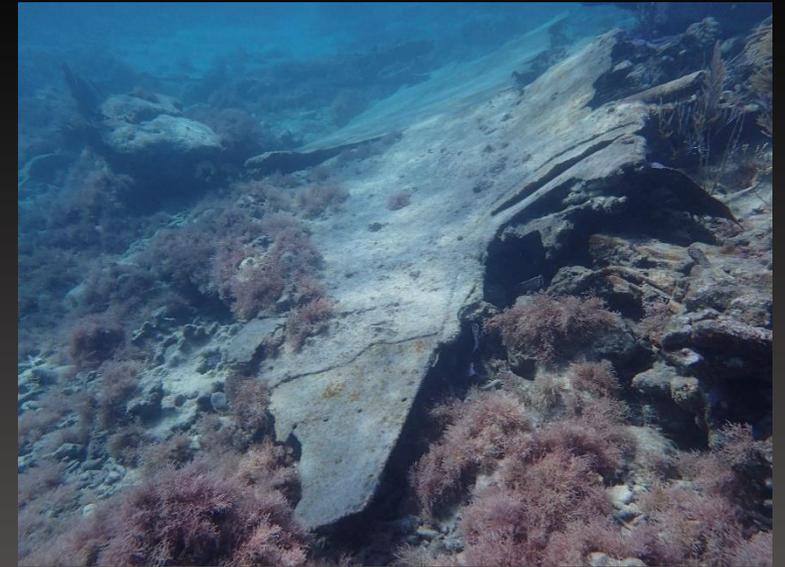
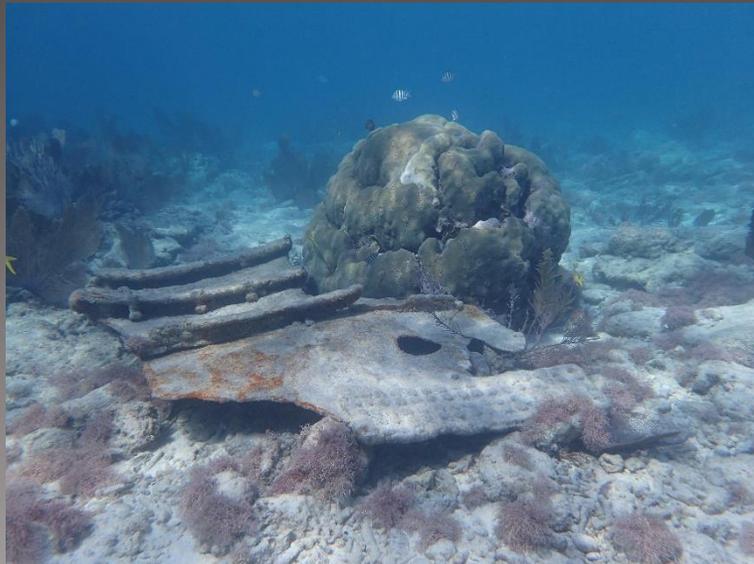
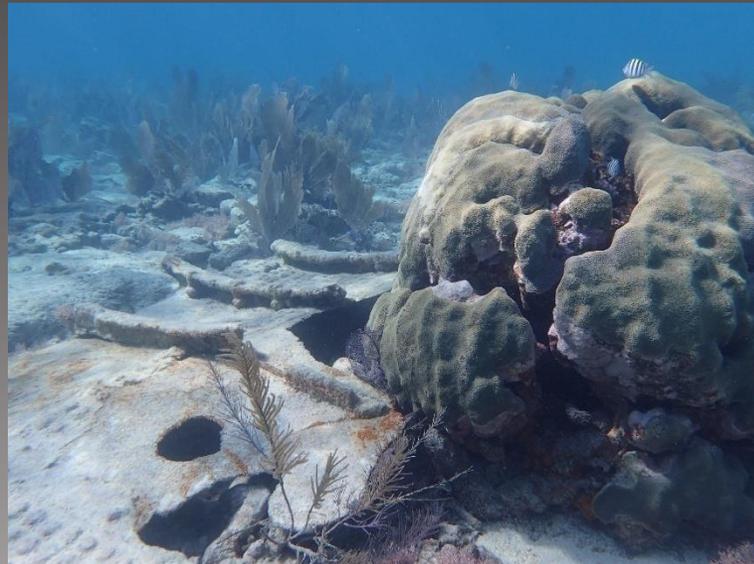
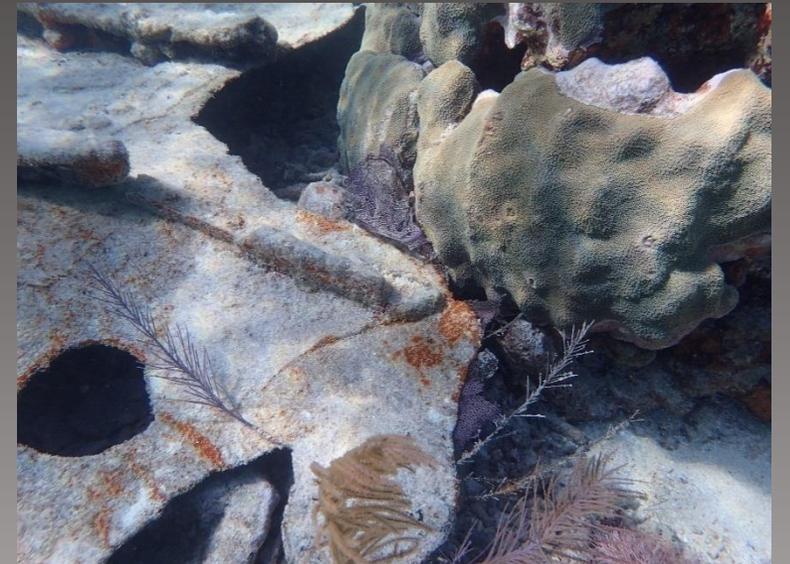
These photos were taken by the Sanctuary during the winter after the storm.

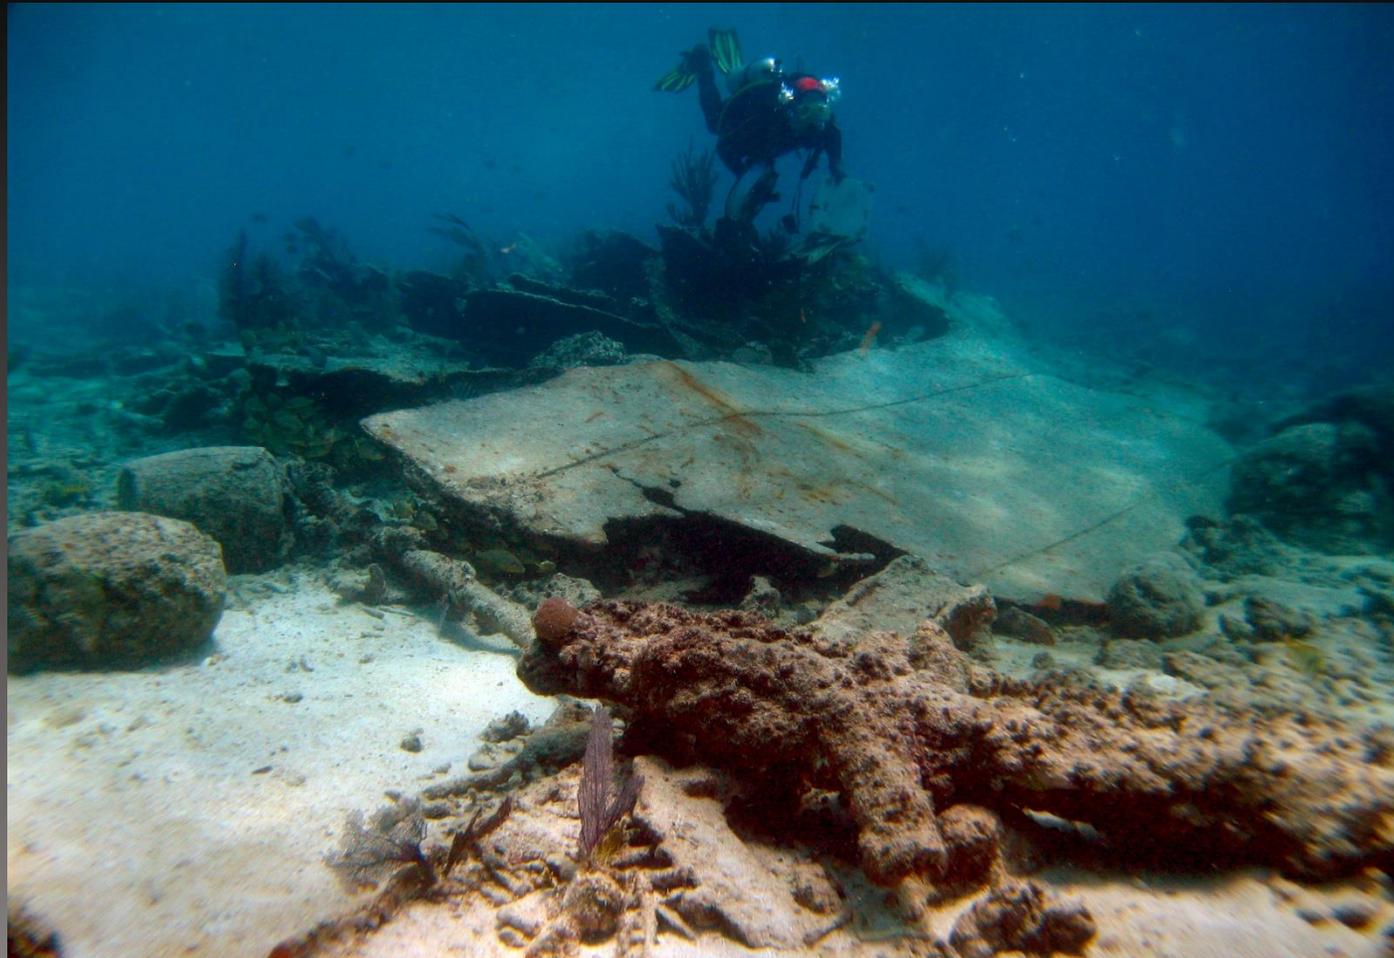
While much of the site appeared to be intact after the storm, there were some substantial changes noted. For example, this very large section of hull plating was found off the end of the keel. The feature was not in that location previously, and we're not sure at this point where it came from.

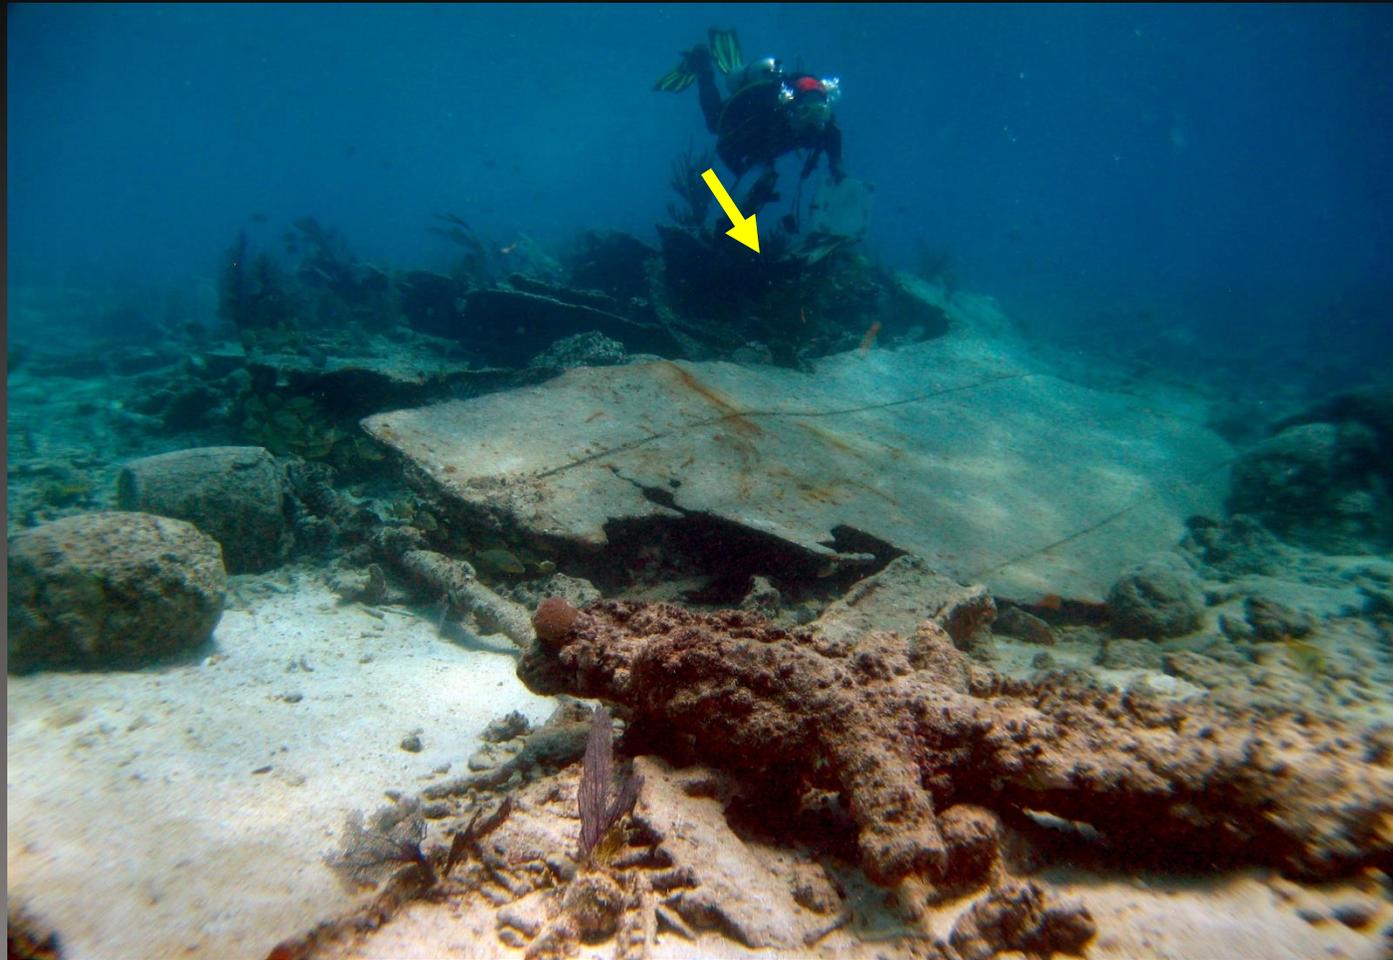
The broken end of the keel assembly, noted earlier as an orientation point, is shown by the arrow below the diver.

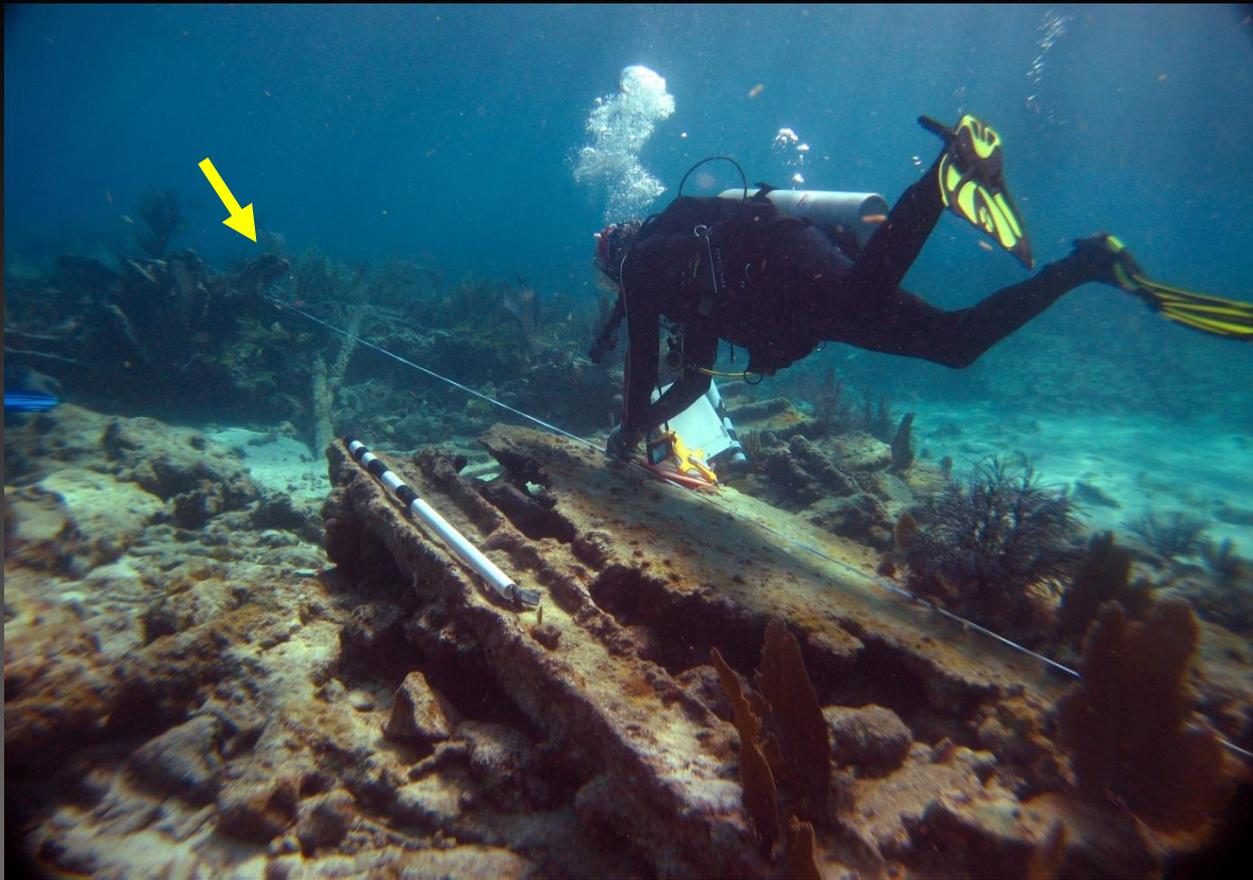
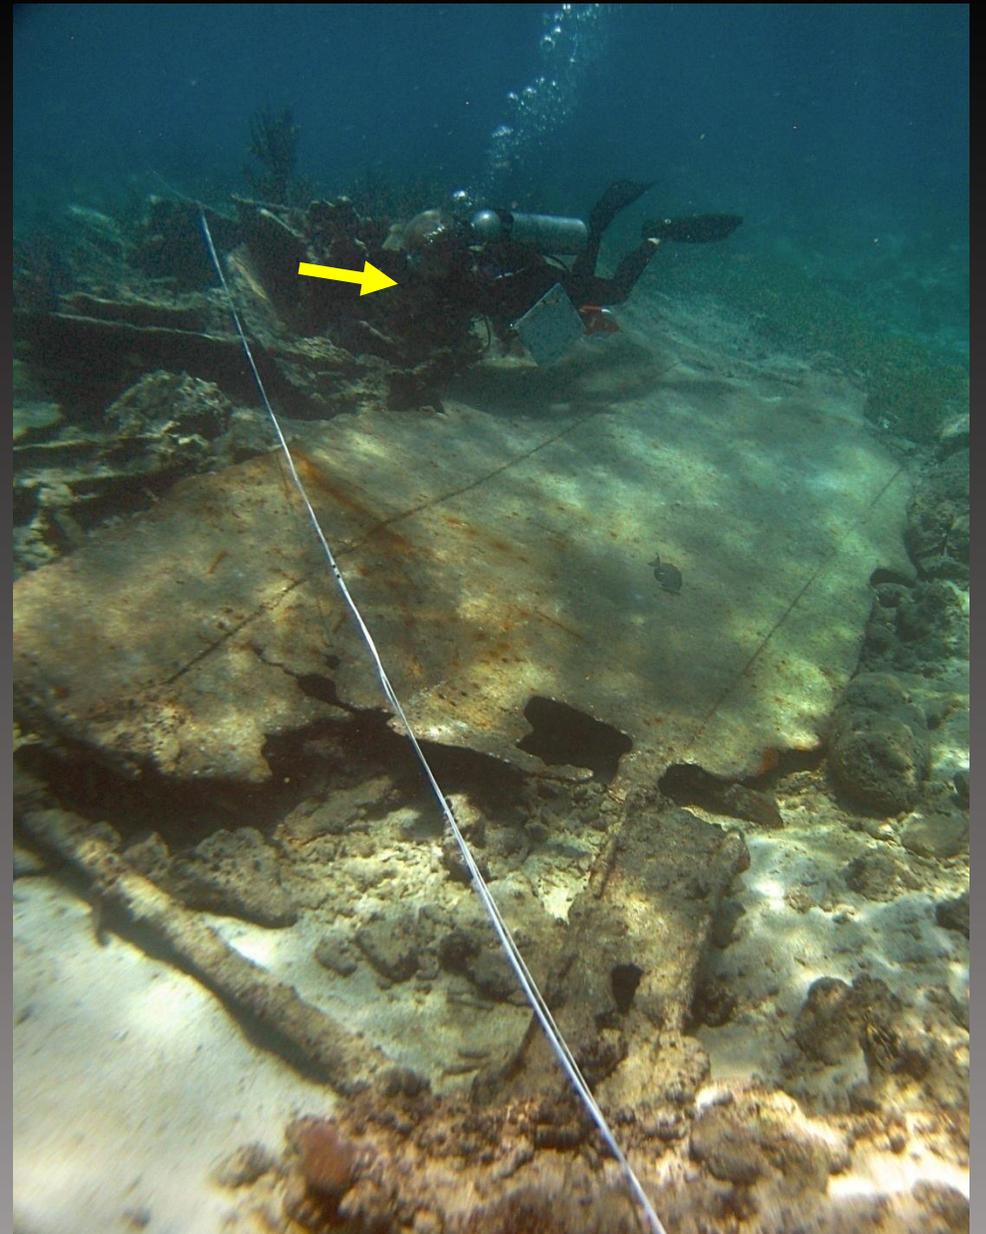
Here are some before and after images of the same area, with arrows again indicating the end of keel.

Above is a pre-Irma view showing miscellaneous metal features. The image to the right is a post-Irma view showing the area from a slightly different angle. Many of the features appear to have moved or to have been covered by the large section of hull plating.

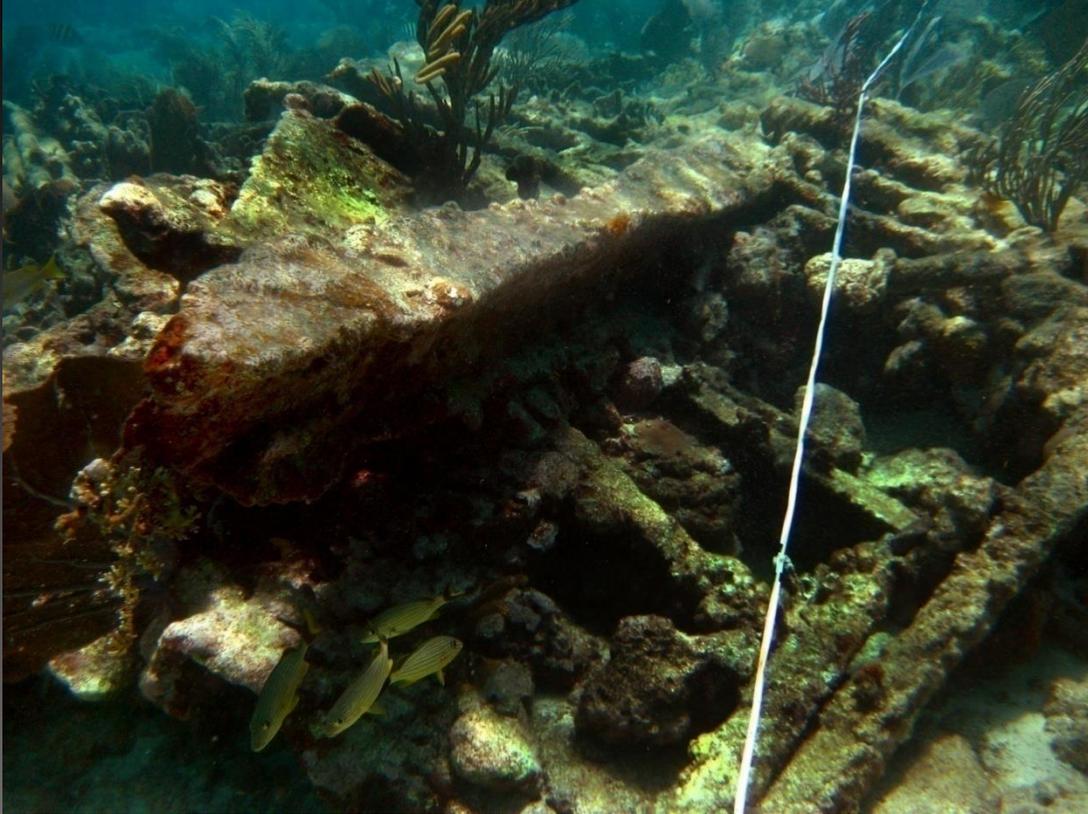
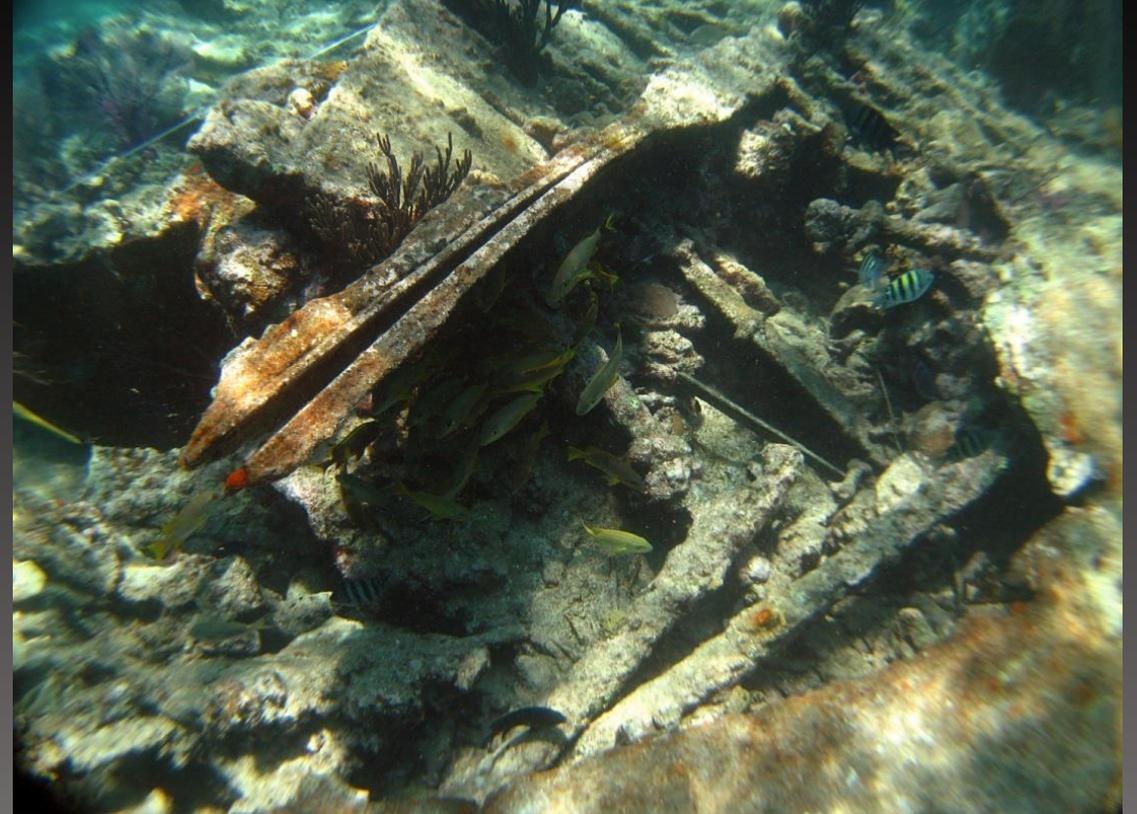
The end of the keel assembly itself had been damaged somewhat.

In the pre-Irma image on the left, the feature looked like a single metal beam. Some of the frames are visible perpendicular to the beam in the foreground and background.

The post-Irma image on the right shows the keel to have a laminated structure and to be separating longitudinally along the joints, presumably after being exposed and battered during the storm. The frames are still visible, although some of the rubble in the foreground has been scoured away.

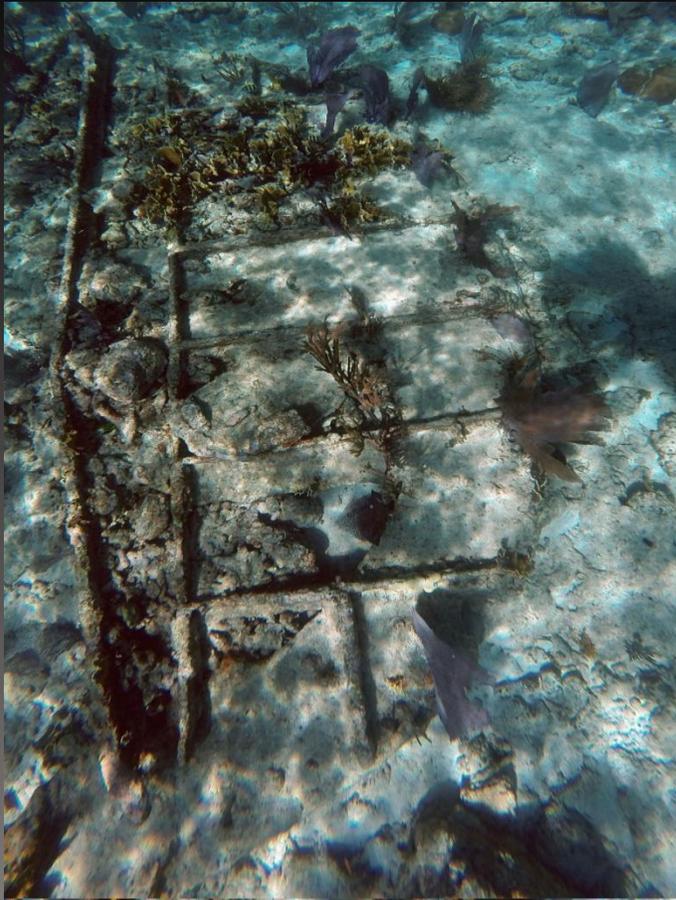
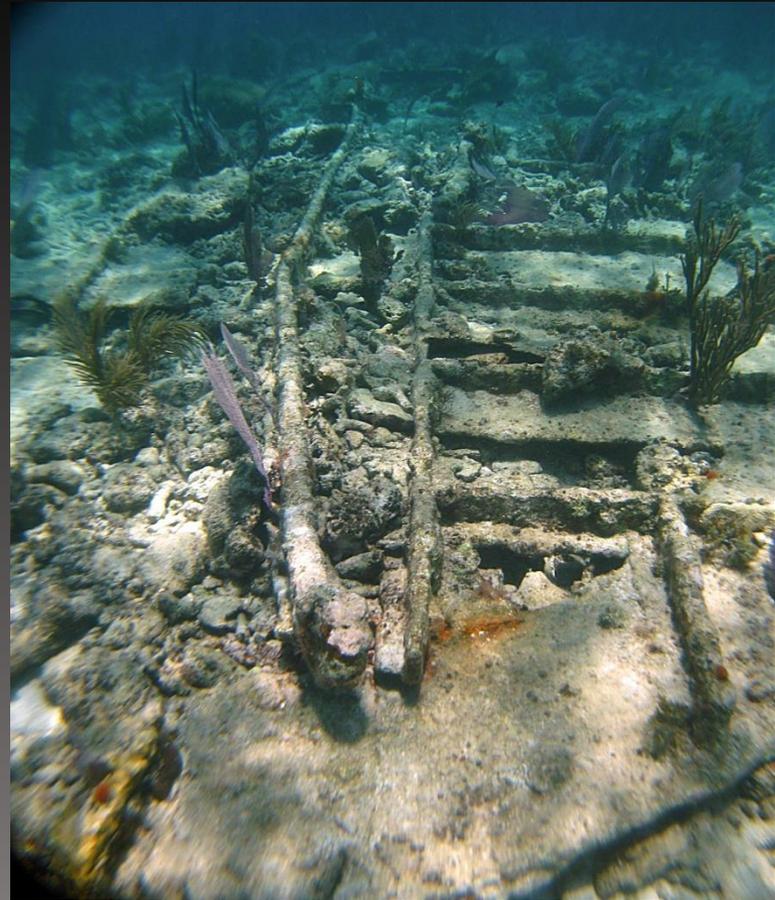
Large features west of the metal wreck, such as this bulkhead, showed little change.

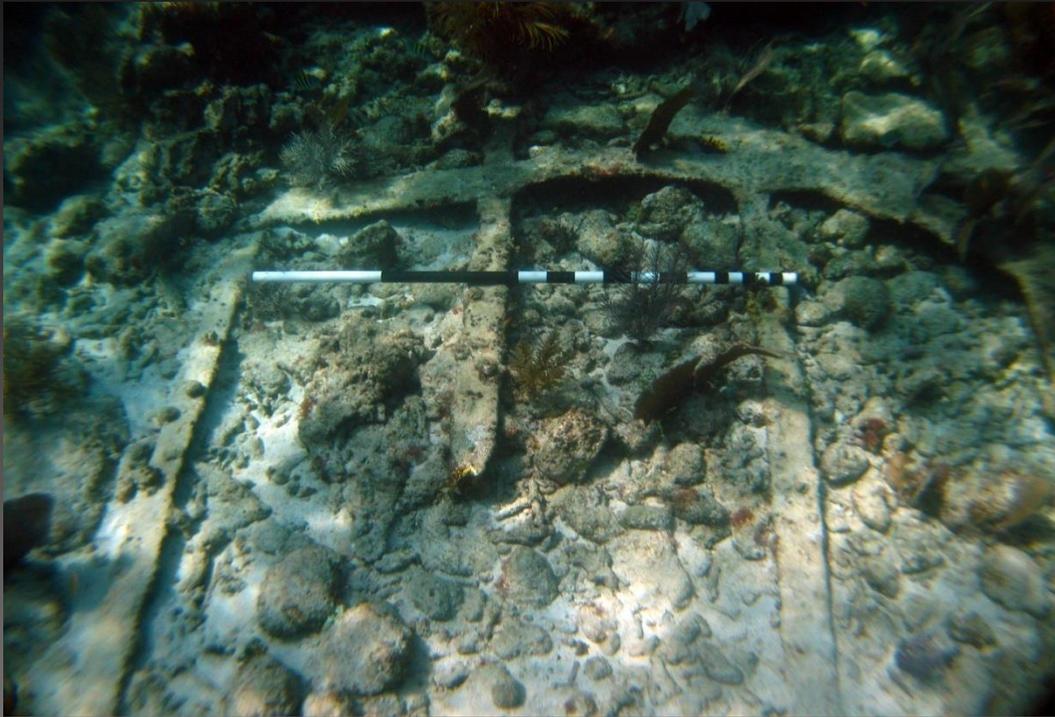
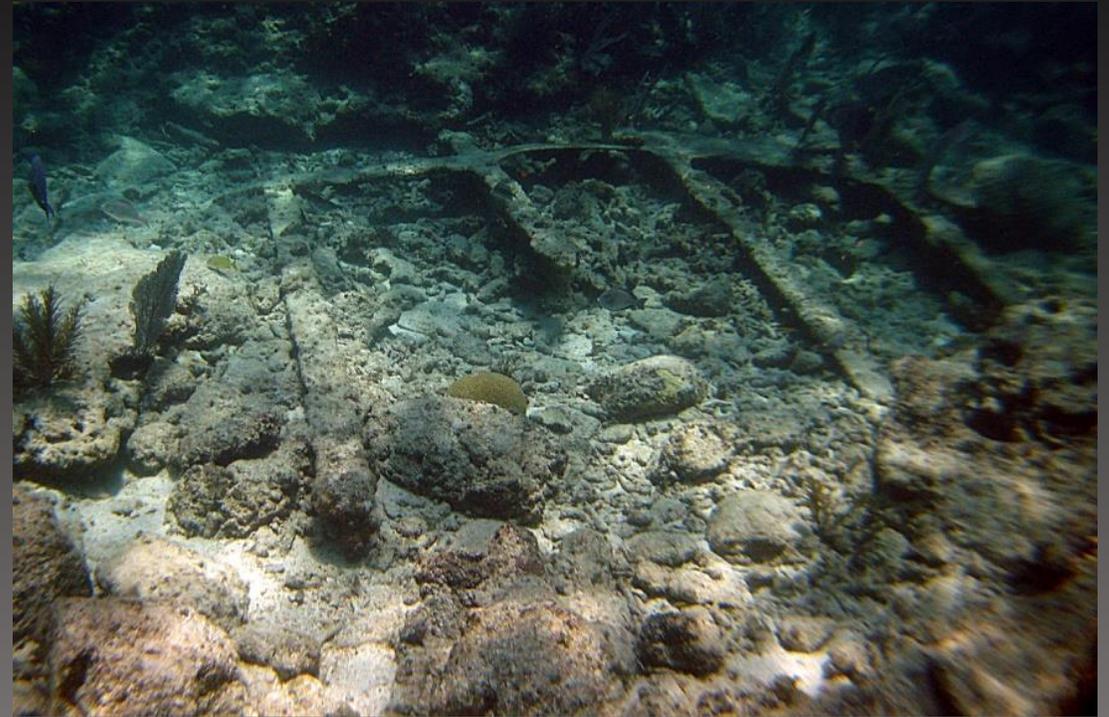
This section of deck framing also showed little change. Some of the smaller rubble had been rearranged, but the feature itself appeared largely unaffected.

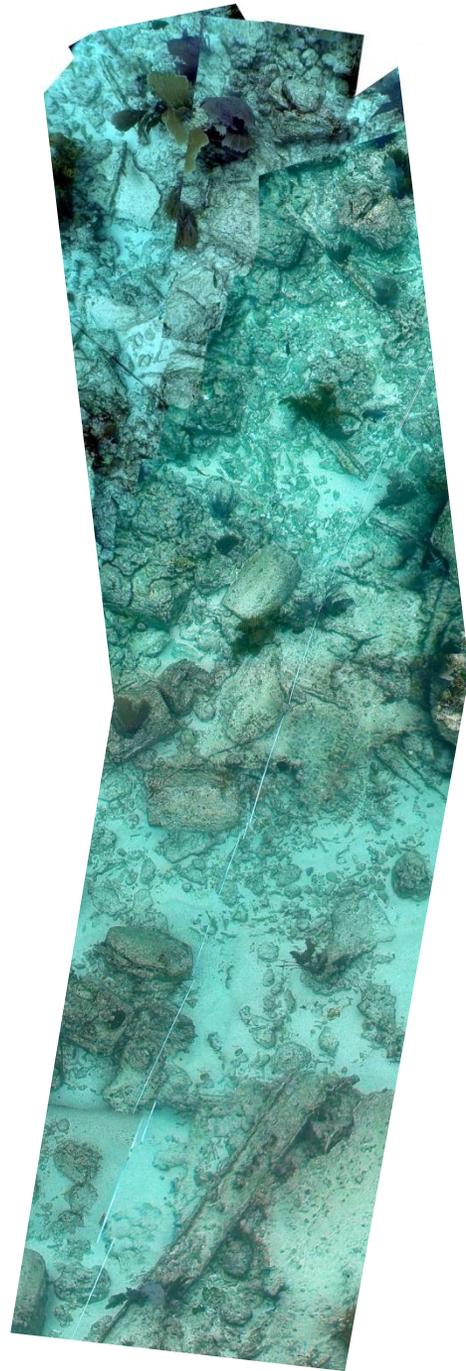
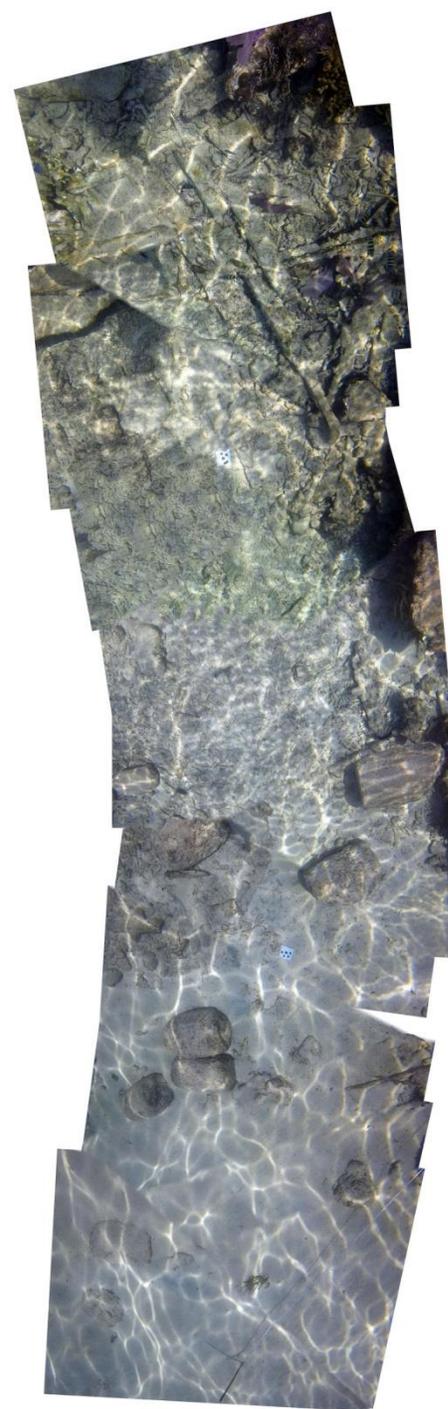
pre-storm

The same area after the hurricane. A few barrel casts remain in place while others, along with loose metal debris, have been moved by the effects of the storm.

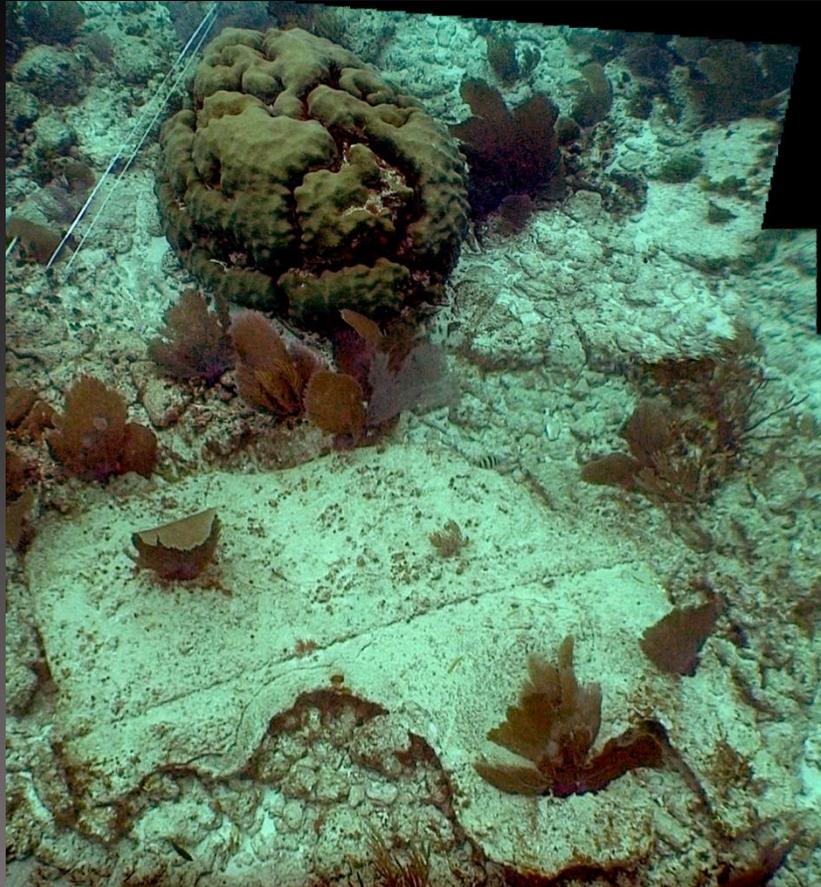
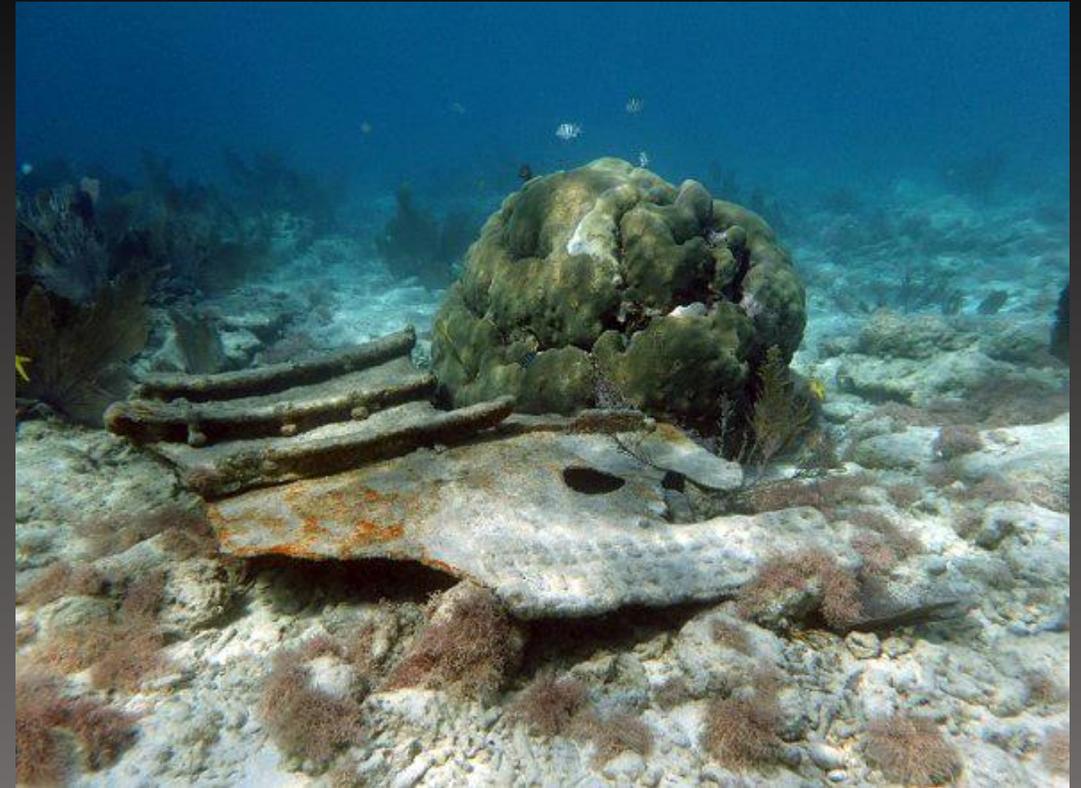
In the image on the right, a section of hull plating plate lay face down near a coral formation prior to the storm. On the left, a post-storm image shows the hull fragment turned over and an additional smaller plate present nearby, but with little apparent effect to the adjacent coral.

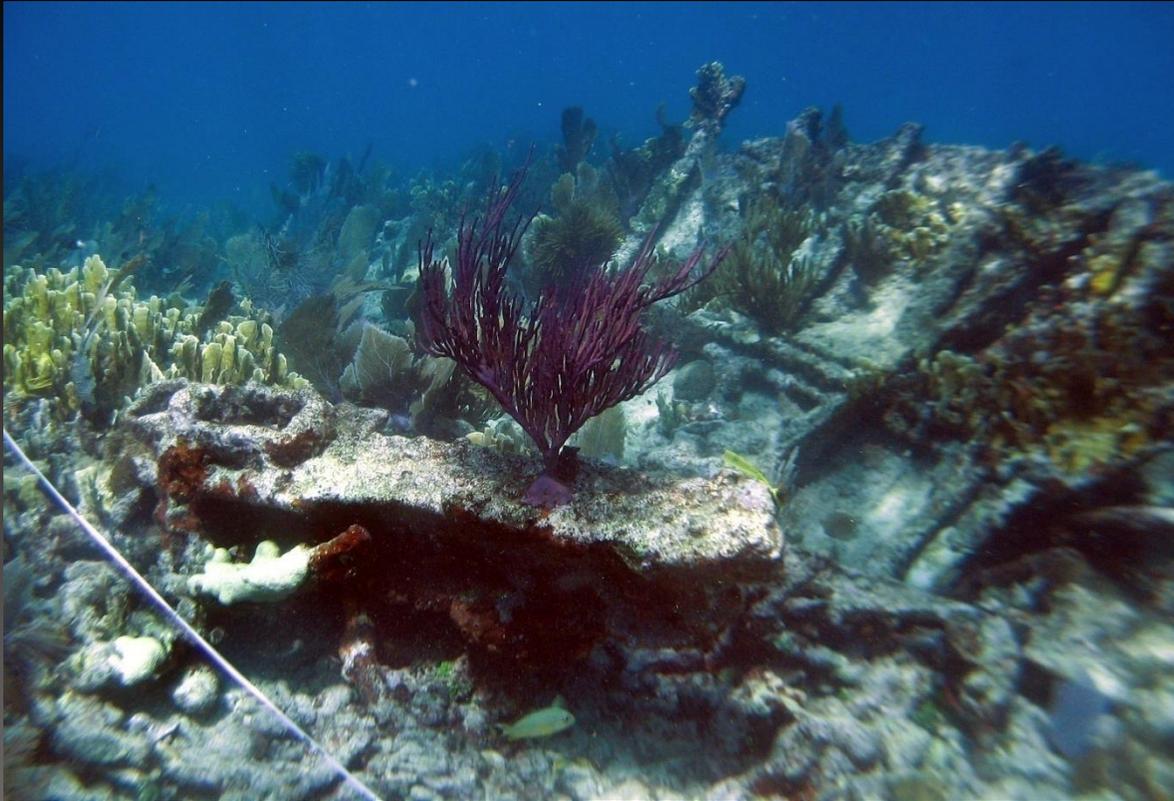
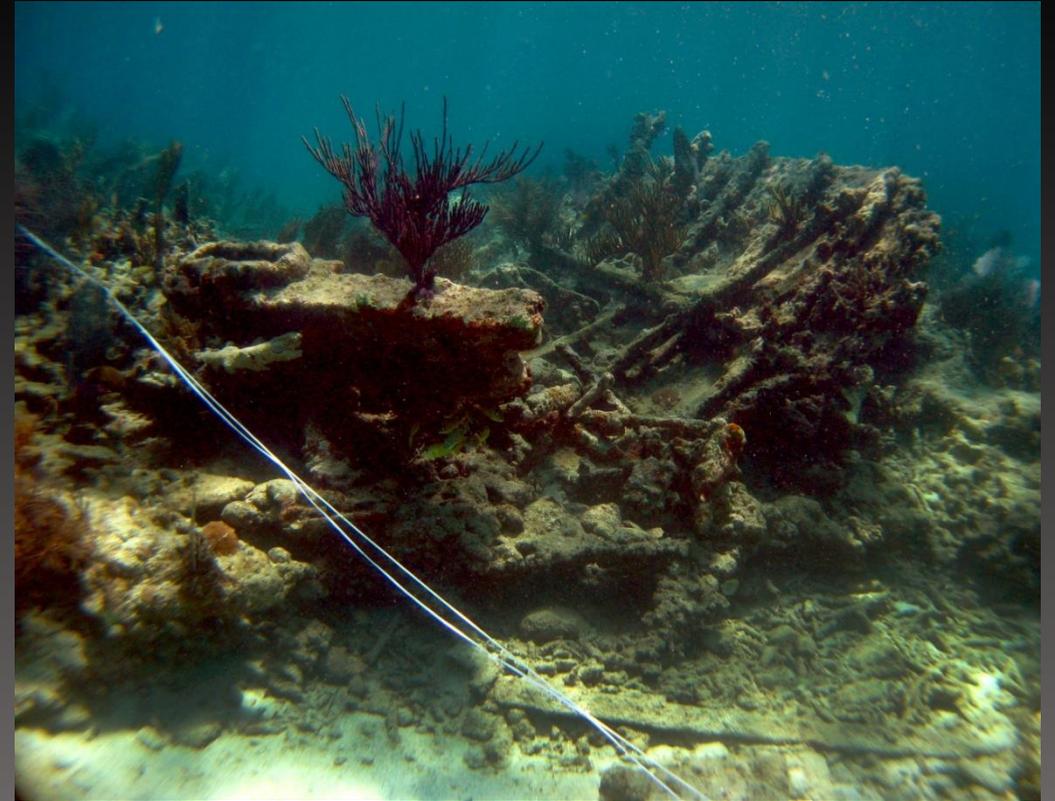
Some of the gorgonians on the site were very sturdy. These images show a mast step and hull section at the north end of the wreck.

The pre-Irma image on the left shows some large and distinctive gorgonians, one on the keel assembly near the mast step, and one attached to a stringer on the hull section in the background.

The image on the right is post-Irma and shows the gorgonians still in place.
