Pamunkey River Project: The 2006 Field Season

By Steven Anthony

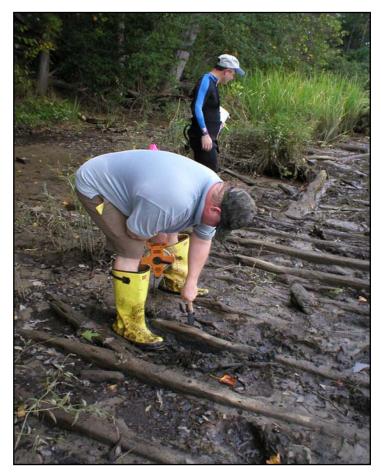
D. Shaw and S. Anthony document the framing pattern of one of the Pamunkey River vessels, Hull #1. Photos in this article by B. Utley, J. Smailes, D. Knepper.

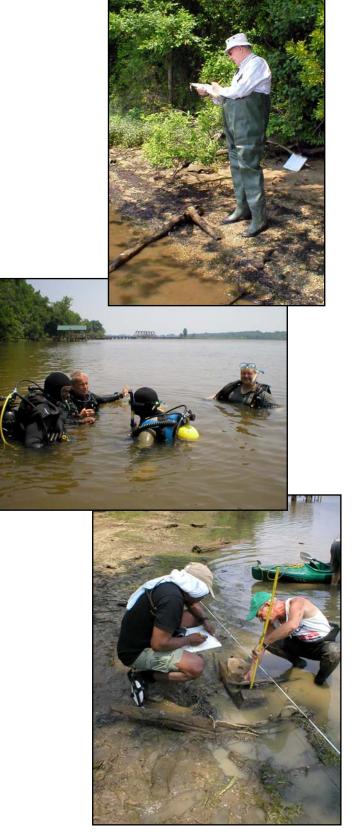
Top: T. Berkey supervises the underwater search around Hulls #4 and #5; middle: J.Beason, J.Craig, S.Anthony, and D. Shaw discuss the initial findings of the underwater survey; bottom: J.Beason and J.Craig collected detailed measurements on Hull #4.

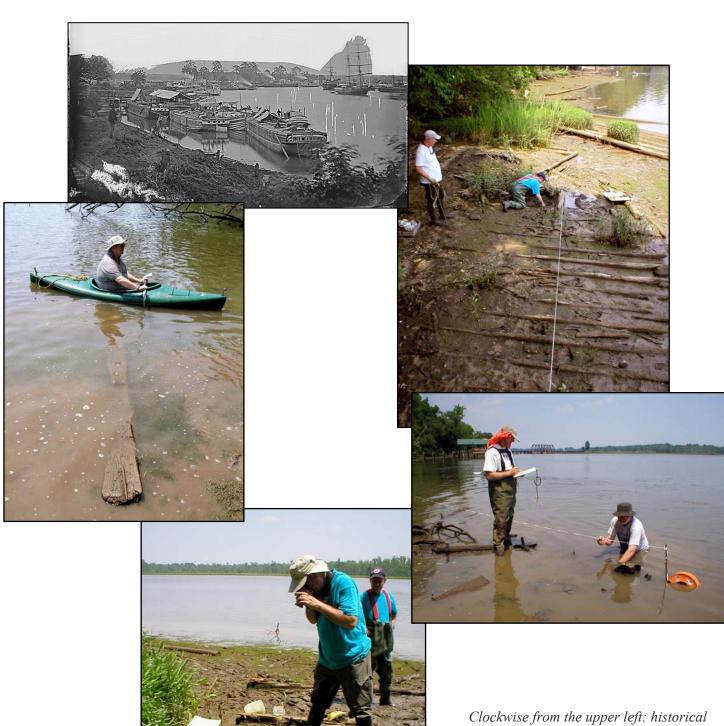
Clockwise from the upper left: historical photograph of White House Landing dated 1862; B.Terrell and S.Anthony document Hull #1; J.Edwards and G.Schmidt document Hull #4 as the tide rises; J Smailes photographs details of Hull #1; D.Shaw conducts a kayak survey.

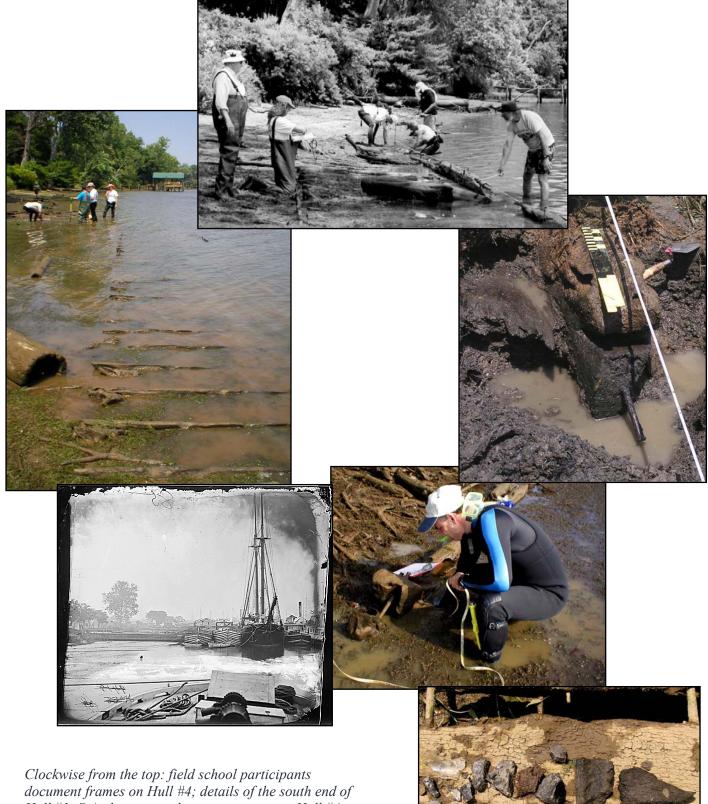
Clockwise from the top: field school participants document frames on Hull #4; details of the south end of Hull #1; S.Anthony records measurements on Hull #4; artifacts from Hull #1, including bottle glass, coal, rope, artillery shell fragment, and wood; historical photograph of barges moored parallel to the shoreline at White House to create a temporary wharf; Hull #5 emerging at lowest tide.

Examination of both Hull #4 and Hull #5 allowed the team to observe that there was no evidence of a keel at the end of either vessel. Instead, a wide plank was noted on the bottom of each hull below and parallel to the keelson. We have only observed this plank feature at the ends of the hulls, and it is possible that the keel had been tapered to allow the bow or stern to fair upward. Yet, if the plank continues the entire length of the hull in place of a heavy keel, then this feature, along with the flat bottoms of the hulls, would imply that the vessels were designed for river work, where shallow draft would been a premium and leeway would not have been an issue.
