**MAHS Survey of Unidentified Shipwreck  
Remains on Pickles Reef within the Florida  
Keys National Marine Sanctuary**

**Conducted under Permit FKNMS -2009-054-A1**

MAHS was issued a revised permit by the Florida Keys National Marine Sanctuary on June 15, 2010, to survey unidentified shipwreck remains on Pickles Reef within the Marine Sanctuary.

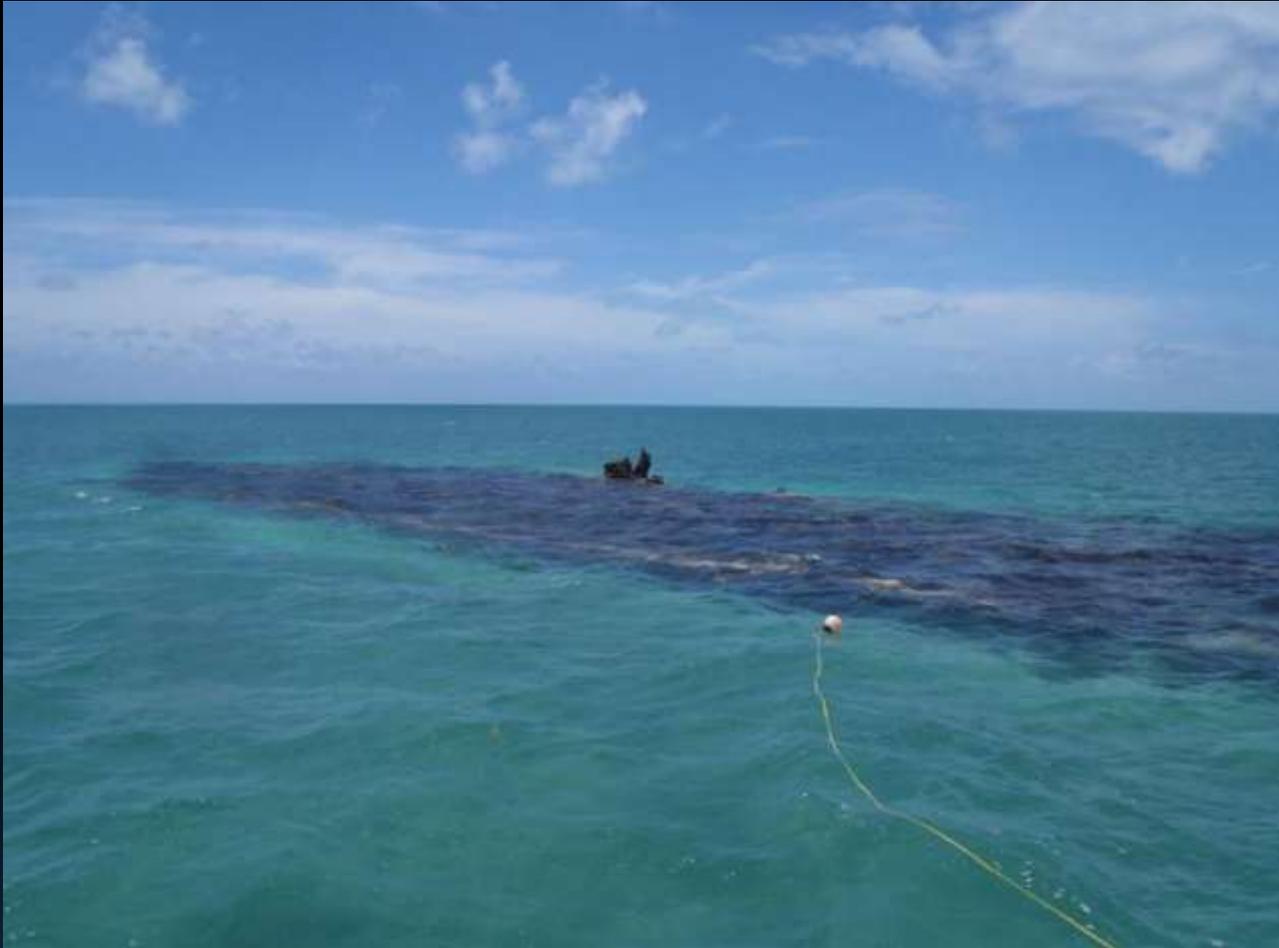
So, the original plan to have everyone working in one location was altered. Instead of Pickles Reef, we took the field school to the wreck seen above, the *Charles W. Baird*, also known as Captain Tom's Wreck.

Lying in from the edge of the reef, the water here was much calmer.

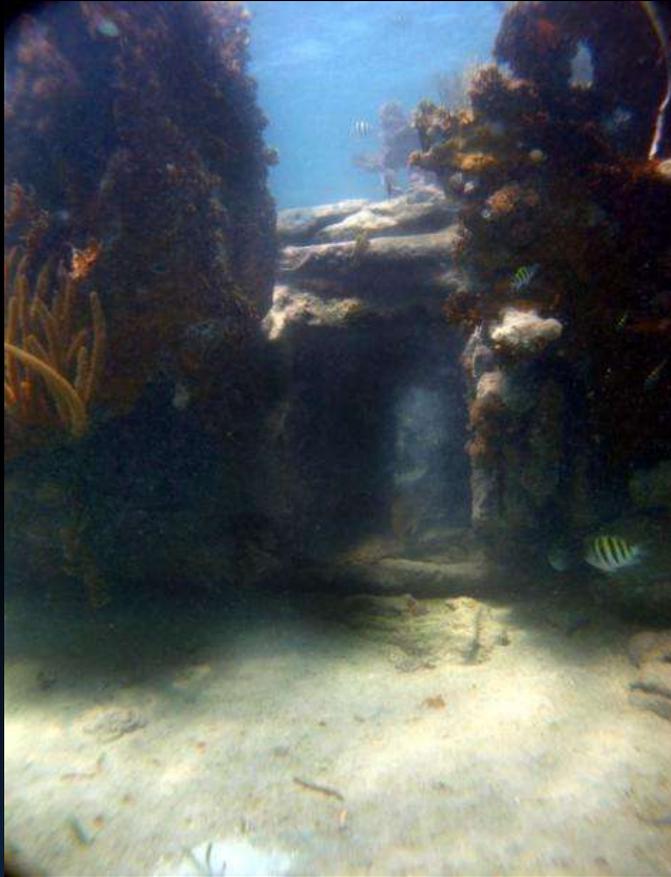
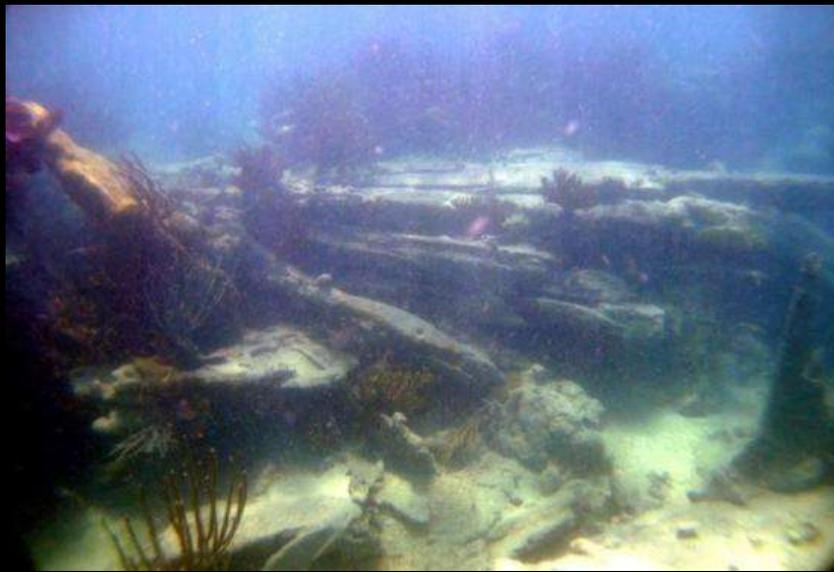
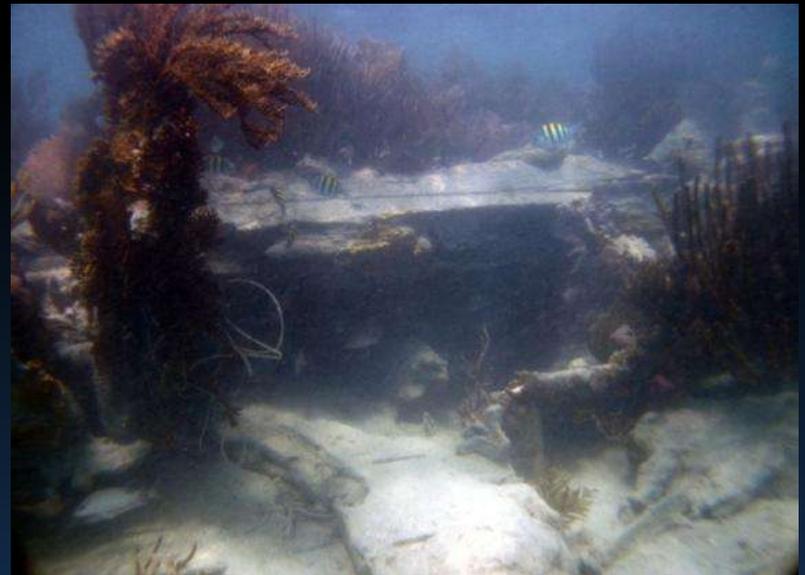
Here are several views of the wreck. Lots of the hull remained, including frames and hull strakes. The vessel had settled upright on the bottom, and since it hadn't wrecked on the reef in a storm, it was not broken up too badly and did not have much of an associated debris field.

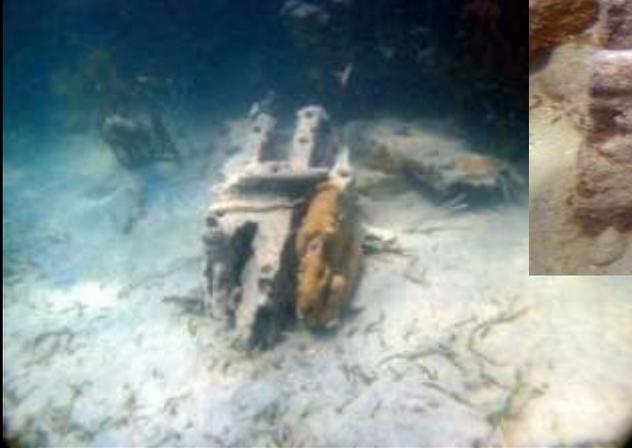
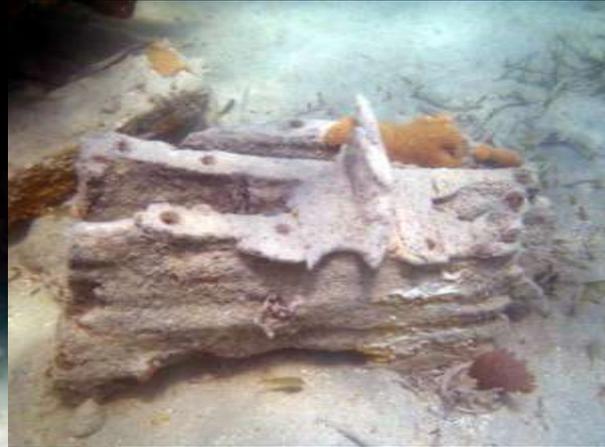
There were a few features lying around in the sand, though. To the left are a couple of views of the end of one of the frames that had broken off.

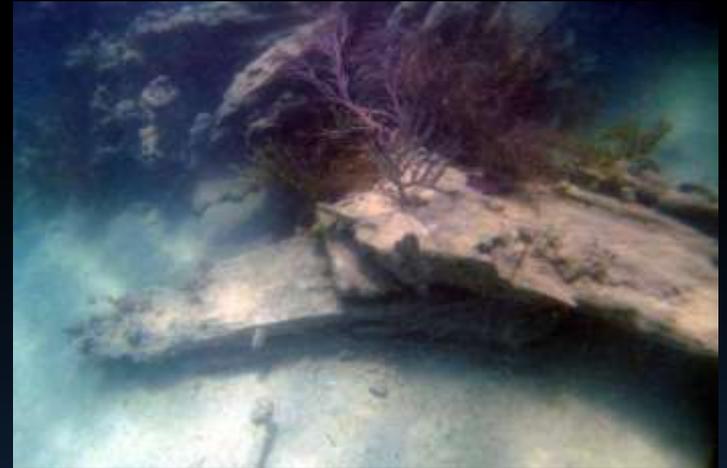
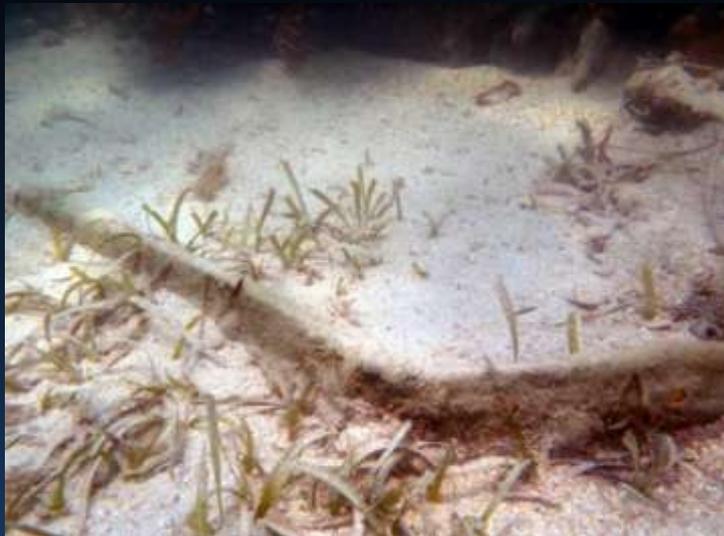
Below is another broken frame.

And to the left is what looks like a knee.

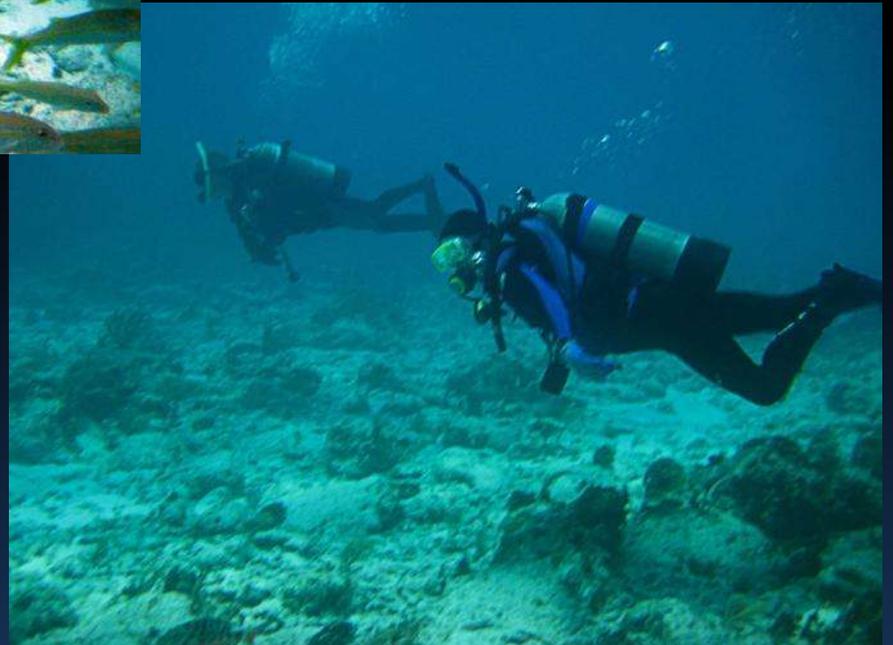
So, we donned SCUBA and went diving for a closer look.

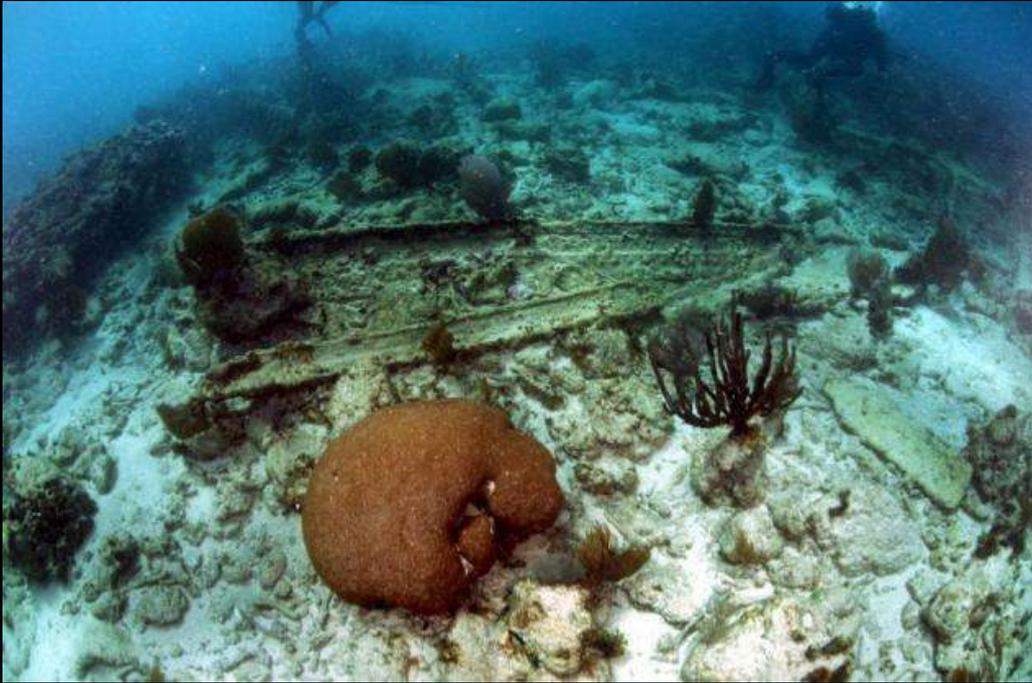
There was lots of metal debris present at the site, including beams and metal hull plating.

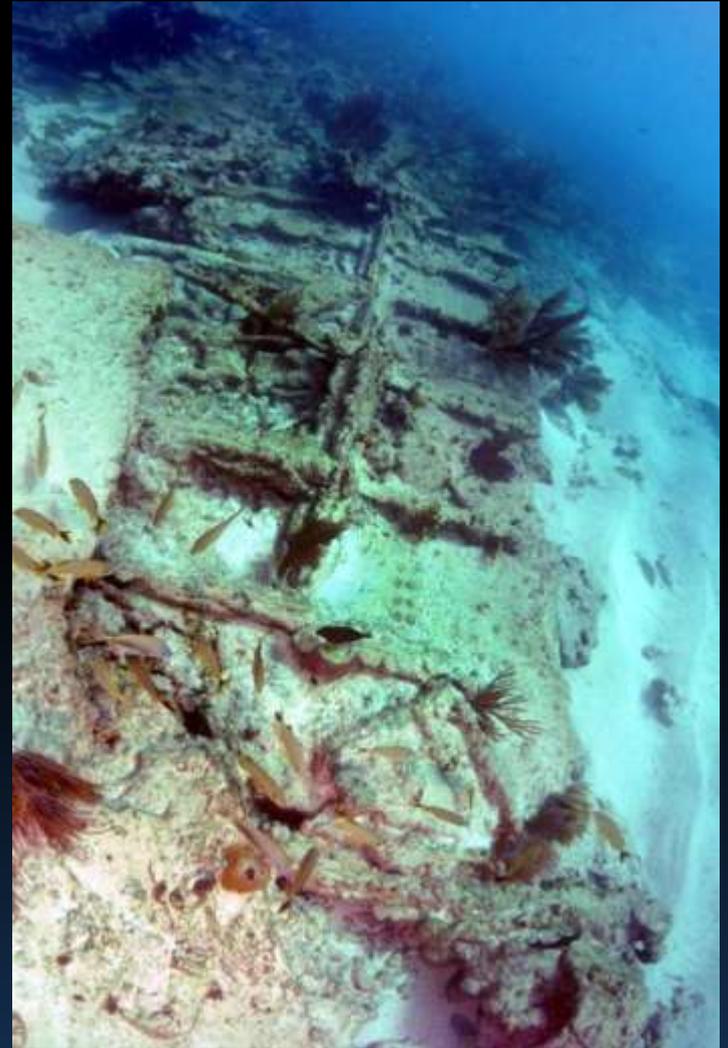
Most of the debris was relatively flat, and we saw no evidence of a keel, so our current theory is that this may have been a barge rather than a ship.

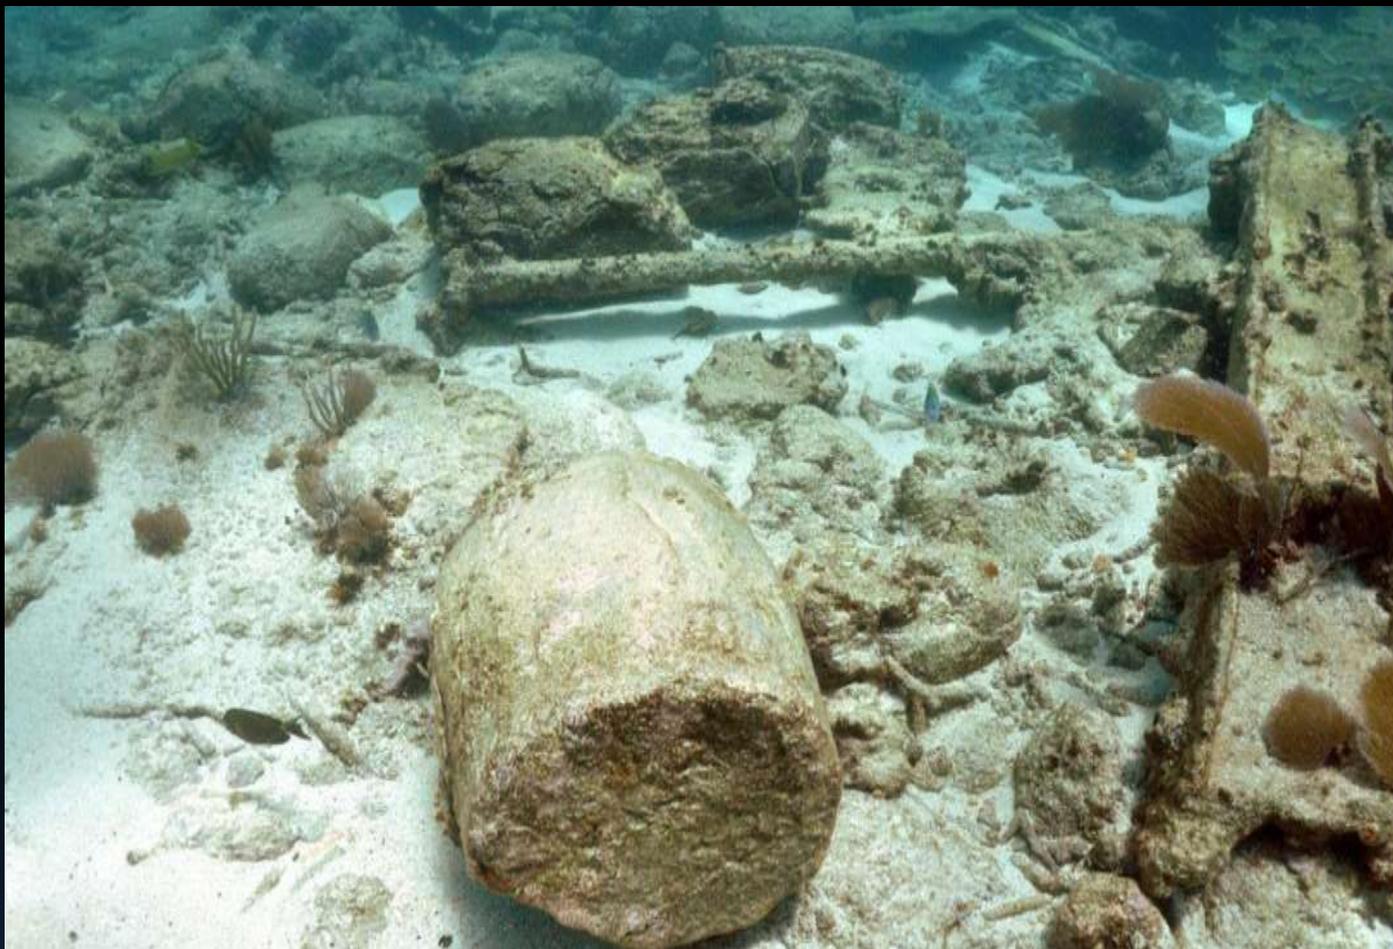
Maybe the most interesting aspect of the wreck is something the reef is known for -- barrels of cement.

The cement appears to have been packed in wooden casks. When the vessel went down, the cement got wet and did what wet cement does – it hardened.

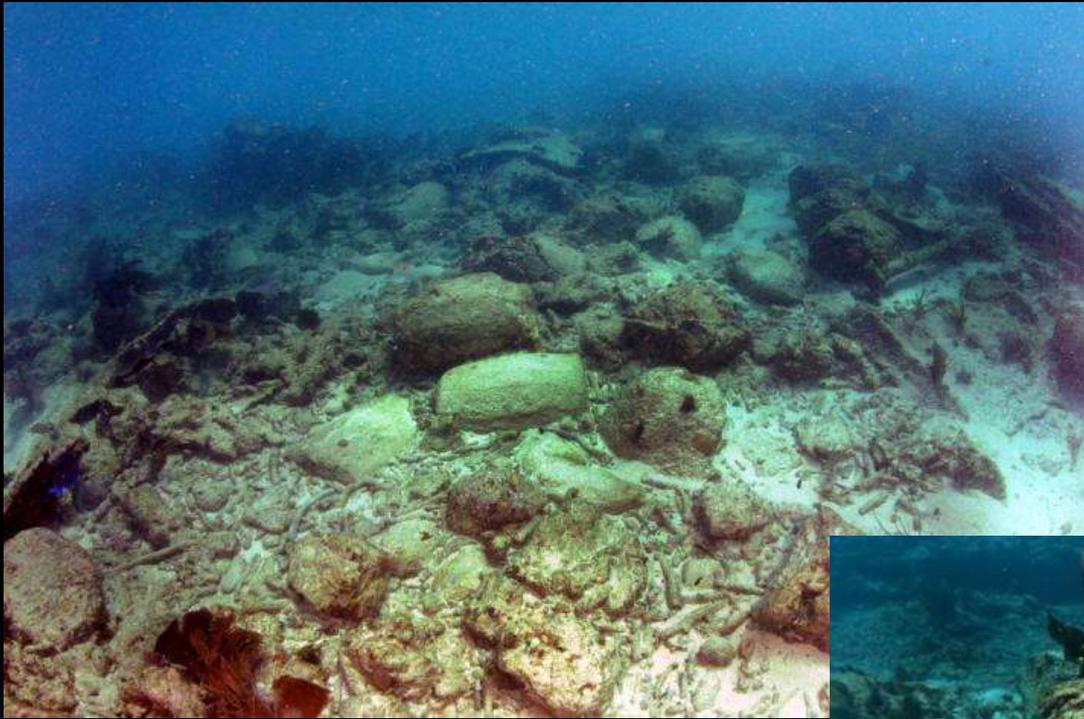
The wooden casks eventually deteriorated and disappeared, but the imprints of the staves are still visible on some of the barrels.

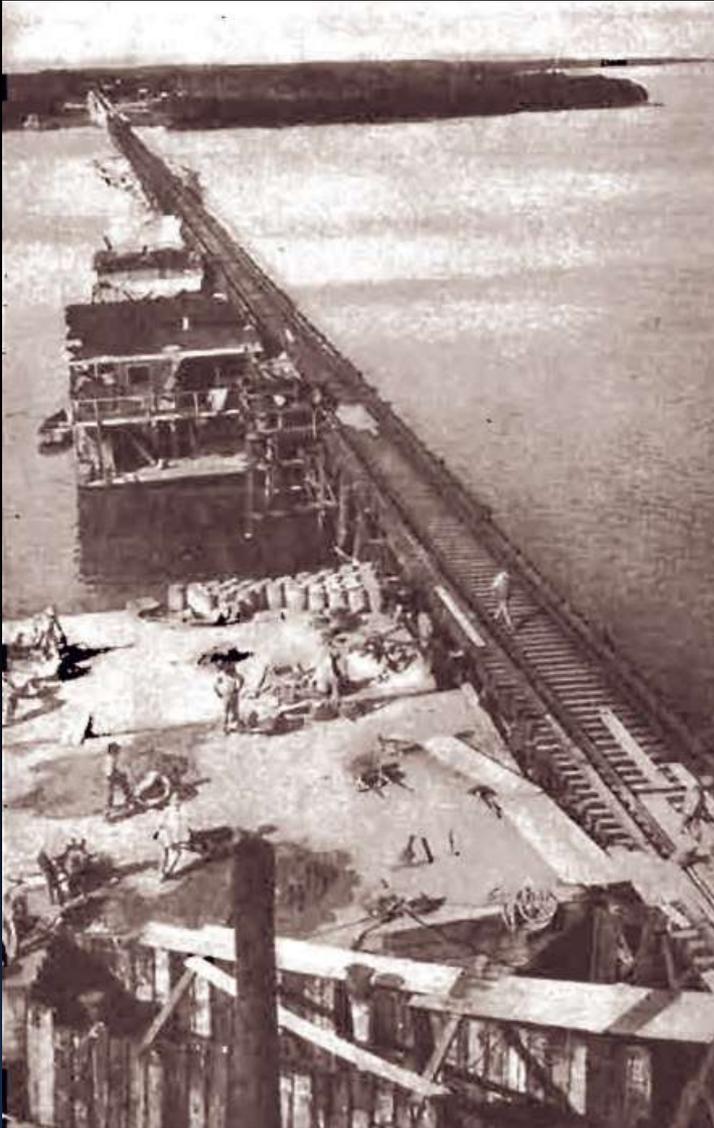
One theory at the moment is that the cement was destined for Henry Flagler's so-called Overseas Railroad, built from Miami to Key West after the turn of the 20<sup>th</sup> century.

This is an image of the railroad under construction. Note the barrels near the center.

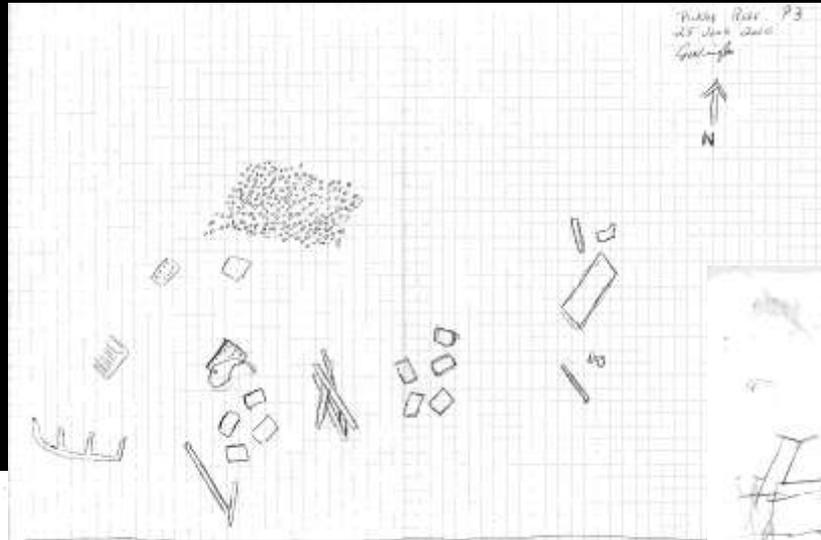
To begin documenting the site, we made a number of sketch maps of the area, as well as sketches of groups of distinctive features.

Using these drawings and a number of photographs, we generated a sketch map of the site.

We delineated the greatest concentration of barrels and in spite of the rough water were able to get some preliminary measurements with tapes. The red oval is as outline of the general area where the barrels were found.

Most of the metal debris was to the right of the oval. We are not sure yet what this means. The vessel may have lost most of it's load, then flipped over, or the cargo may have been jettisoned in an attempt to float the vessel off the reef.

We will need to return to the site for more detailed work to determine whether there is more information there to help tell the story.

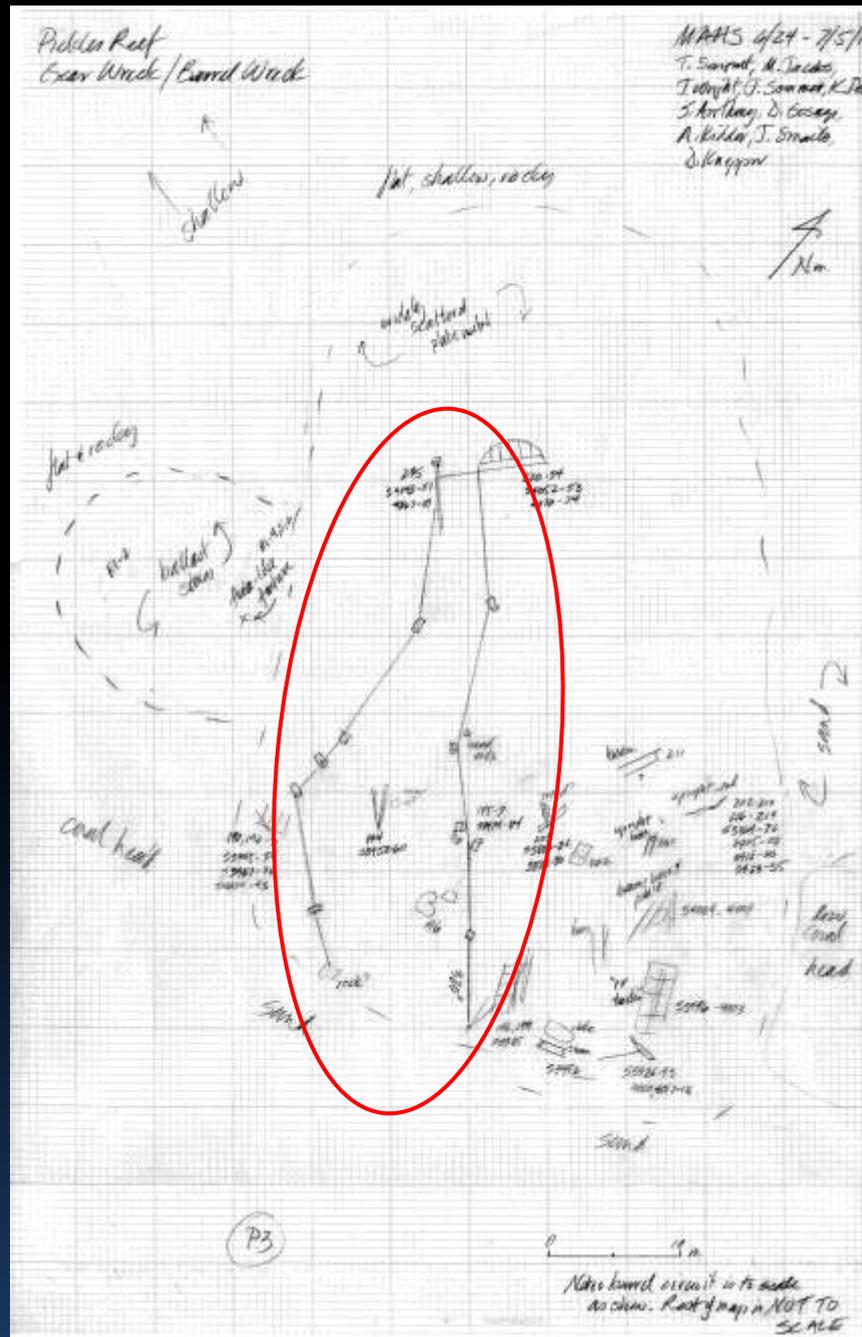
Note that the outline of the barrel distribution is roughly to scale. The rest of the map is not to scale.

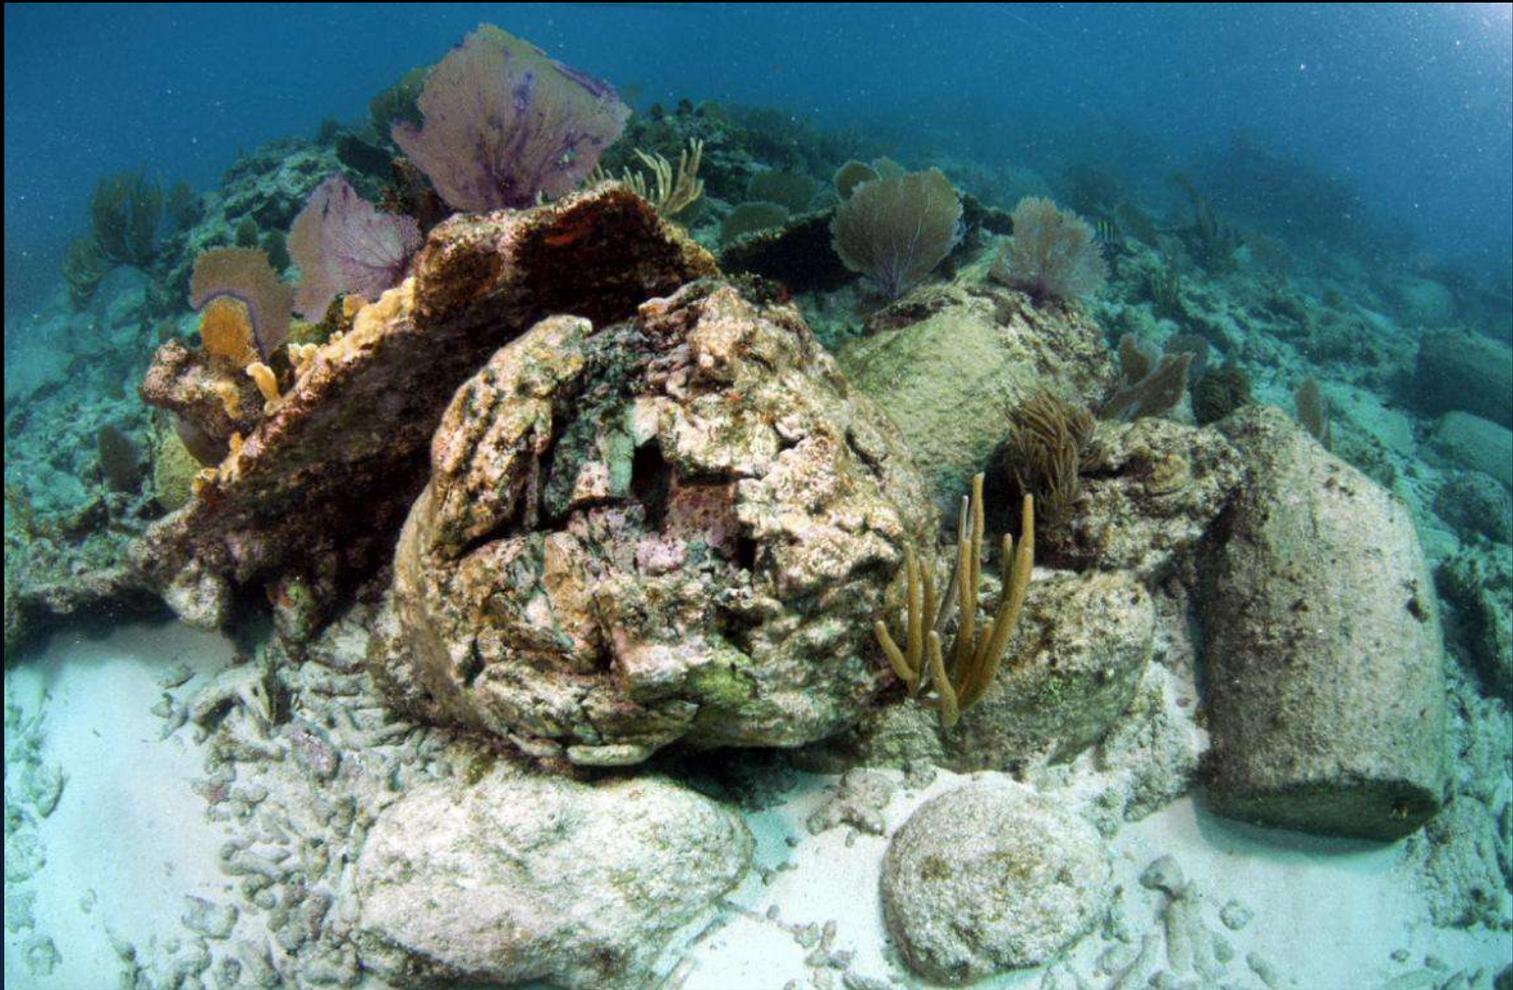
This is what the barrels look like when they exfoliate. Some of them appear to have gotten wet slowly, and the layering effect makes them separate.

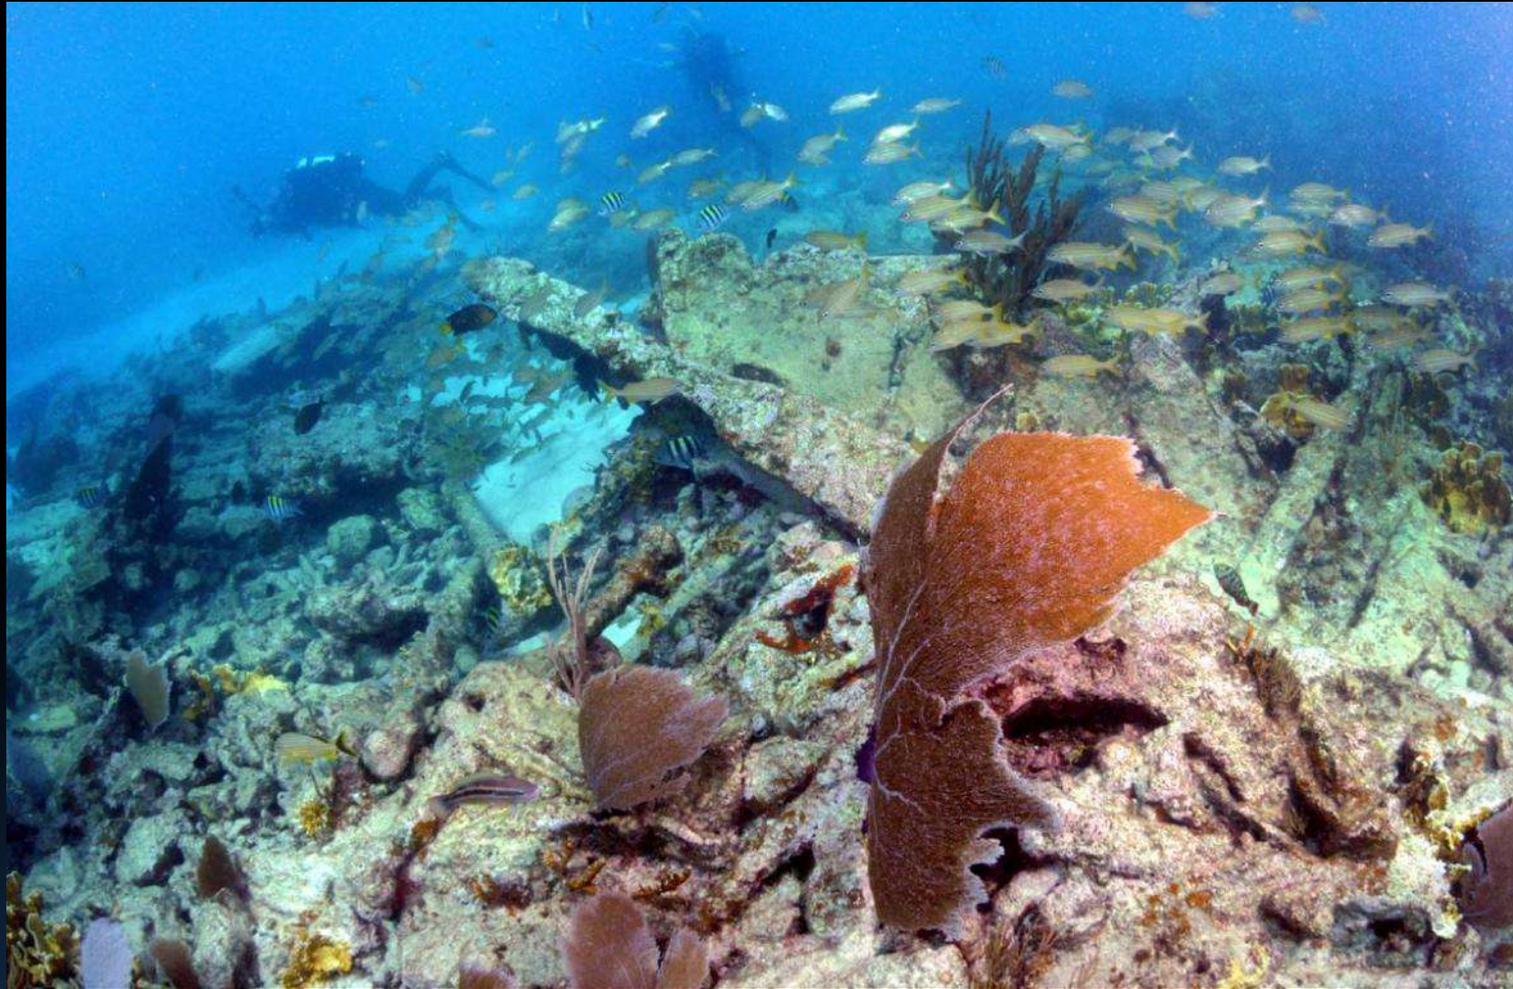
Twisted metal debris and some colorful sea life. But notice how the stiff fans are bent over to the right by the surge.

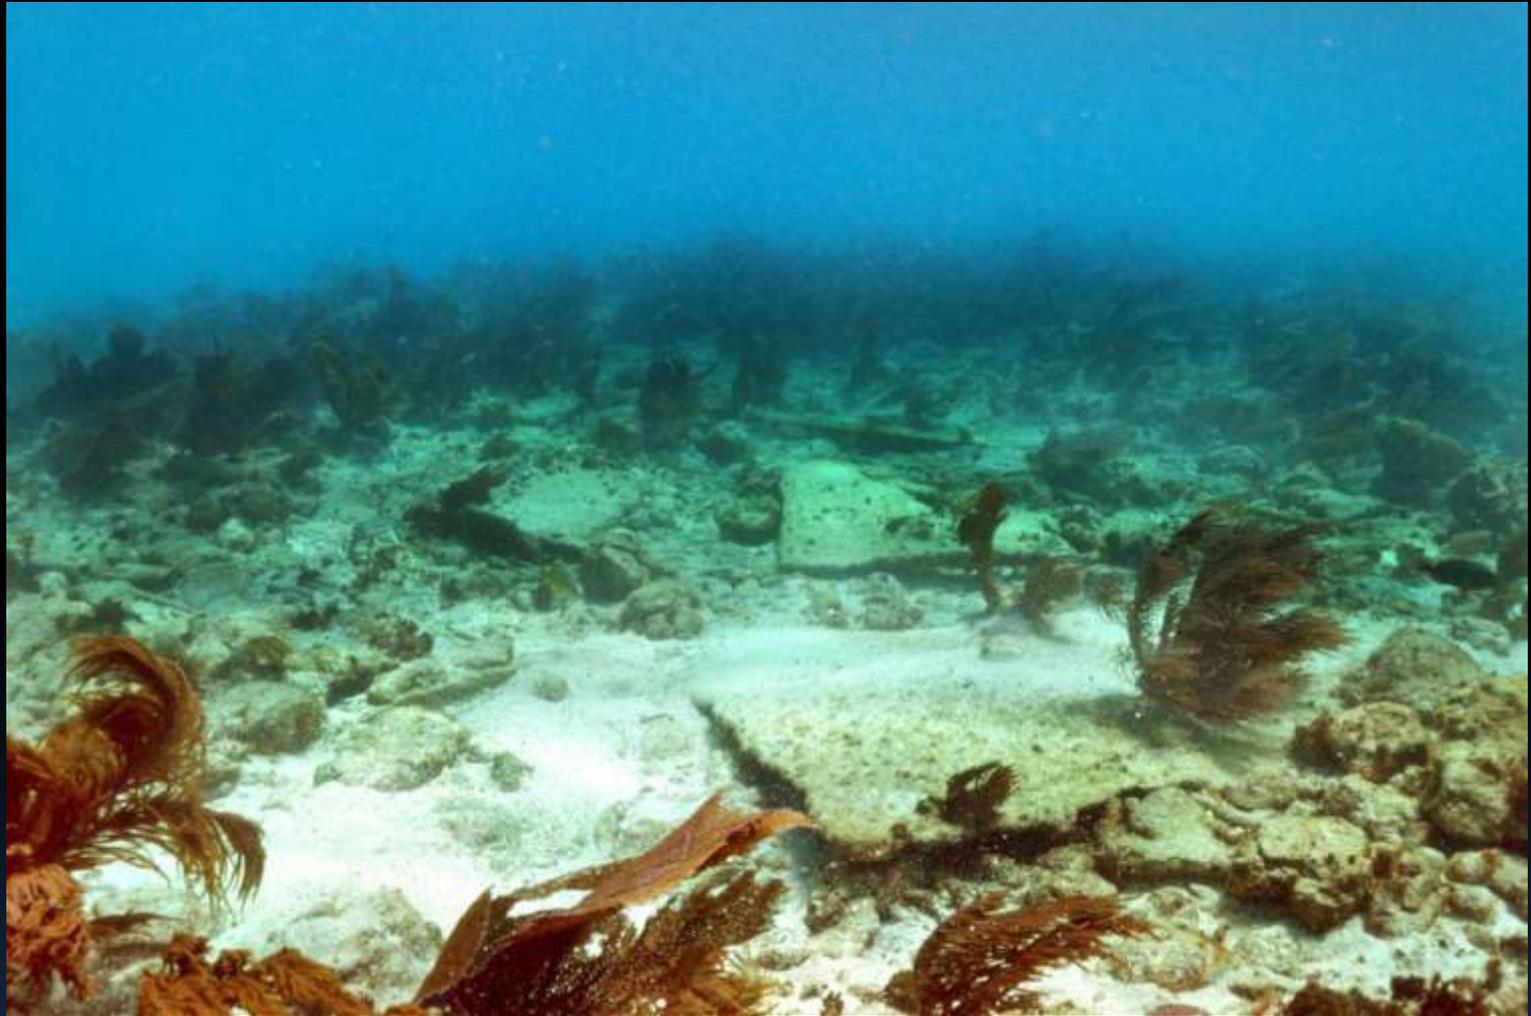
All of the fans and gorgonias are leaning to the right – looks like a windswept plain, with everything blowing in a stiff wind.

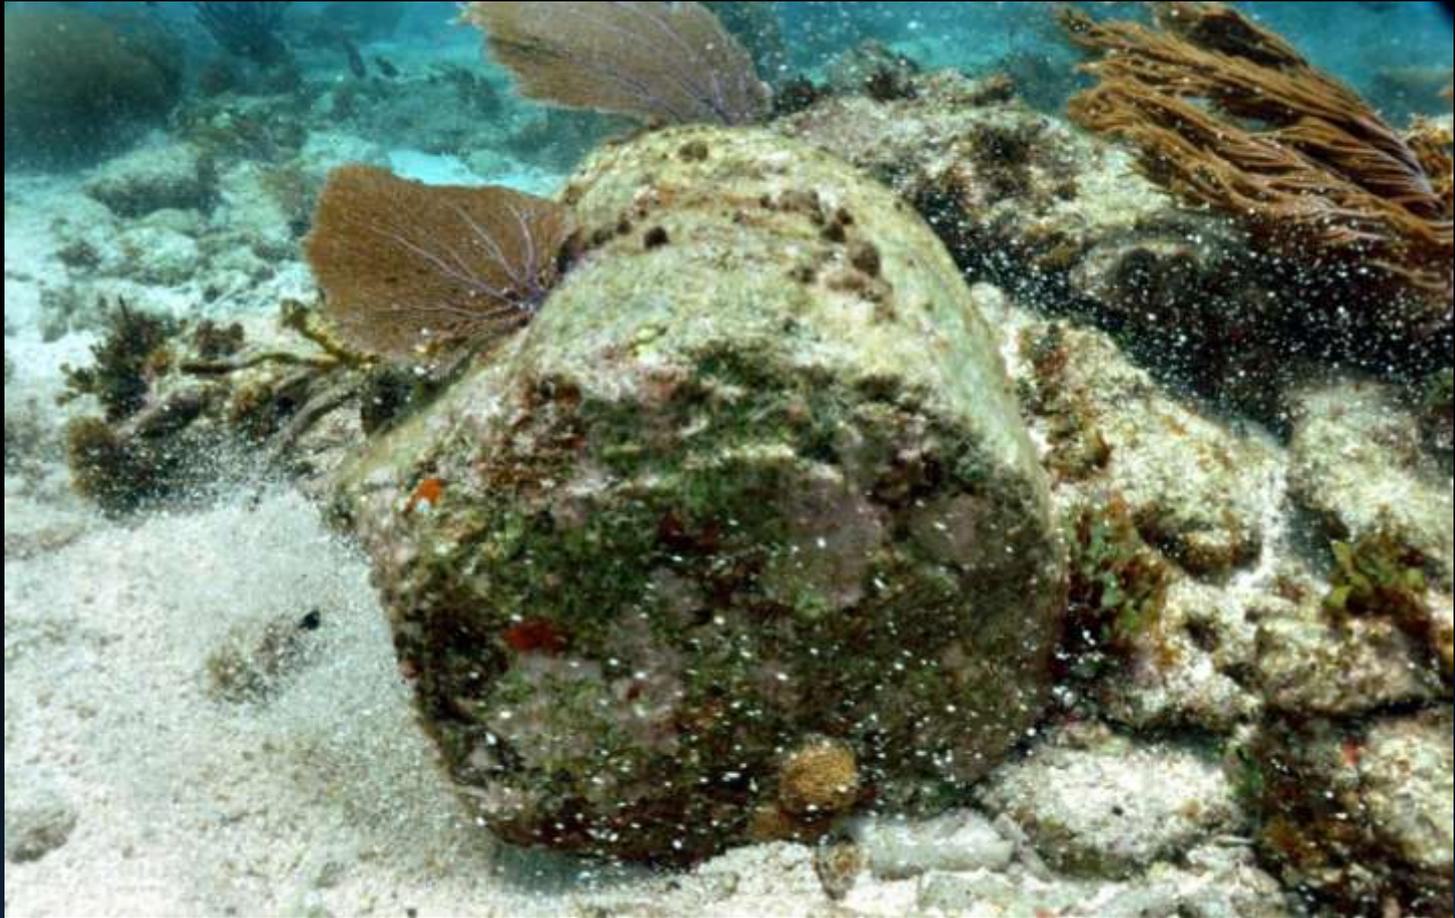
Not only were the fans leaning in the surge but the heavy sand was stirred up by the waves.
