## MAHS Survey and Field School 2014

## **Pickles Reef**

## **Florida Keys National Marine Sanctuary**

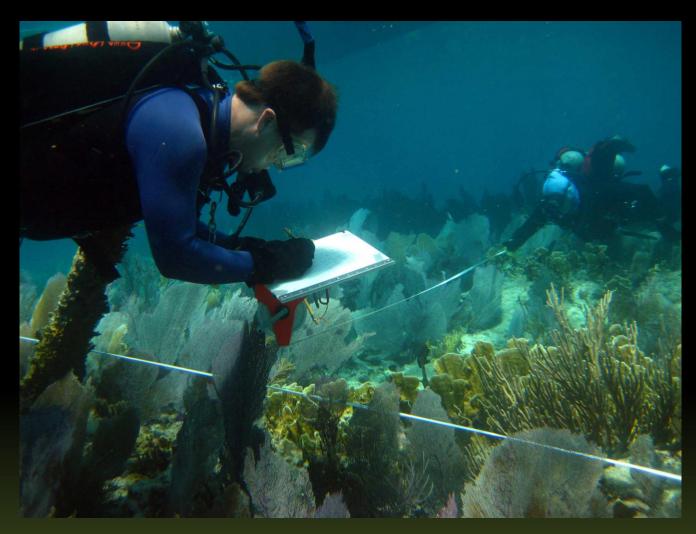
The field school continued mapping features along the keelson of the wreck, parallel to the baseline.

The main mapping technique used in training was baseline trilateration.

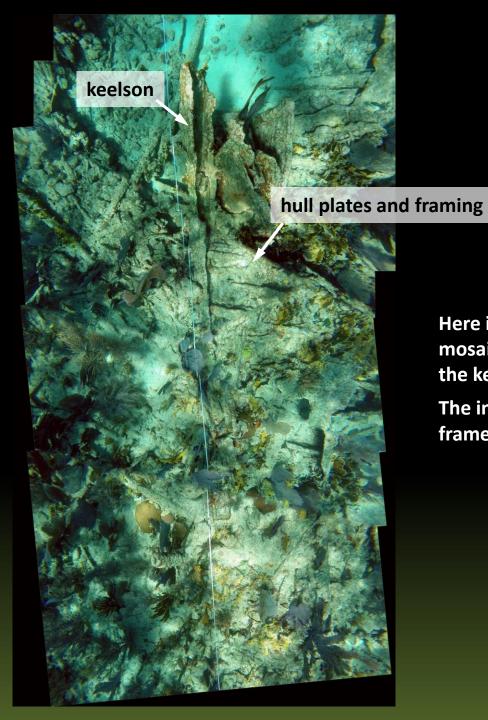
Here is a preliminary photomosaic of features at one end of the keelson.

The image was constructed from frames captured from the video.

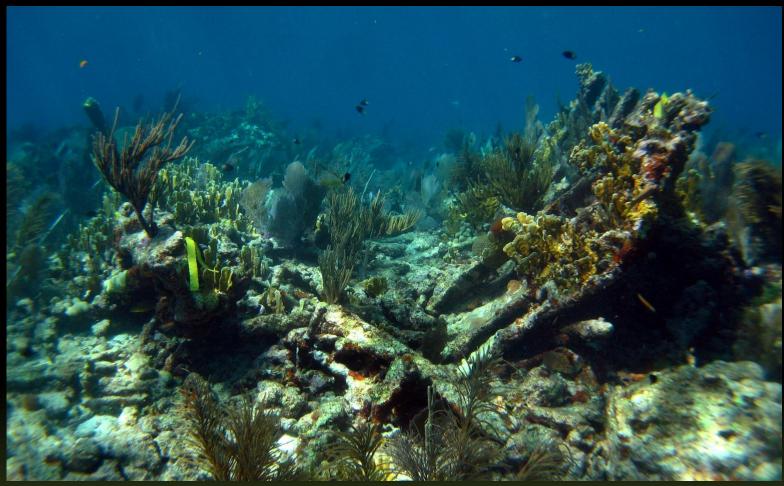
Profile view of Feature 8 (mast step, left) and Feature 16 (hull section, right).

a mast step (Feature 8), and a large section of framing and hull plates (Feature 16).

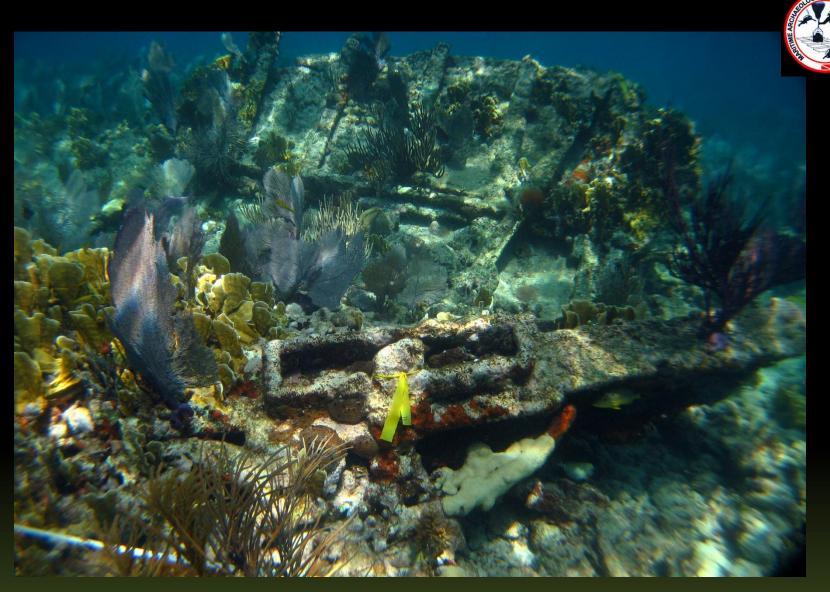
Mast step (foreground), hull section (background).

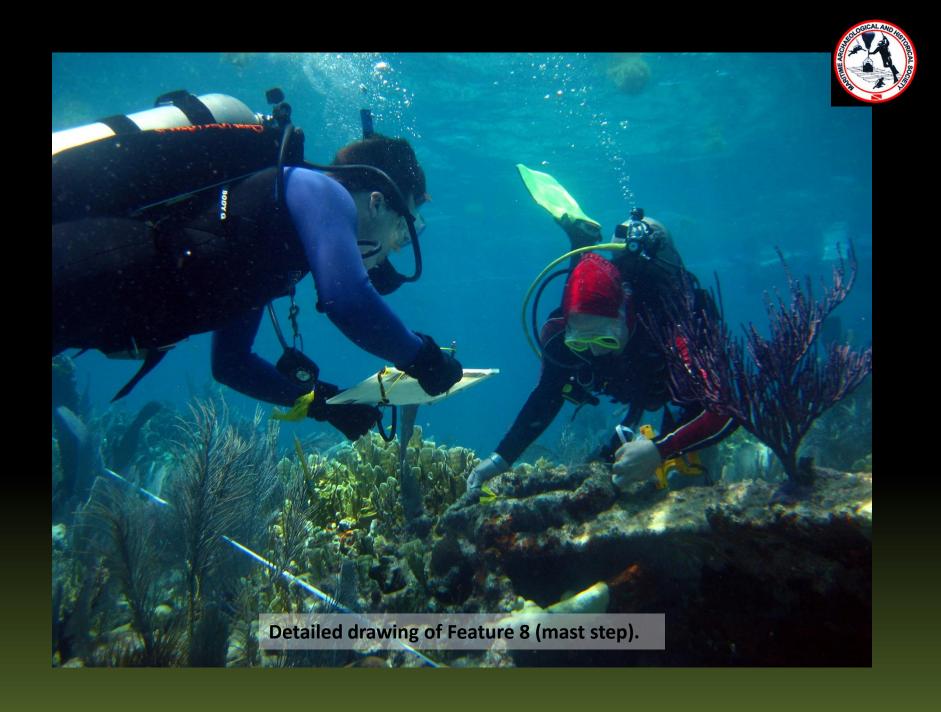
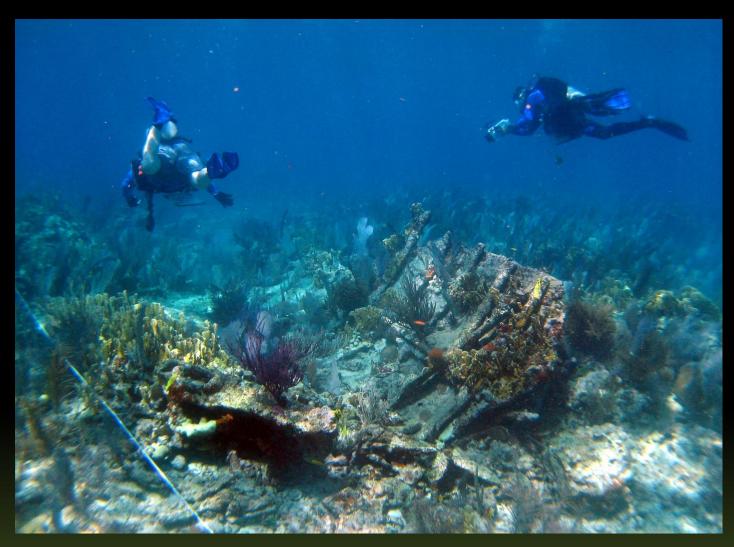
Video documentation of the mast step and hull section.

At the north end of the baseline we recorded details of two important features:

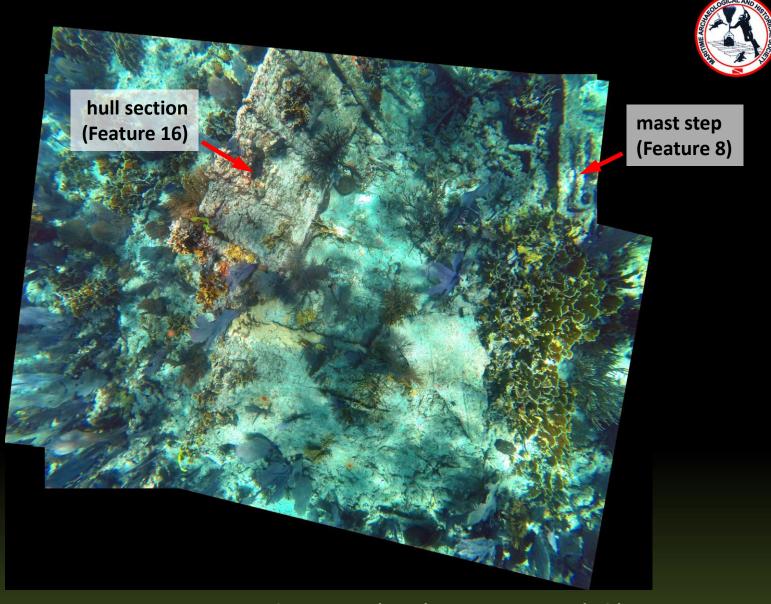
Preliminary photo-mosaic of mast step (right) and hull section (left). The image was constructed from frames captured from video.

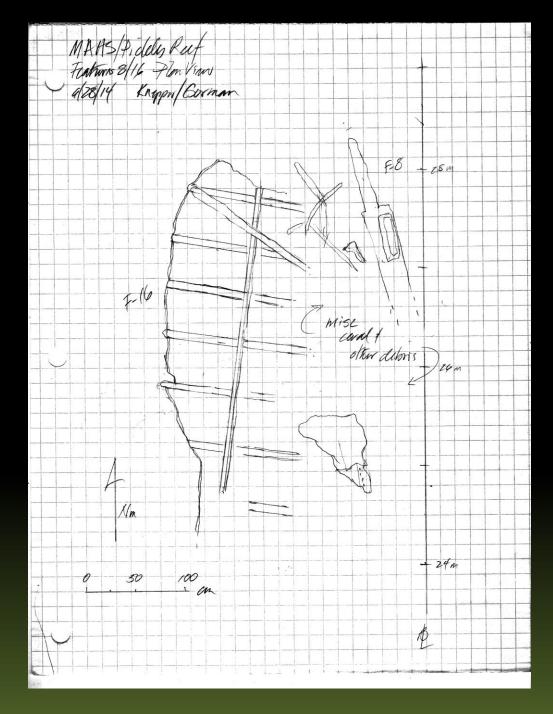
Here is a plan view or overhead drawing of Feature 8 and Feature 16 developed from photo-mosaic and on-site measurements.

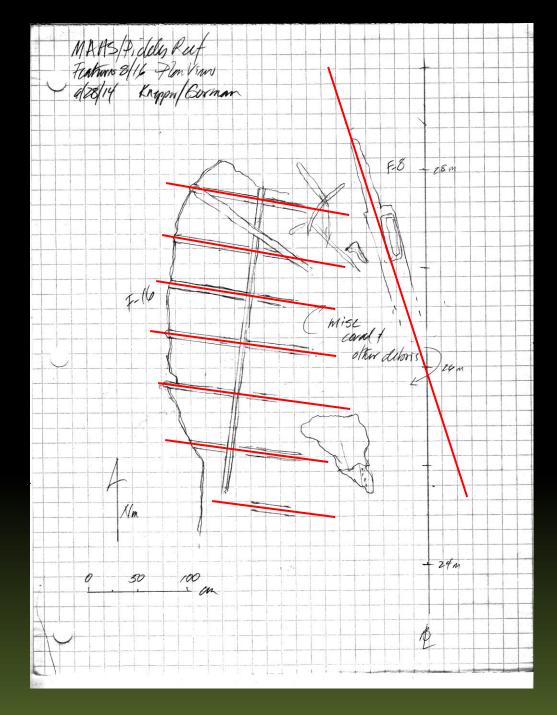
The alignment of keelson and frames is highlighted in red to indicate the apparent lack of articulation – that is, the hull section may not be connected to the keel any longer in this location.

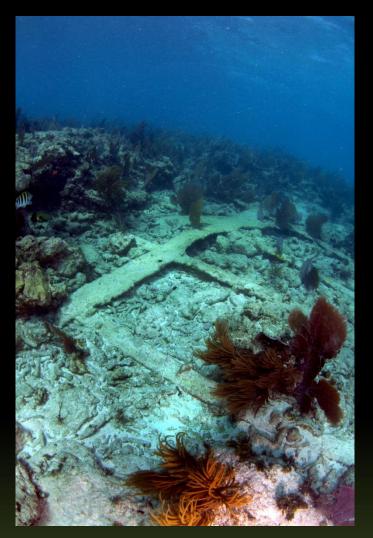
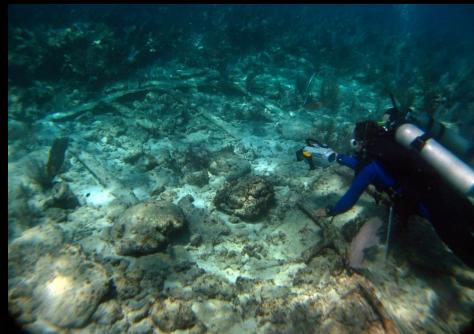
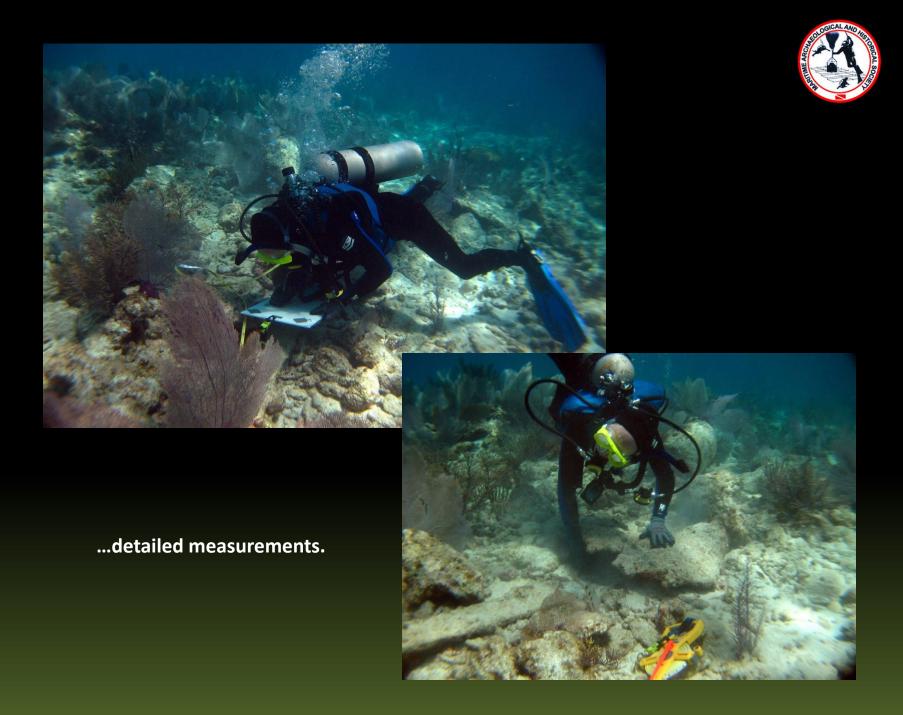
We also continued documentation of Feature 6, a lattice-like structure that may have been deck framing.

The documentation included videography and...

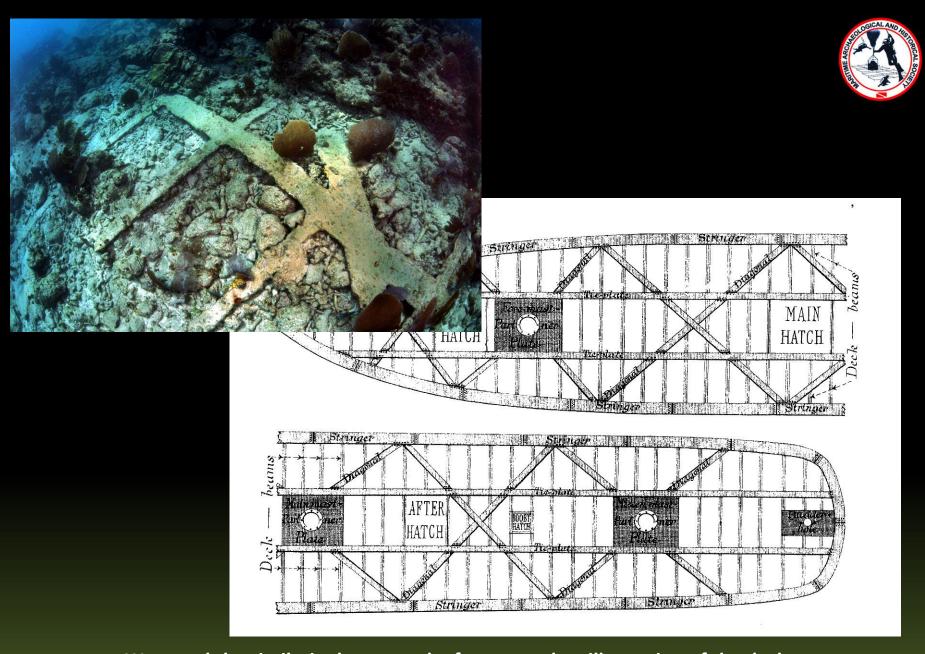
We noted the similarity between the feature and an illustration of the deck plan of an iron-hulled ship from a 19<sup>th</sup>-century publication by H. Paasch.

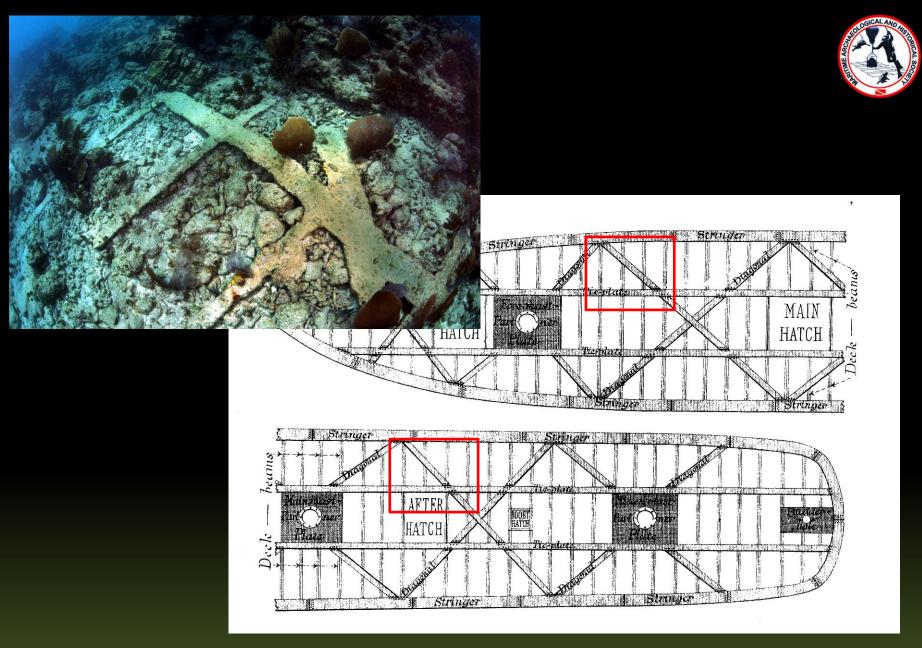
We noted the similarity between the feature and an illustration of the deck plan of an iron-hulled ship from a 19<sup>th</sup>-century publication by H. Paasch.

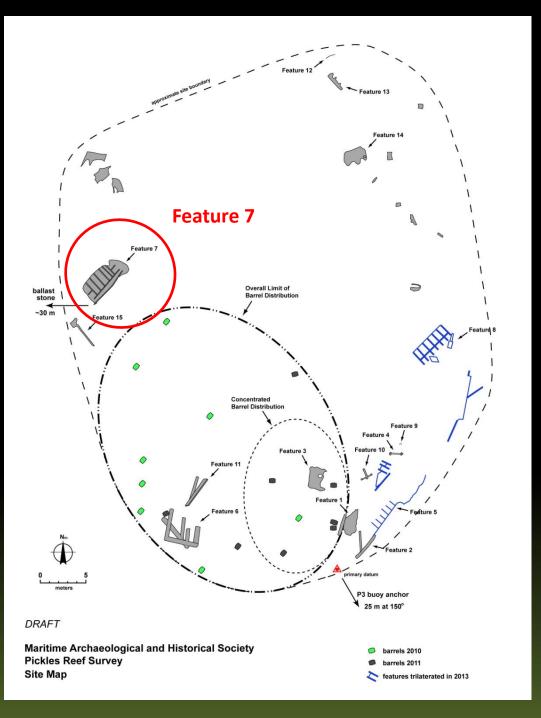
Detailed measurements were also taken of Feature 7, a bulkhead-like feature.

Feature 7 was located away from the rest of the site.

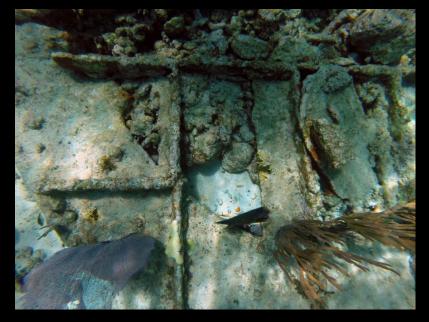
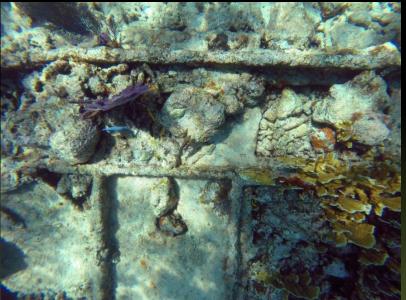
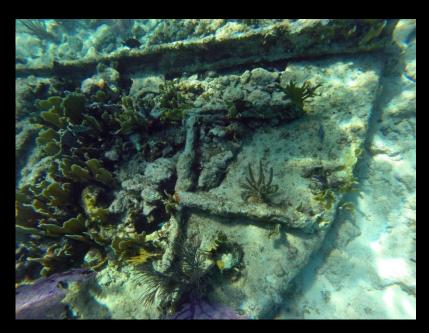
While many video images were taken, construction of a photomosaic proved unsuccessful.
