MAHS Survey 2015

Pickles Reef

Florida Keys National Marine Sanctuary

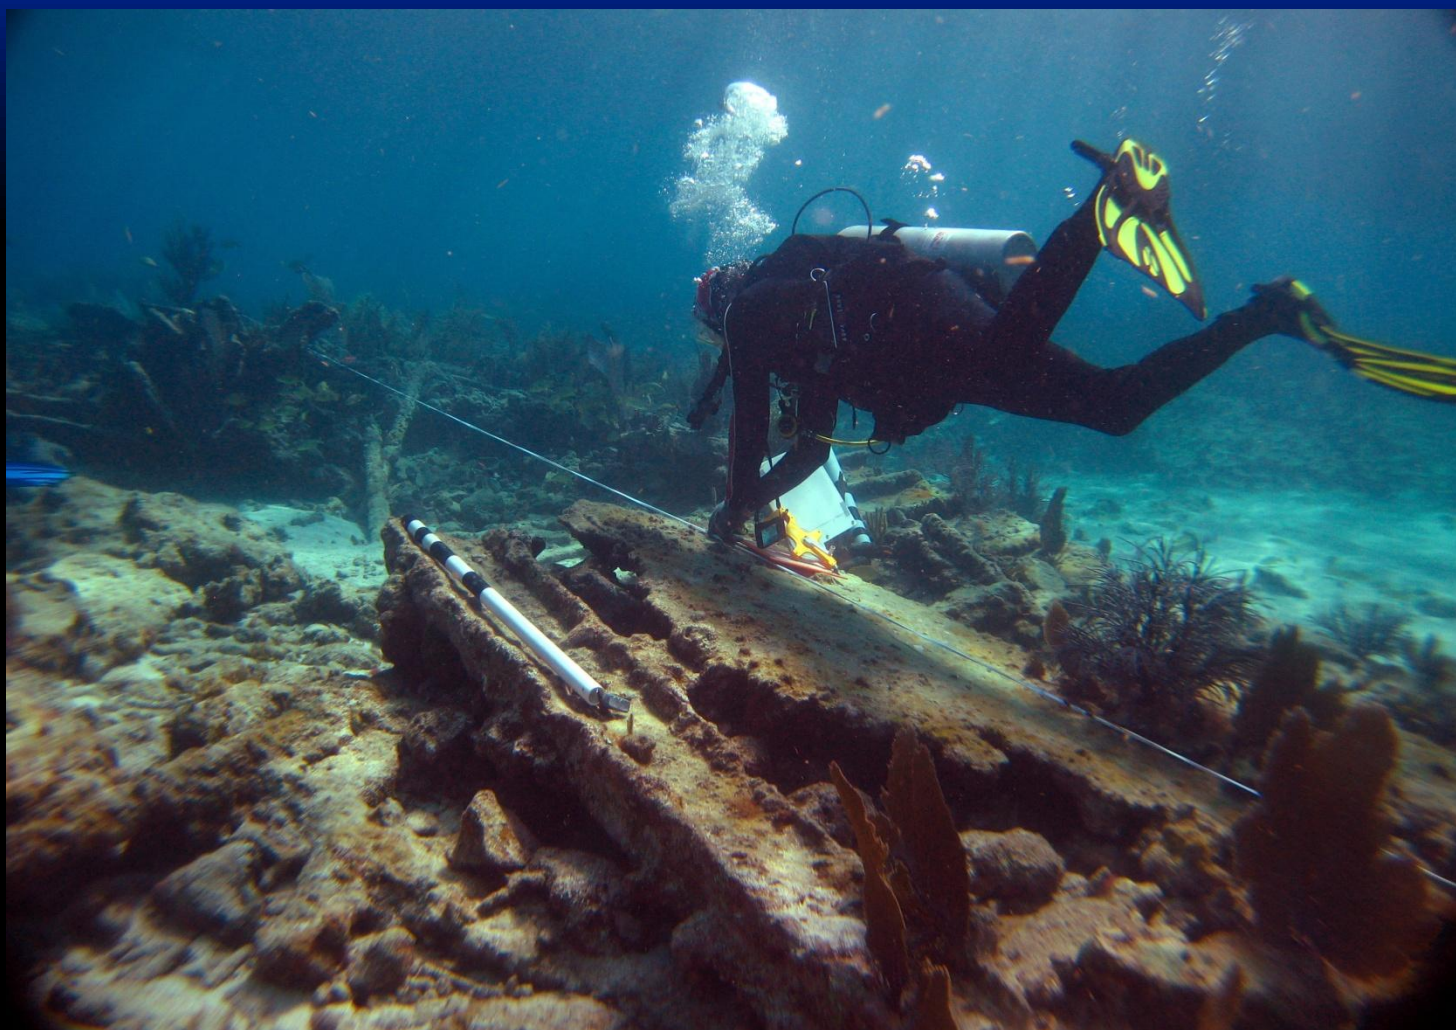
Once the baseline had been stretched between the datum stakes, it was straightened and pulled tight.

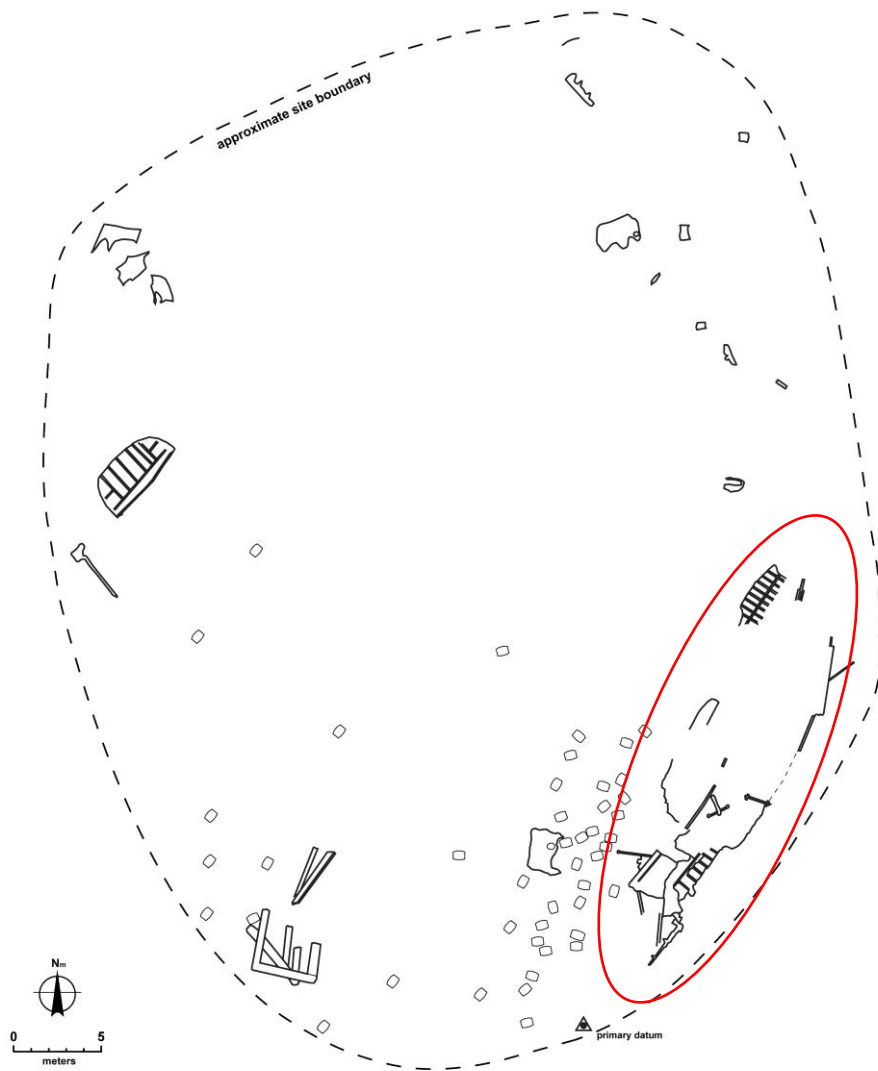
Maritime Archaeological and Historical Society
Pickles Reef Survey
Site Map June 2015

We spent time this season refining the site map, collecting additional detailed data on the metal wreckage that we now think was a schooner.

There is a lot of twisted metal covered in coral and other marine growth in this part of the site, but careful mapping is beginning to show the outlines of the vessel.

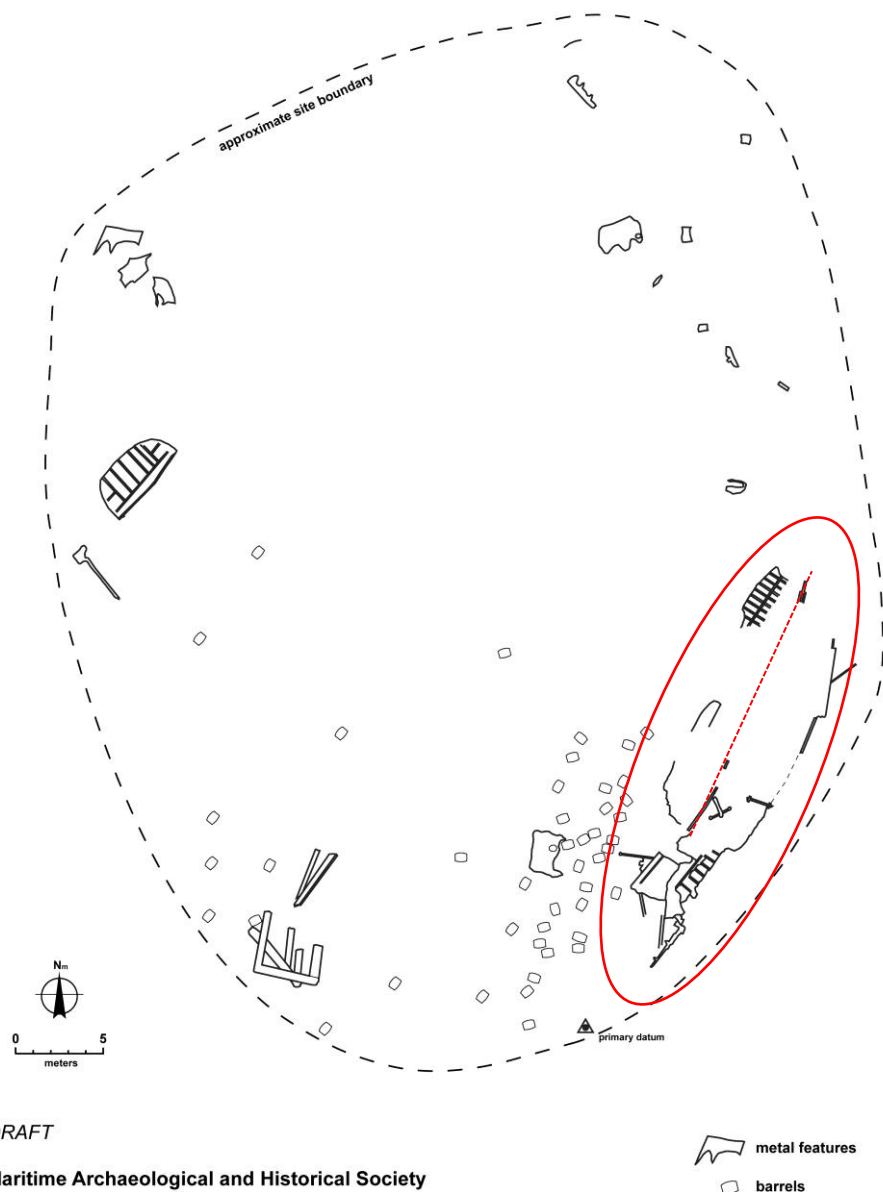
Maritime Archaeological and Historical Society
Pickles Reef Survey
Site Map June 2015

We spent time this season refining the site map, collecting additional detailed data on the metal wreckage that we now think was a schooner.

There is a lot of twisted metal covered in coral and other marine growth in this part of the site, but careful mapping is beginning to show the outlines of the vessel

...with a keelson running down the centerline.

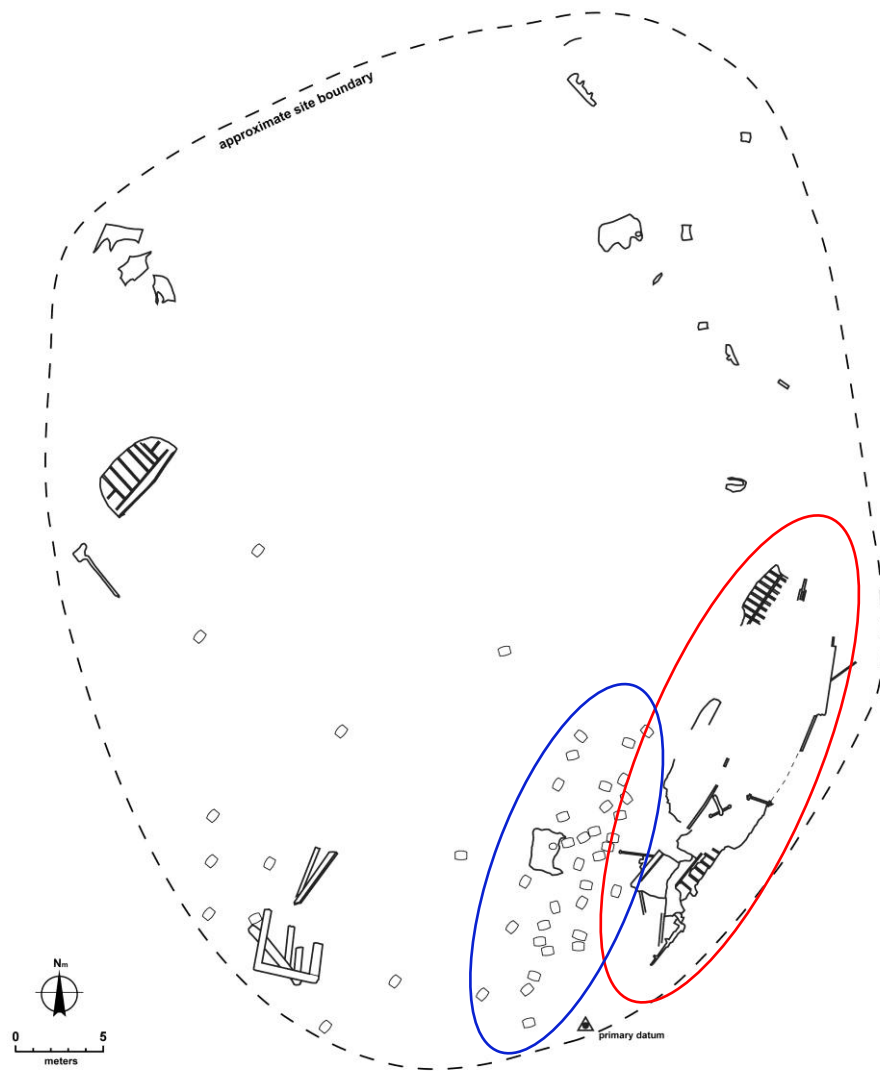
Maritime Archaeological and Historical Society
Pickles Reef Survey
Site Map June 2015

metal features
barrels

A concentrated area of barrels lies adjacent to the metal wreckage, but with very little overlap between the features.

This suggests that the archaeological remains in this part of the site may have been derived from two separate vessels.

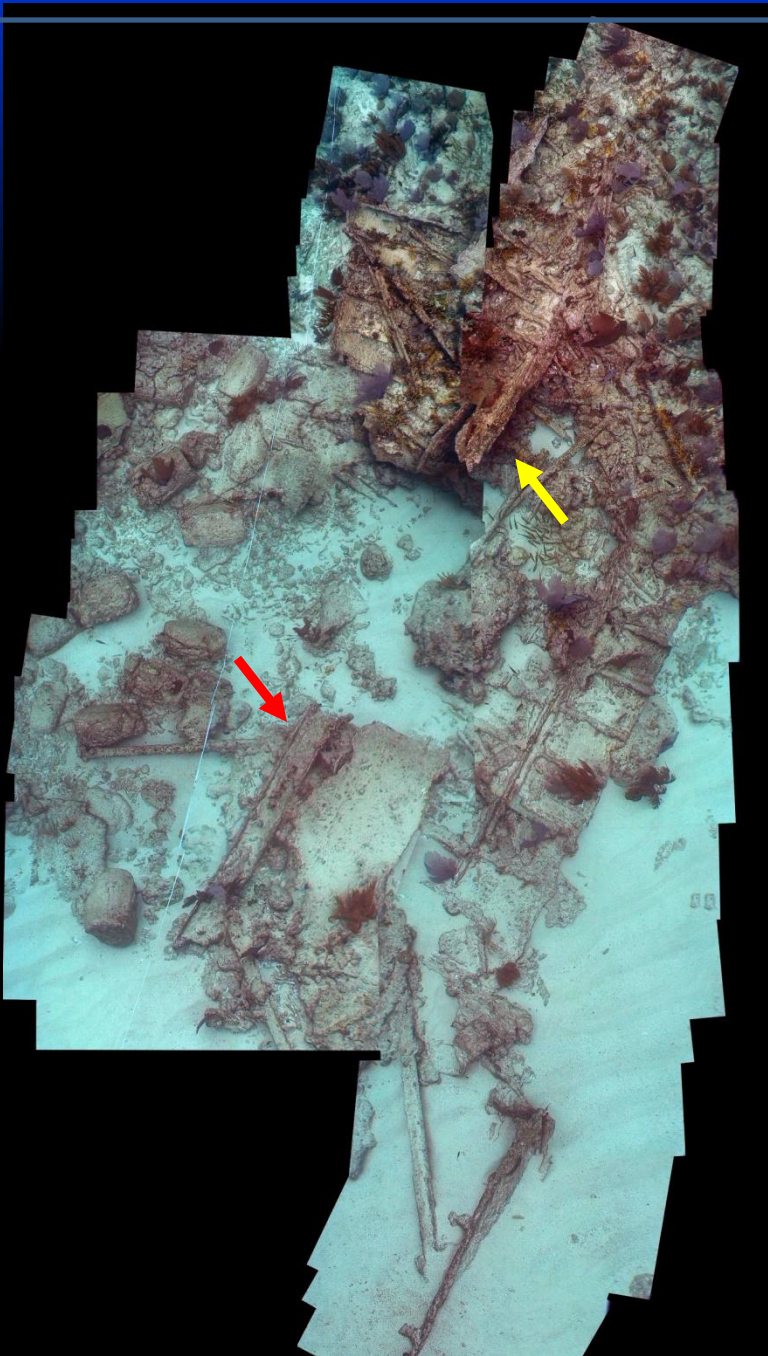
We also continued work on a photomosaic of some of the iron wreckage.

This composite image shows extensive damage to what we think was the bow of the schooner.

The yellow arrow points to the truncated forward end of the vessel's keelson.

The red arrow points to a section of the keelson that has broken off and lies disconnected in the sand.

Based on these reports, our current operating theory is that the steamer hit the bow of the already wrecked schooner, causing the extensive damage we see today.

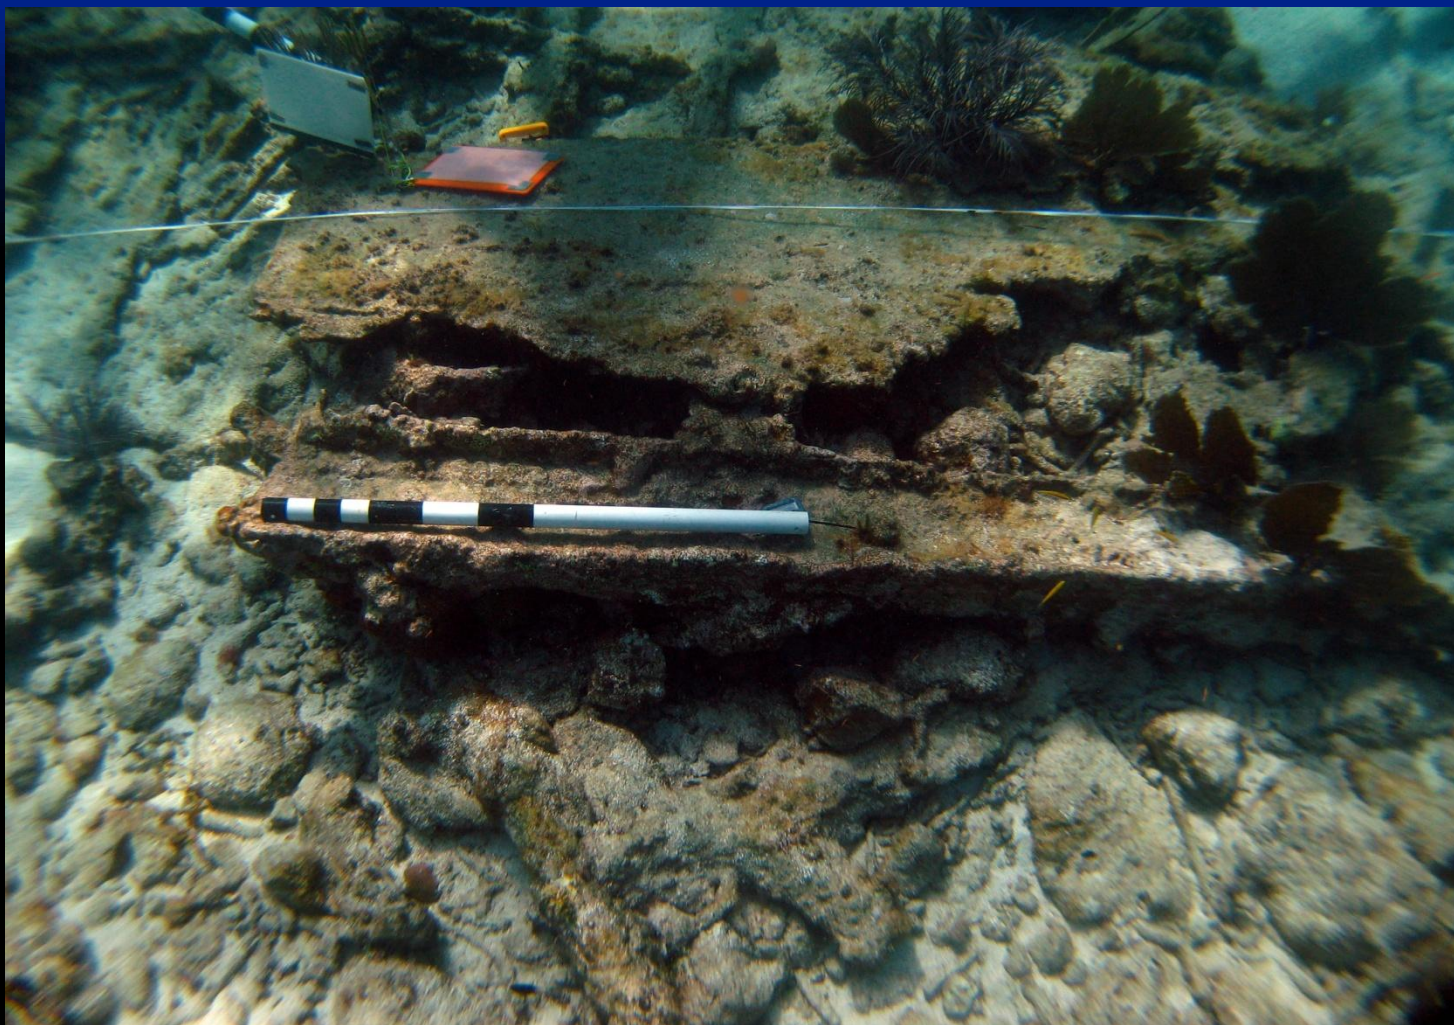
This is the broken segment of the keelson, lying next to a large but unrelated section of hull plate.

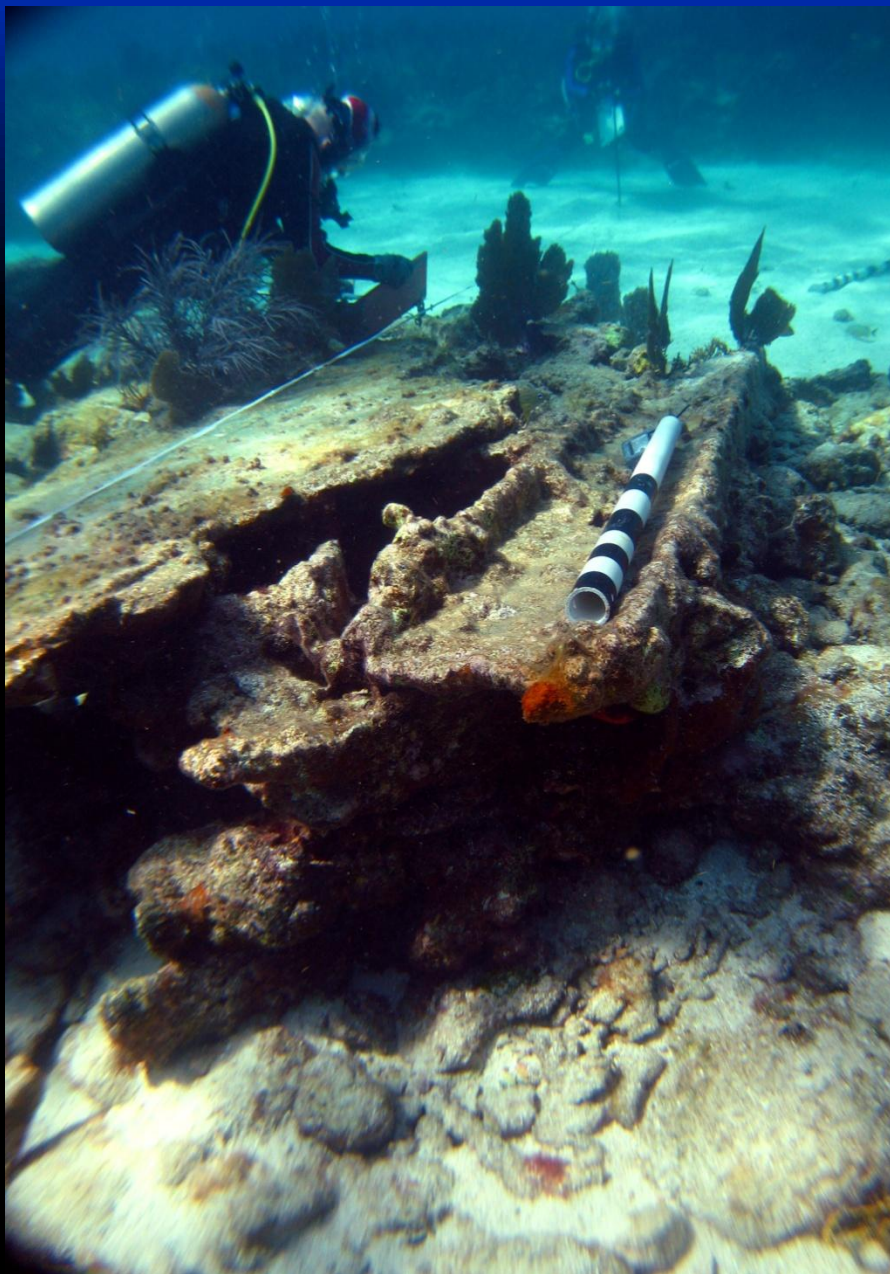
Here is an oblique view of the keelson segment.

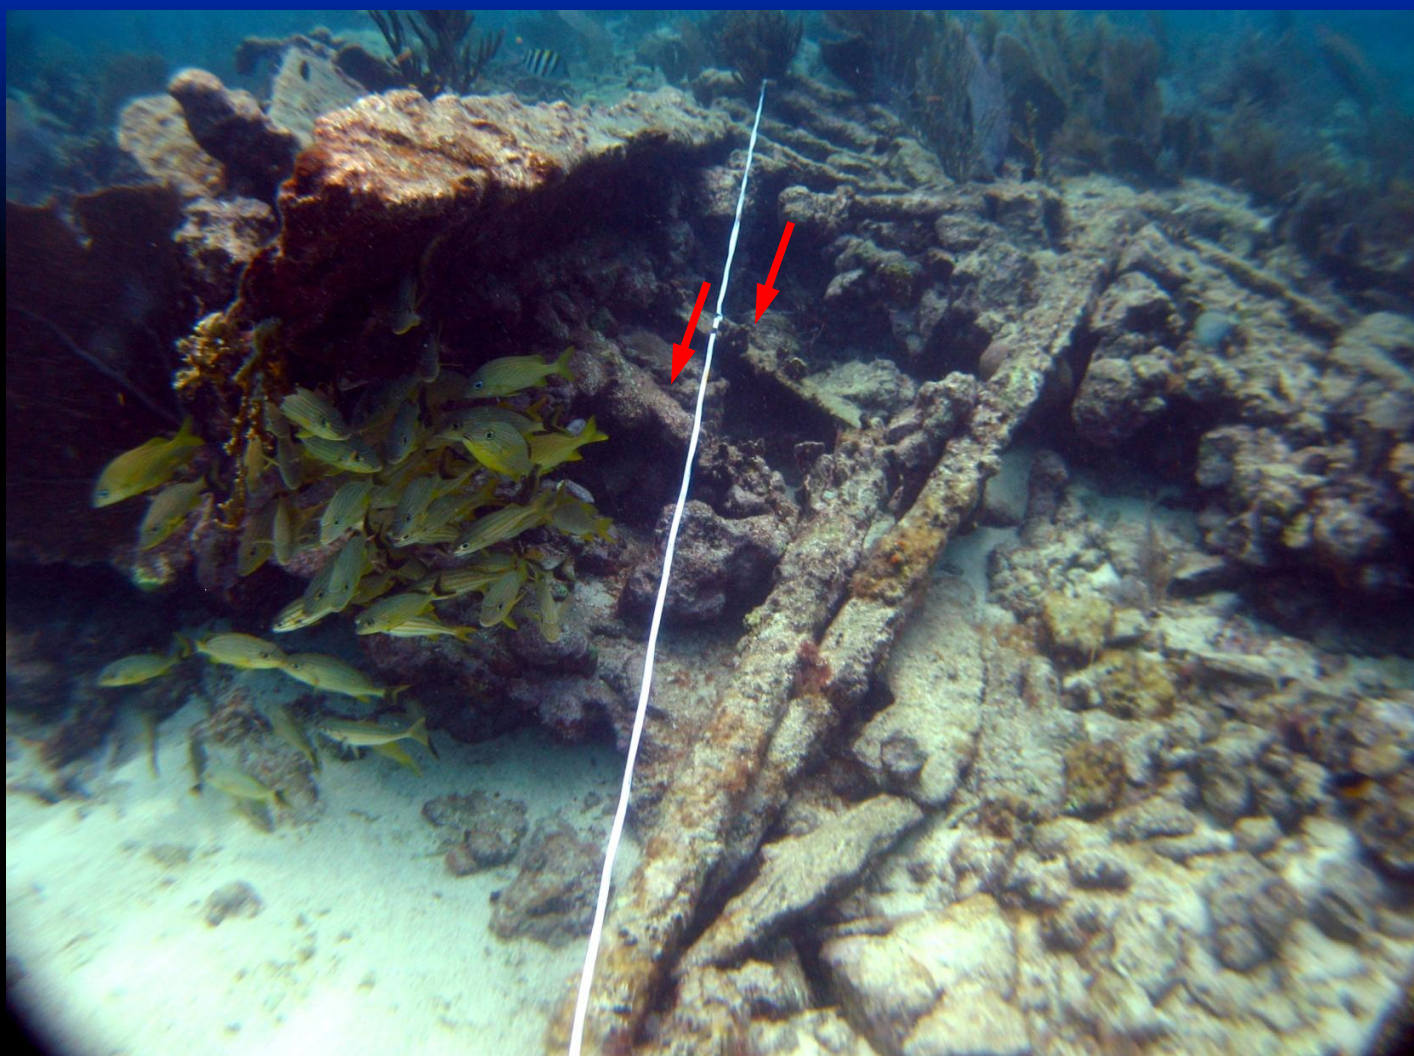
Some additional intact hull structure has been identified.
The yellow grunts are sheltering beneath the truncated end of the keelson.
The arrows mark frames beneath the keelson.

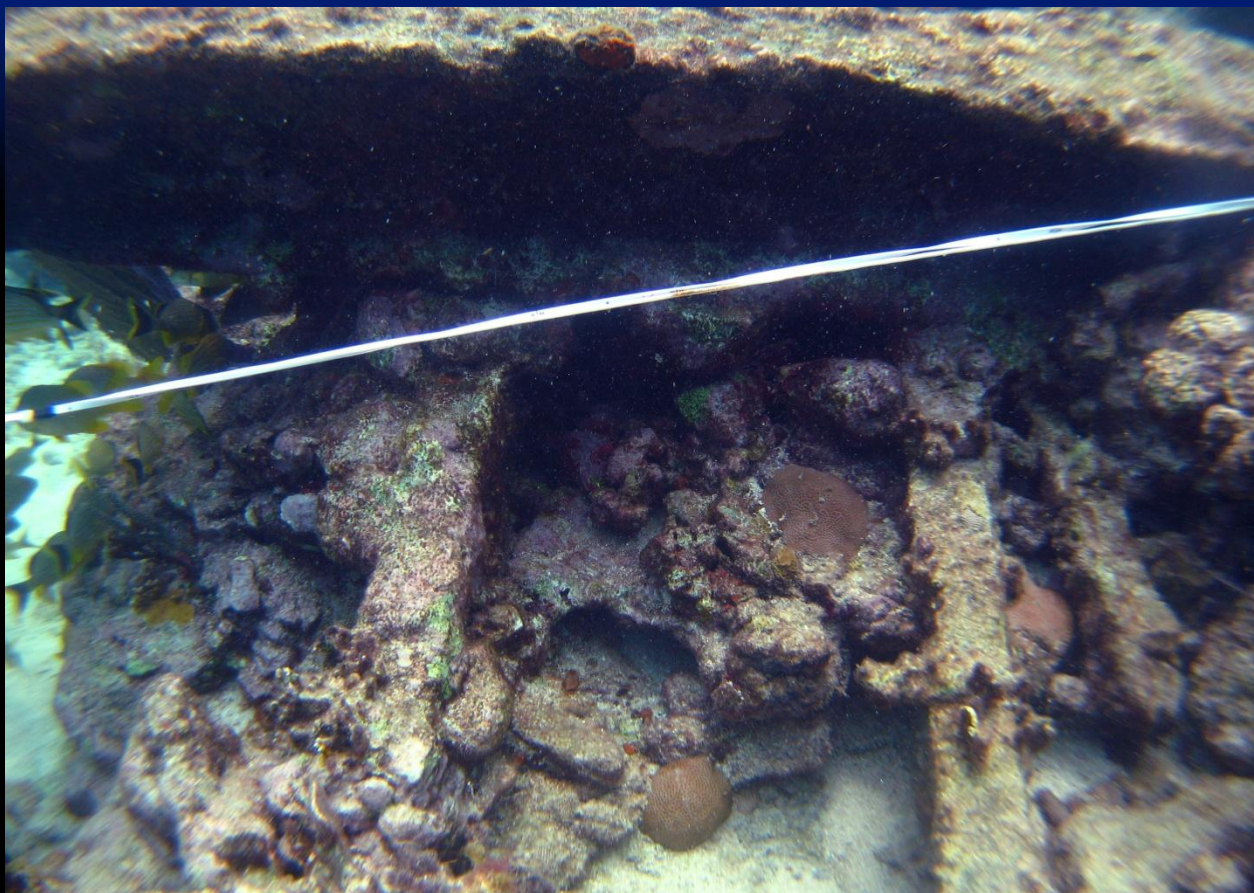
In spite of the marine growth, the frames can clearly be seen extending beneath the keelson and connected to it.

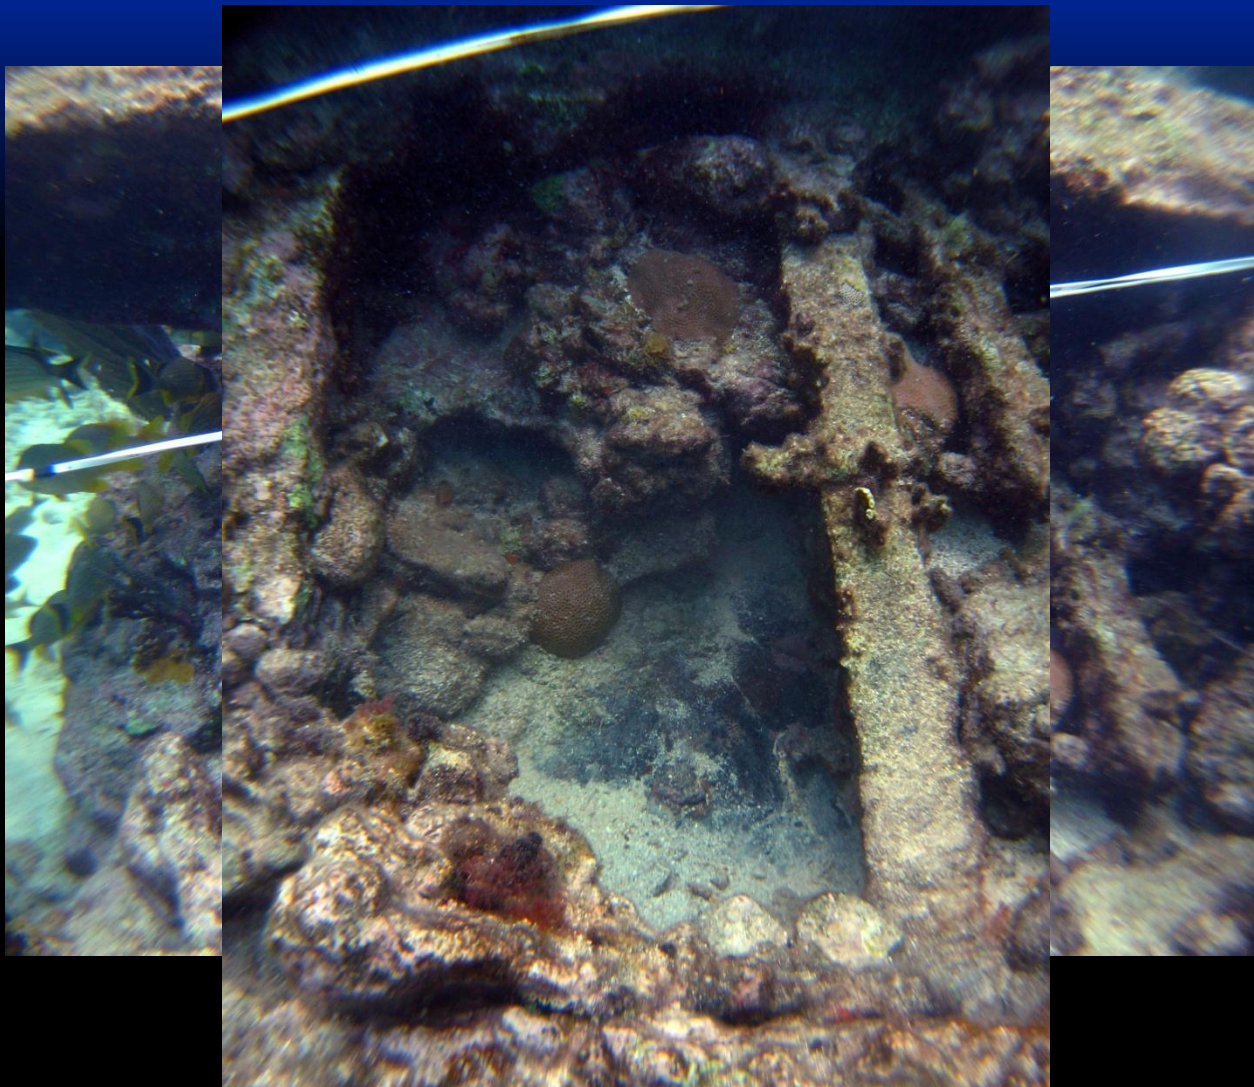
A little hand fanning reveals the inside surface of hull plates attached to the frames.

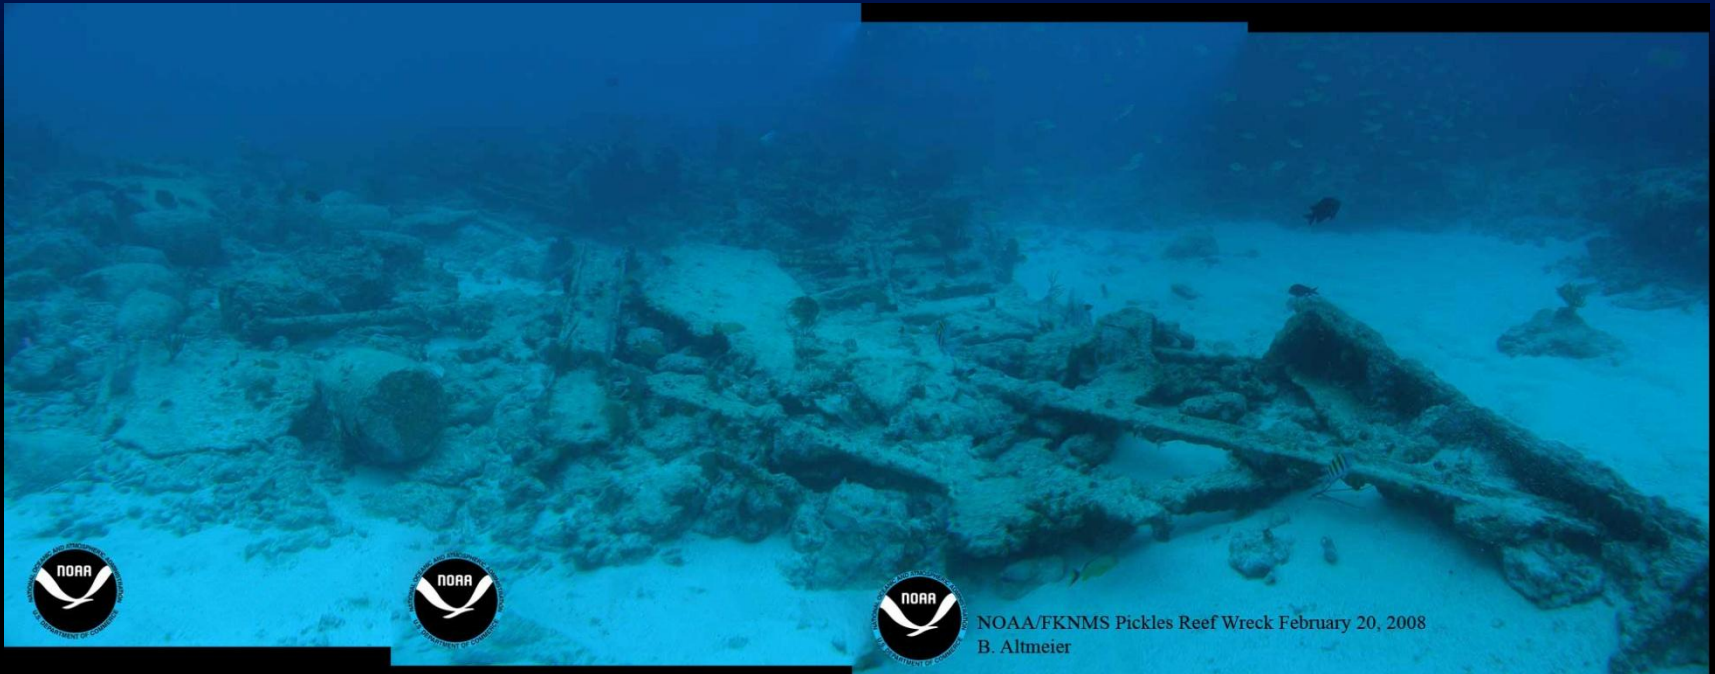
Here is a final view looking toward the bow end of the schooner. This is a composite image constructed from three pictures taken in 2008 by Brenda Altmeier, Maritime Heritage Coordinator for the Florida Keys National Marine Sanctuary.

The broken keelson fragment can be seen left of center and part of the barrel scatter to the left of that.
