**ARCHAEOLOGICAL INVESTIGATION OF  
SHIP REMAINS ALONG THE UPPER WICOMICO RIVER  
AND A SURVEY OF SITE 18WC185 (UPPER WICOMICO #1),  
SALISBURY, MARYLAND**

**Prepared by  
Dennis Knepper, Steven Anthony, Thomas Berkey  
Maritime Archaeological and Historical Society  
Washington, D.C.**

**Prepared for  
Maryland Maritime Archaeology Program  
Maryland Historical Trust  
Crownsville, Maryland**

**August 2007**

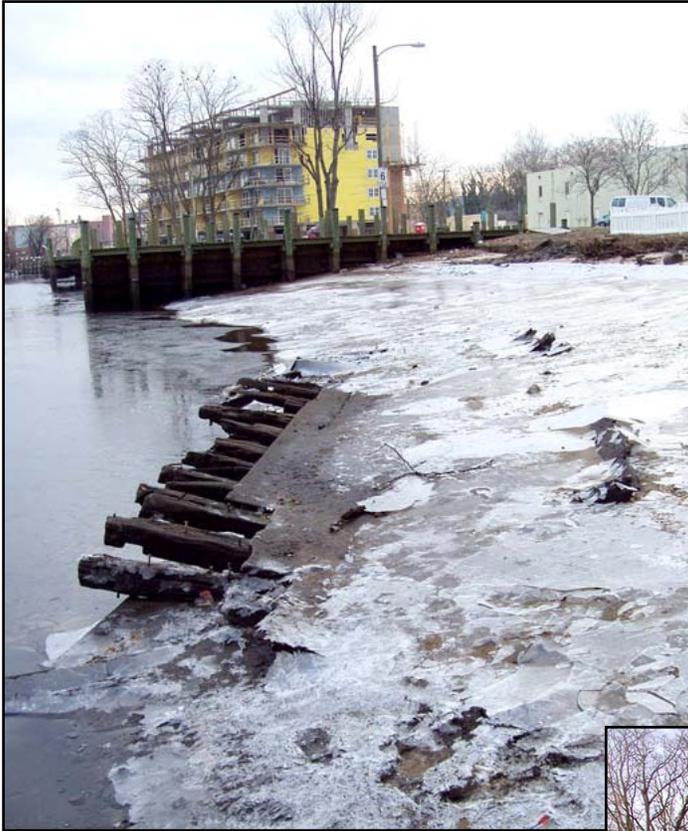
The wreckage at Site 18WC185 consisted of a section of hull from a large wooden vessel (Figure 3). The hull fragment measured approximately 12.5 meters (41 feet) in length and 3.5 meters (11.5 feet) at its widest point. The hull had separated from the keel (which was not present), and lay frame-up and partially buried in the river silts. Portions of at least 17 frames were noted along with associated ceilings and outer hull strakes (Figure 4). The hull was most intact at the west end, where 14 contiguous frames were present. At the opposite end, the wreckage was more deteriorated—the frames were badly weathered and ceilings were not apparent (Figure 5).

**Figure 3. Site 18WC185, view east with public boat ramp and pier in background.**

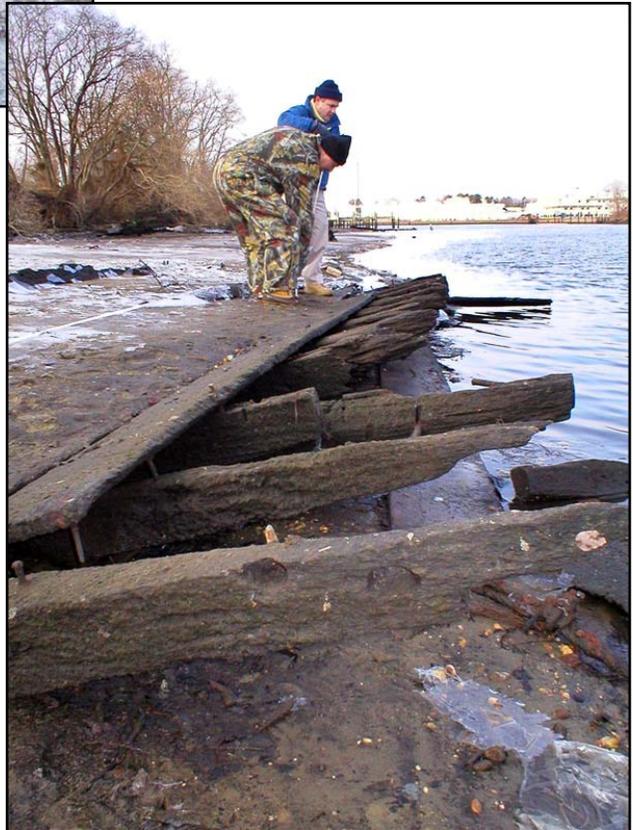
**Figure 4. Site 18WC185, frames and ceilings.**

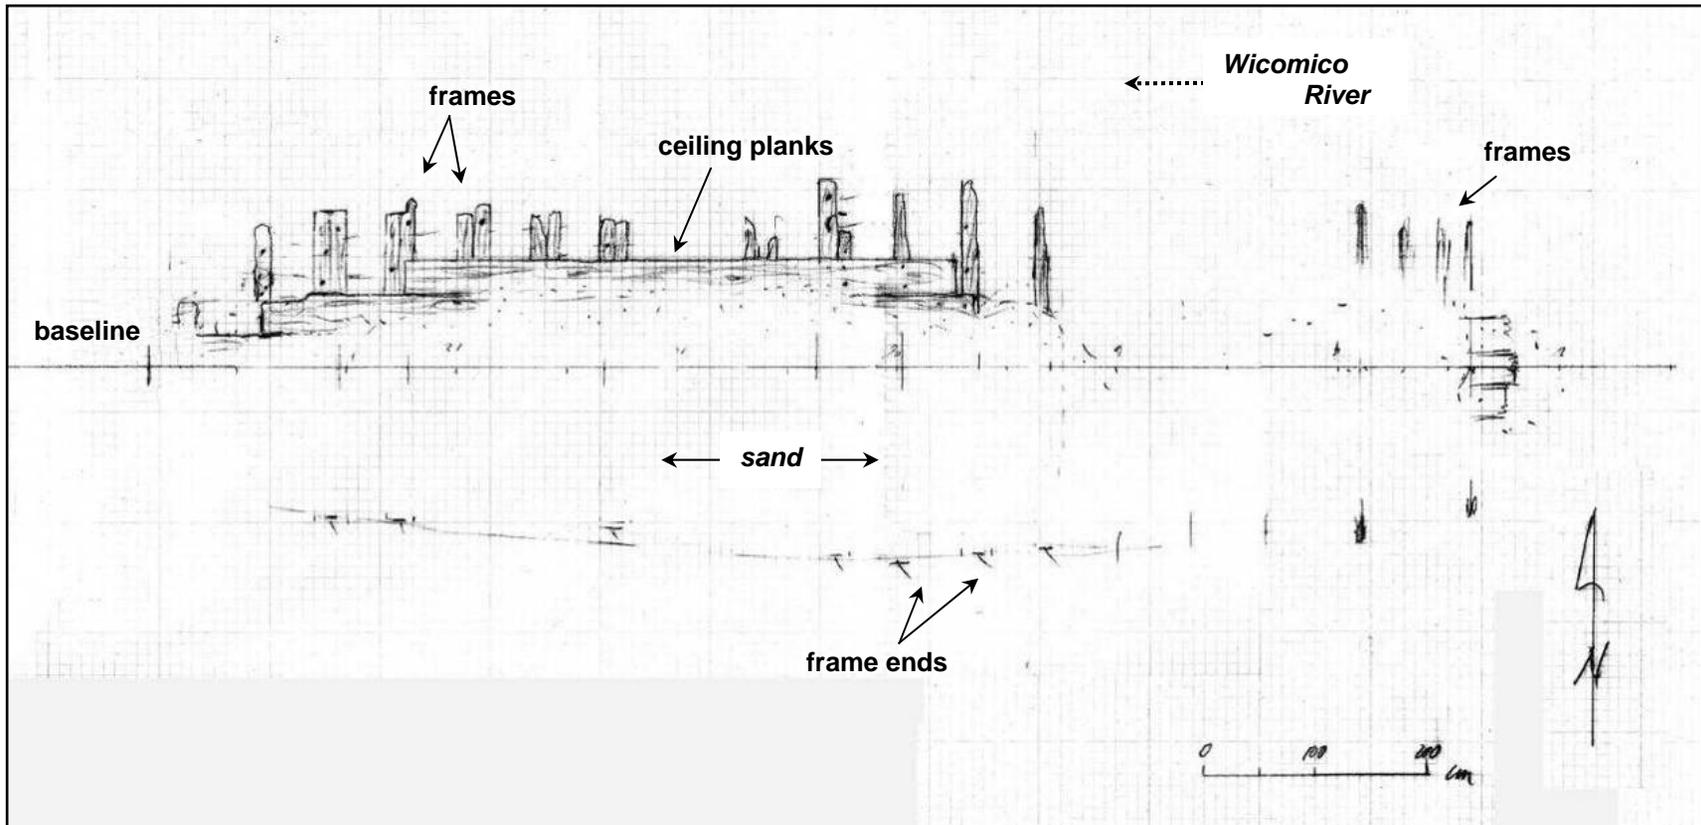
Figure 5. Plan view of Site 18WC185.

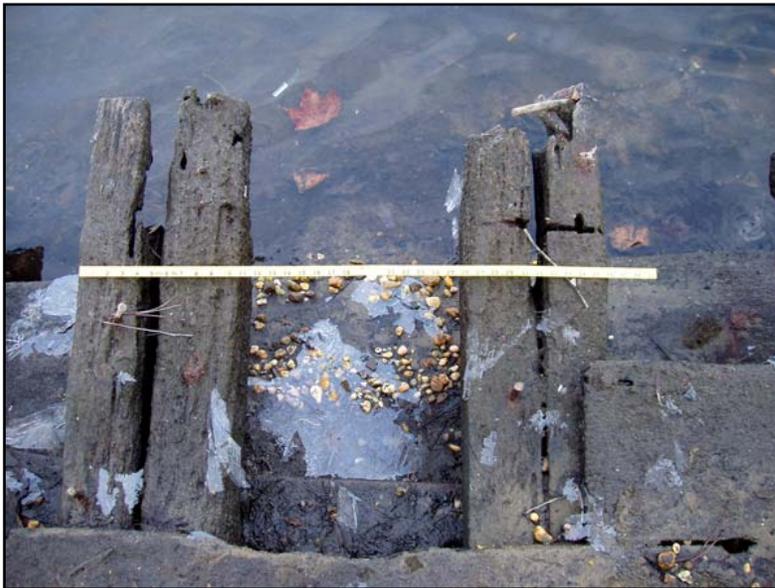
The frames were doubled, each timber measuring approximately 15 centimeters (6 inches) in width and 15 centimeters (6 inches) in thickness (sided and molded, respectively) (Figures 6 and 7). The width between frame sets was approximately 38 centimeters (15 inches), resulting in a room-and-space measurement of approximately 68 centimeters (26.5 inches). Limber holes were noted in the frames (Figure 8) indicating that the wreckage was from an area near the base of the hull where bilge water was allowed to run freely between frames. Ceilings and hull strakes both measured approximately 29 centimeters (11.5 inches) in width and 4 centimeters (1.5 inches) thick. Fasteners noted on the frames and planking consisted of iron spikes and drift pins.

**Figure 6. Site 18WC185, frames, ceilings, and outer hull planking.**

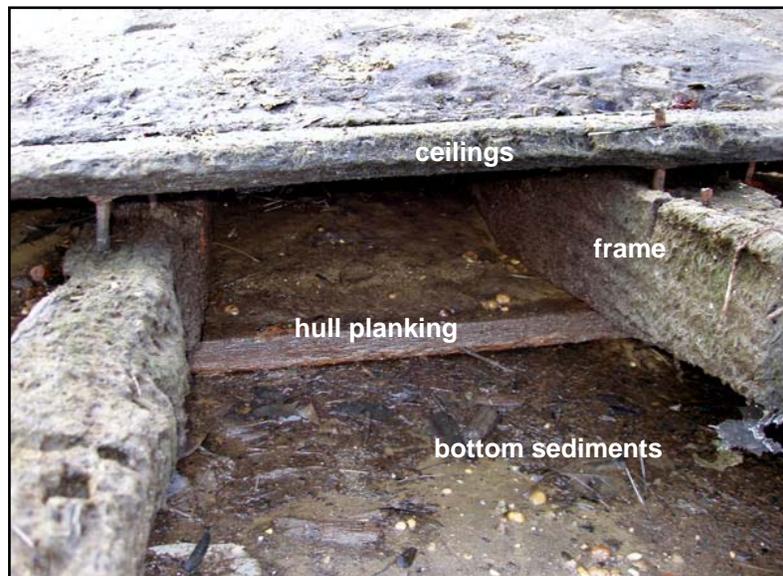
**Figure 7. Site 18WC185, frames, ceilings, and outer hull planking.**

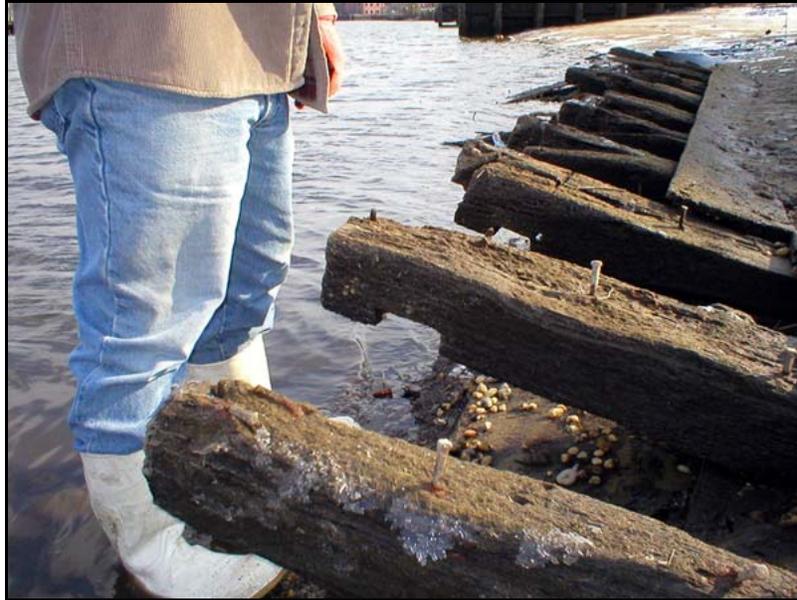
**Figure 8. Site 18WC185, limber holes in frames.**

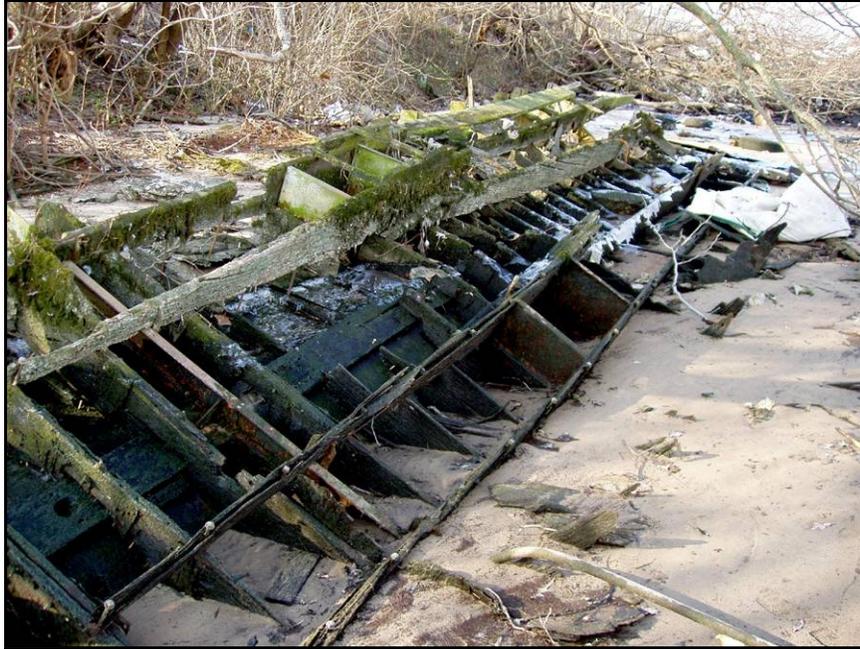
The second vessel (18WC188 - Salisbury Wreck #3) was identified by Bilicki and Langley as a Higgins Landing craft. The vessel remains lay among tree roots and miscellaneous debris at the edge of the river bank (Figure 9). Higgins Boats were used throughout World War II and were considered instrumental in the success of the Allied Invasion of Normandy on D-Day. They had unique features that included a reinforced bow that allowed the boat to run onto shore without damage, and a wide front ramp that permitted personnel to exit quickly.

**Figure 9. Site 18WC188, Higgins Landing Craft, view west.**

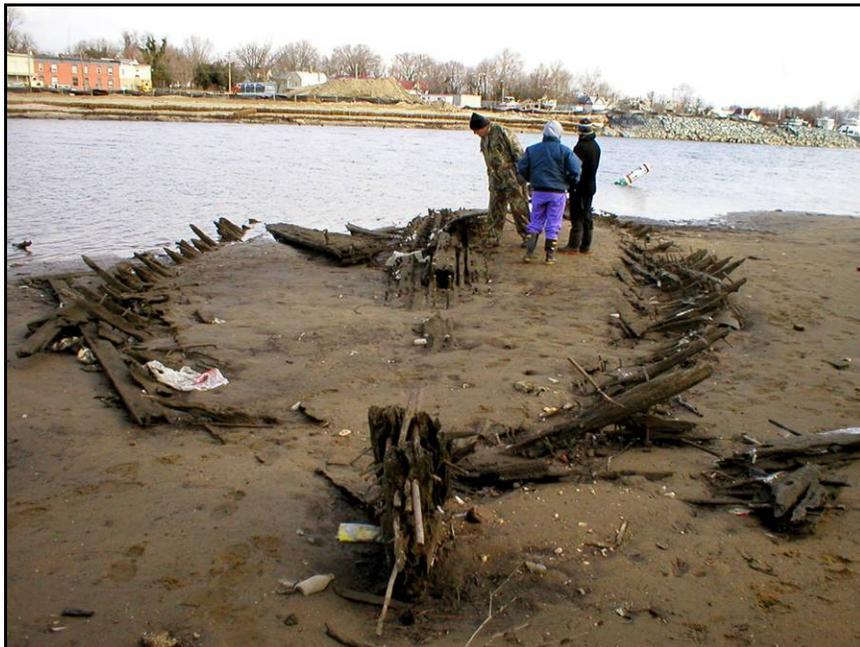
The third wreck (18WC187 - Salisbury Wreck #2) was a large centerboard vessel, possibly a schooner (Figure 10). Although close to the channel of the river and submerged beneath three to four feet of water at high tide, the vessel was completely exposed at the seasonal low tide. The vessel lay upright with the lowest portion of the hull buried in the bottom silts. Deadwood at one end, possibly the bow, can be seen in the foreground of the photo image in Figure 10. The centerbox or trunk was present along the midline of the hull, and the centerboard also survived, although it was found in several pieces (Figure 11). The pintle or spindle on which the centerboard pivoted remained in place, as seen in the detailed image in Figure 12.

**Figure 10. Site 18WC187, Centerboard Vessel, view north.**

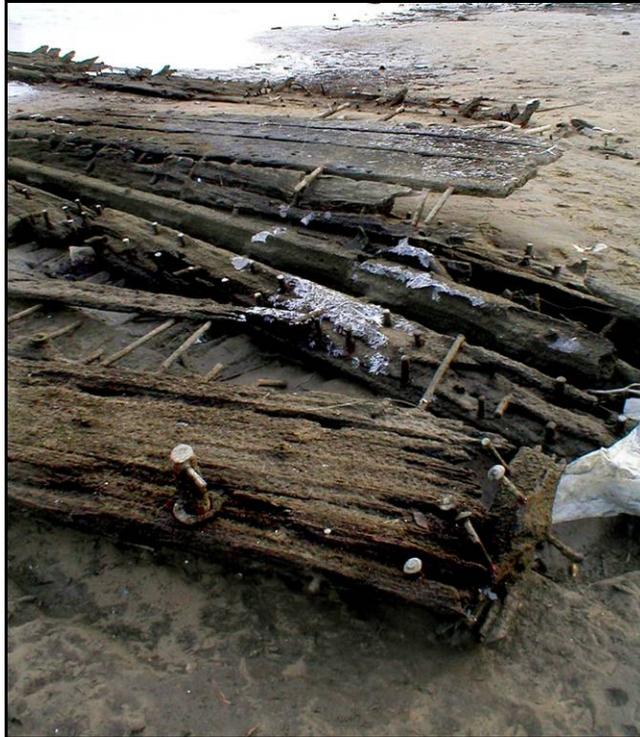
**Figure 11. Site 18WC187, Centerboard Vessel,  
detail of centerboard fragments.**

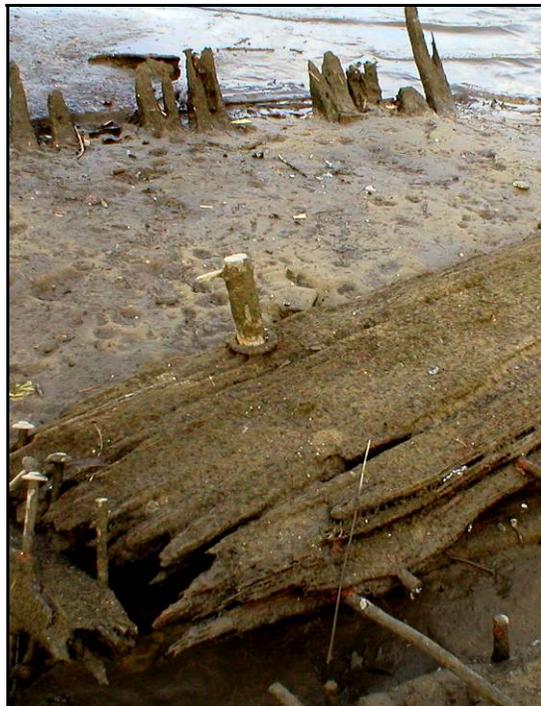
**Figure 12. Site 18WC187, Centerboard Vessel,  
detail of pintel.**

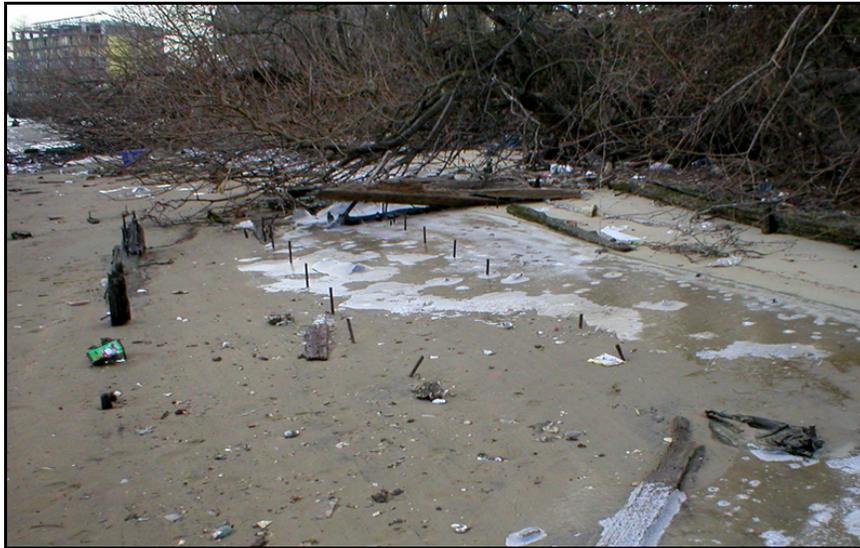
The fourth vessel (18WC186 - Salisbury Wreck #1) was identified by Bilicki and Langley as a square or rectangular barge. Little was visible above the silty bottom sediments other than a series of metal fasteners (Figure 13).

**Figure 13. Site 18WC186, with fasteners standing out of the silt in two parallel rows, view E.**

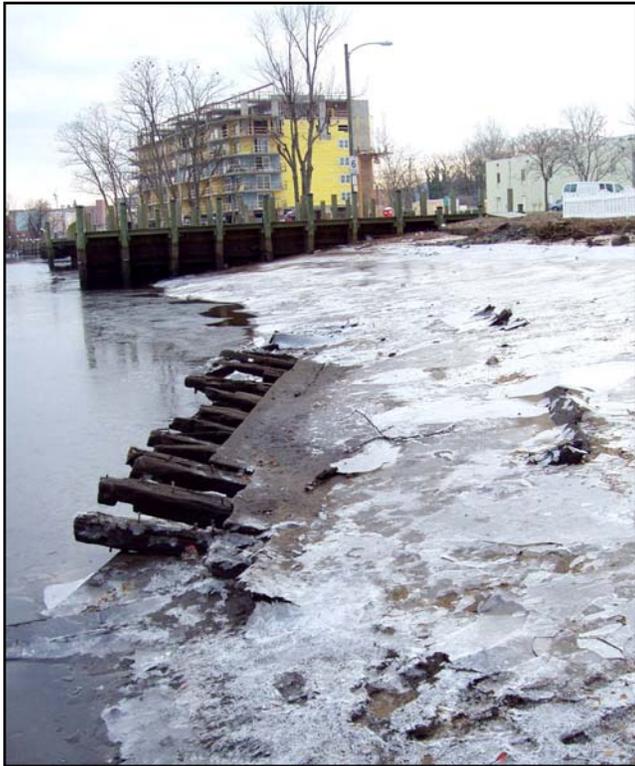
*Upper Wicomico #1 showing hull remains in the icy silts at low tide on the Wicomico River in Salisbury. The public landing east of the site is in the background. Photos by T. Berkey and D. Knepper.*

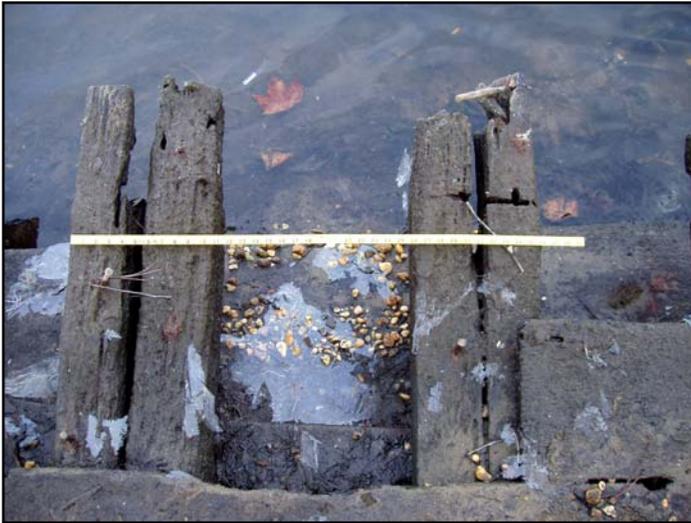
The frames were doubled, each timber measuring approximately 15 centimeters (6 inches) in width and 15 centimeters (6 inches) in thickness (sided and moulded, respectively). The width between frame sets was approximately 38 centimeters (15 inches), resulting in a room-and-space measurement of approximately 68 centimeters (26.5 inches). Limber holes were noted in the frames indicating that the wreckage was from an area near the base of the hull where bilge water was allowed to run freely between frames.

*Detail of frames showing spacing and fastener pattern.*

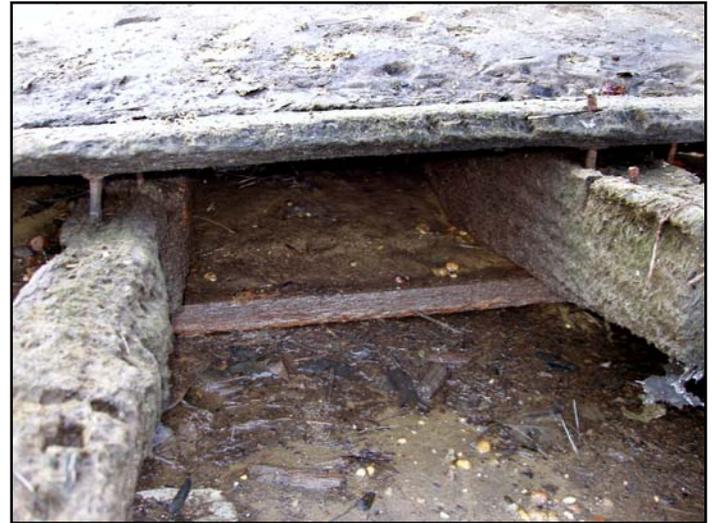
Ceilings and hull strakes both measured approximately 29 centimeters (11.5 inches) in width and 4 centimeters (1.5 inches) thick. Fasteners noted on the frames and planking consisted of iron spikes and iron drift pins.

*Detail showing frames, ceilings (above) and hull strakes (below).*

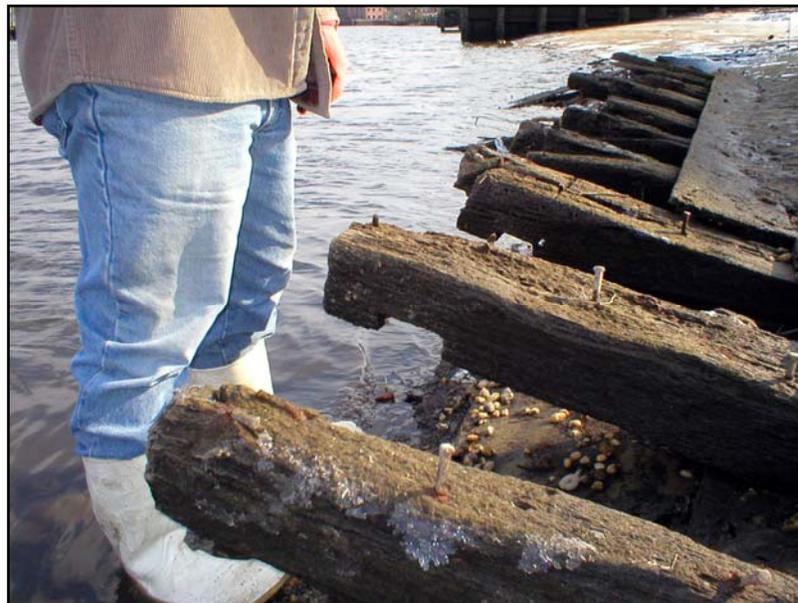
*Frames showing limber holes.*
