**MAHS Field School 2018
Pickles Reef
Florida Keys National Marine Sanctuary**

MAHS returned to Pickles Reef in June of 2018 to hold its annual field school.

FKNMS reported extensive damage to both natural and cultural sites in the Upper Keys, including Pickles Reef. The Sanctuary asked MAHS to resurvey the Barrel Wreck to assess its condition following the storm.

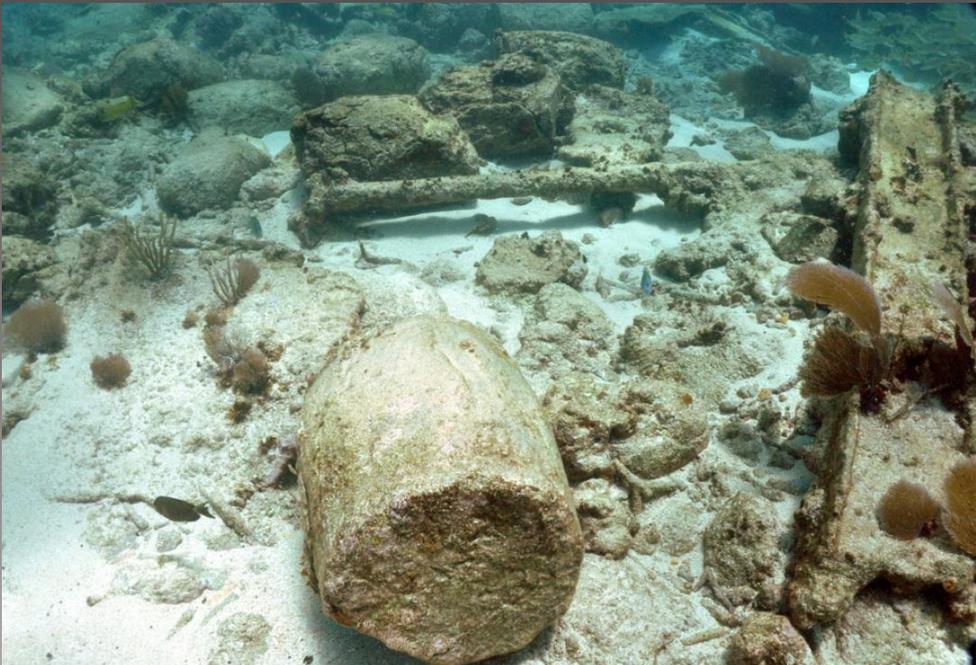
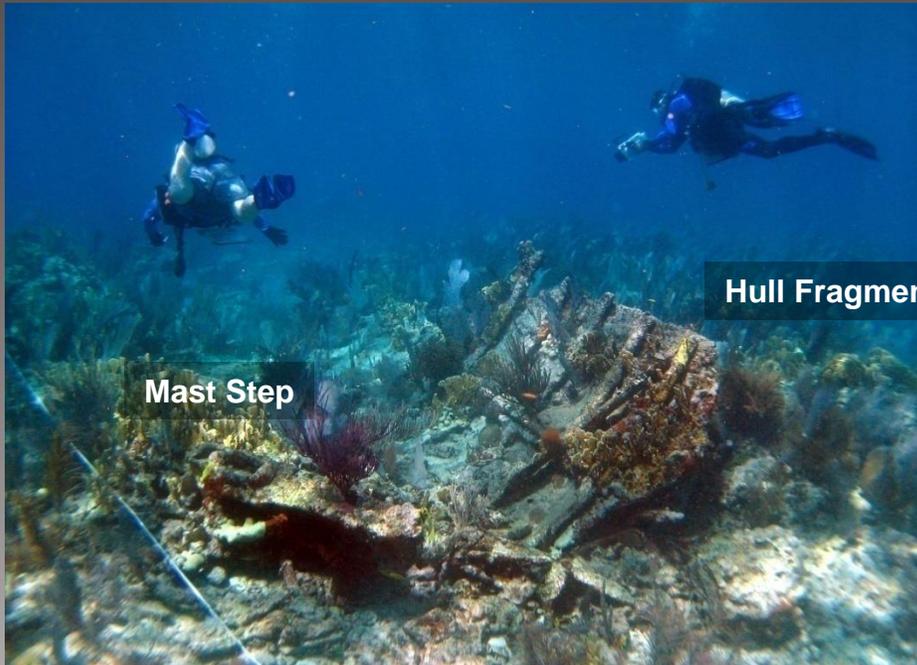
Mast Step

Hull Fragment

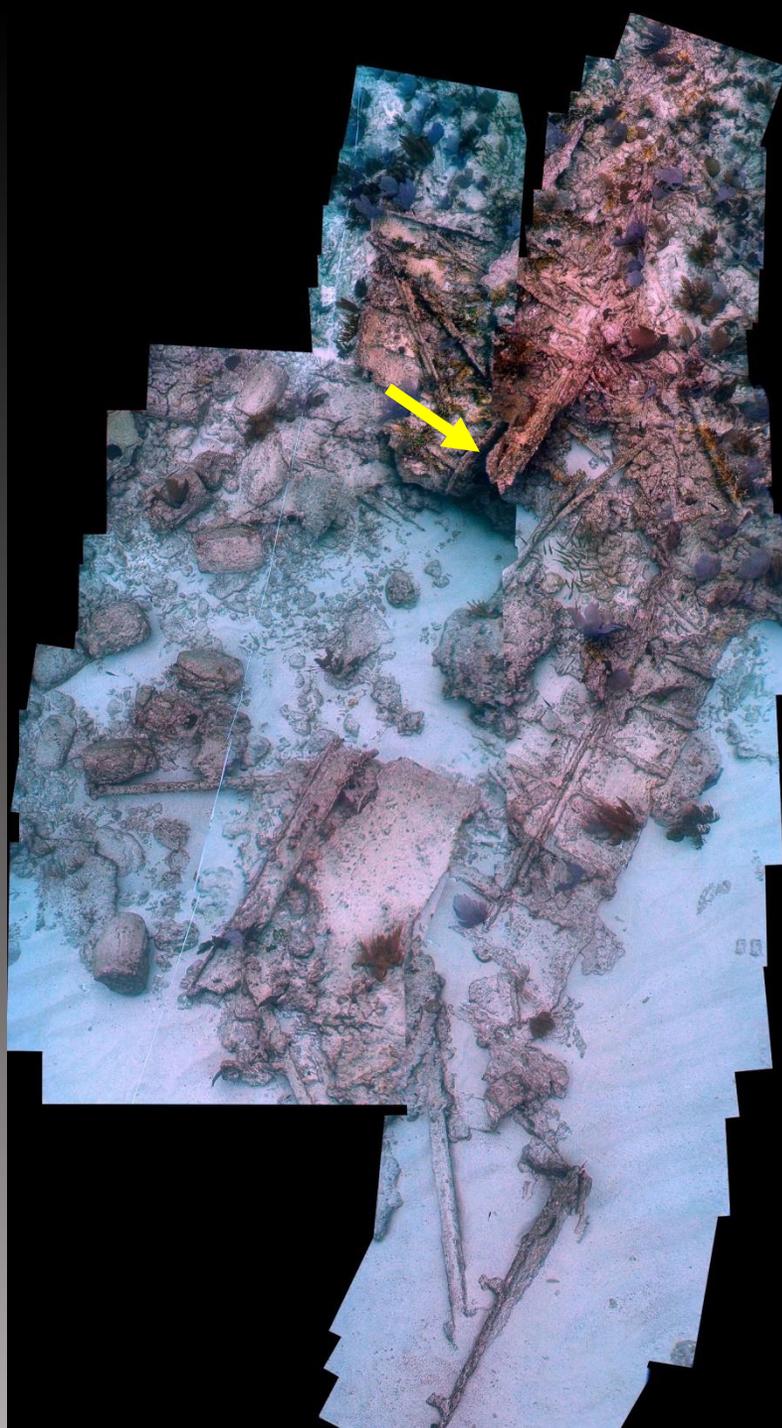
Over the years we've constructed several photomosaics of parts of the wreck. This image is of the south end showing the truncated end of the keel assembly, which is indicated by the arrow and has been used by divers for orientation.

Various disarticulated debris lies to the south, in the bottom part of the image.

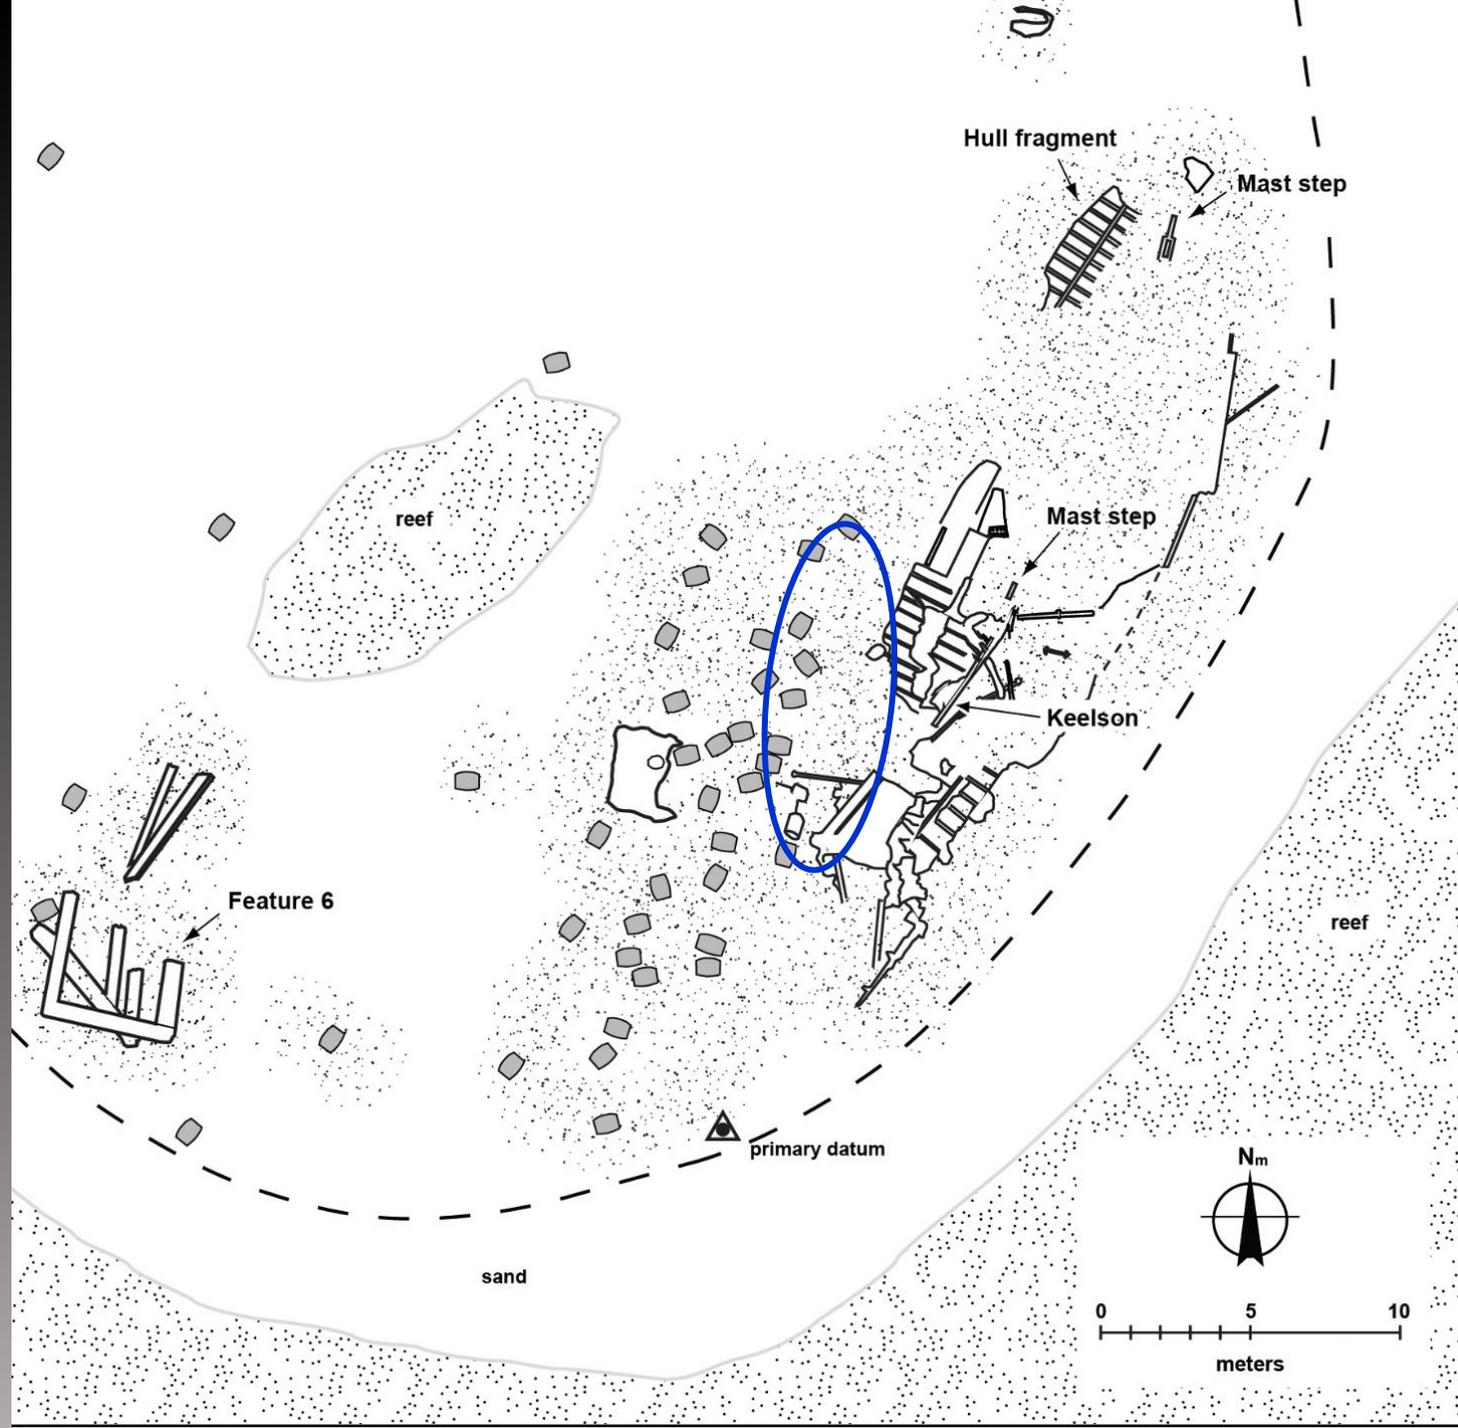
The photo-mosaics in the following slide show before and after images of barrels and metal fragments just south and west of the wreck.

The location of the transects is approximated by the blue oval.

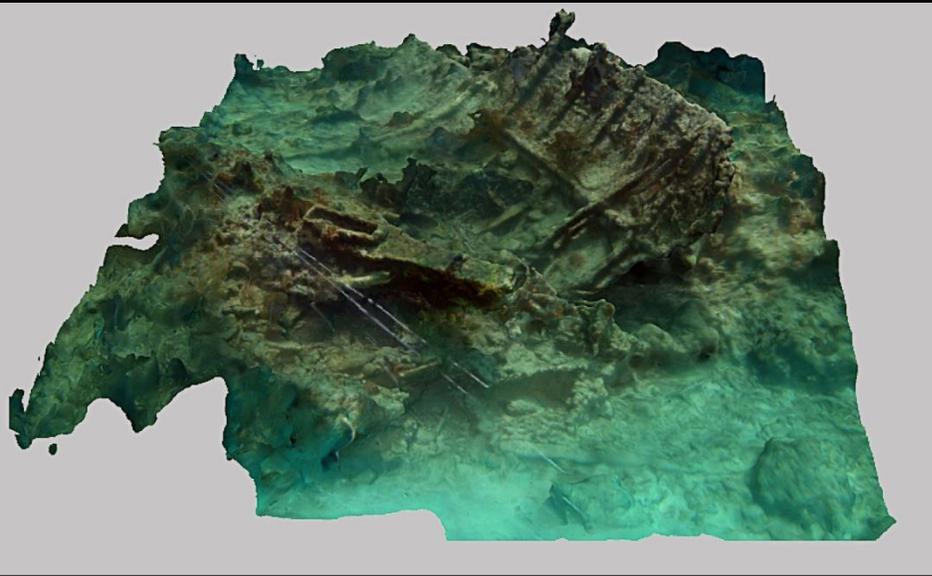
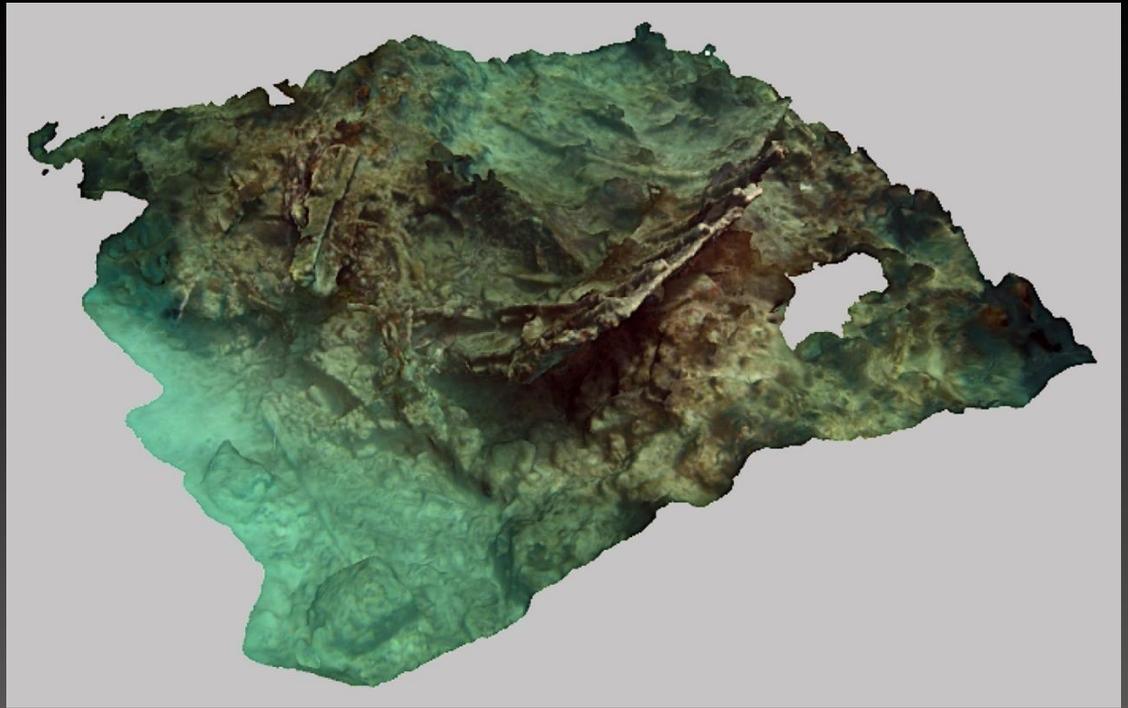
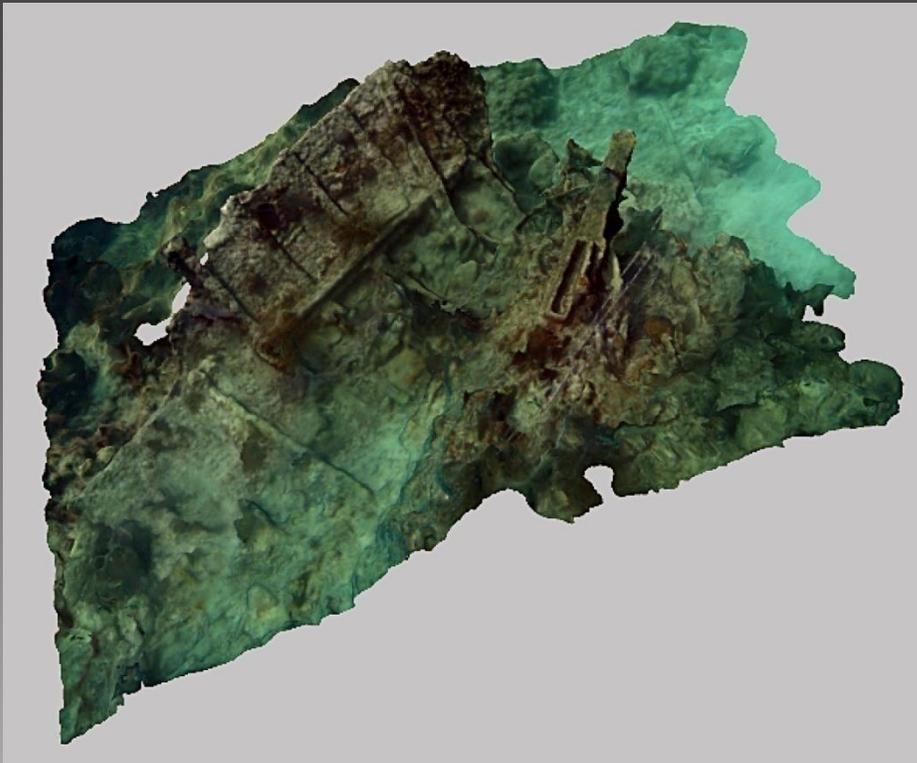
These are 3-D images of the mast step and hull fragment at the north end of the wreck, some of the results of the photogrammetry work.
